MUSH

Architectural Heritage at Risk

This study, in which the historical structures of Mush are considered, primarily aims to assess the architectural history in the province, identify the current conditions of at-risk architectural works, and contribute to their continued existence through scientific suggestions. We believe that this book may be beneficial in the decision-making processes of relevant persons, institutions, and conservation boards since it contains information about settlement history, buildings' history, architectural analysis, legal status, risk assessment, and potential future scenarios. We hope that it may also help to transfer cultural heritage to future generations and create awareness.

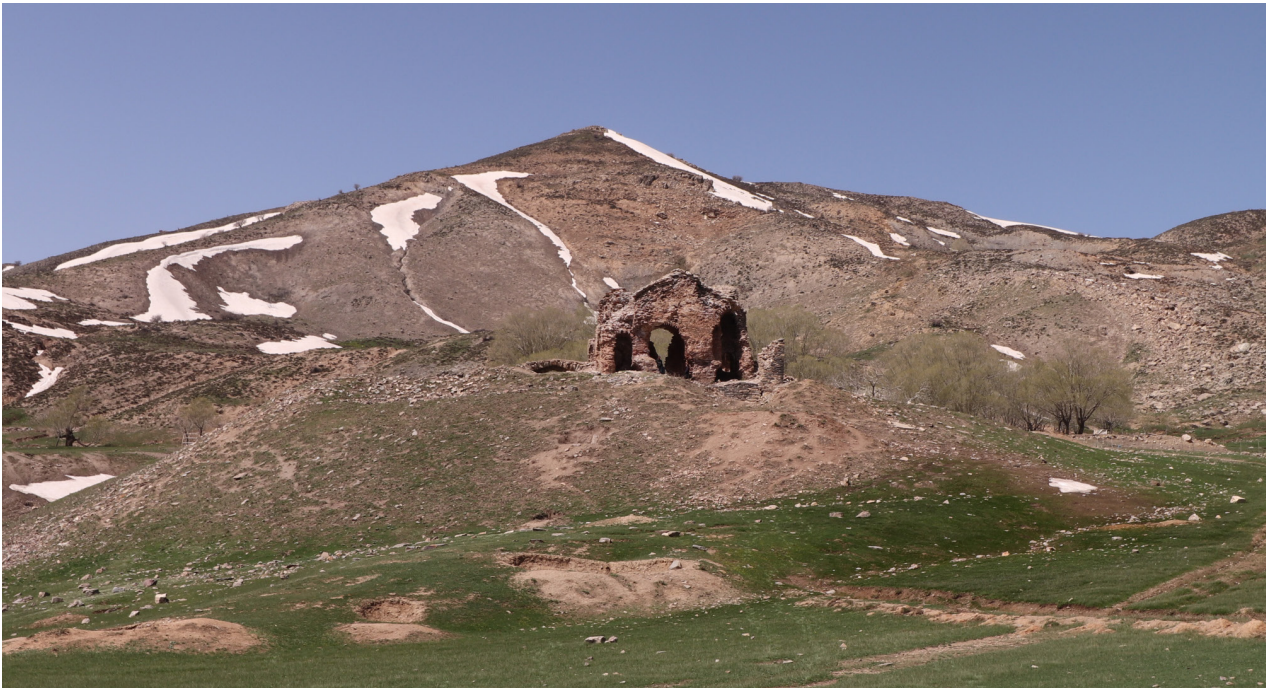
Fig. 5 - Surp Arakelots Monastery, view from the east

Surp Arakelots Church was built in the 11th century; it has a cross-in-square plan layout with a single nave and a central dome (Fig. 5).

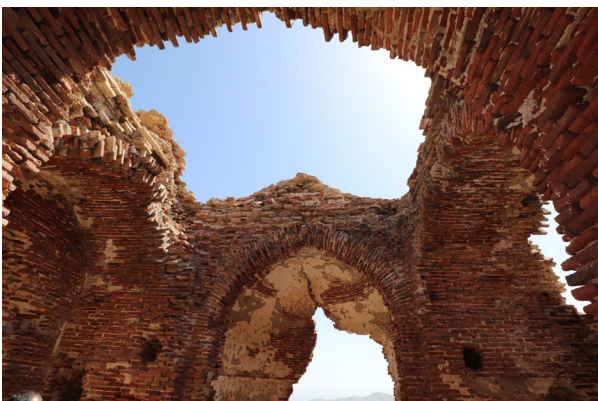
Fig. 6 - Surp Arakelots Church, detail of brick masonry from the walls and arches

The wall thickness in the church varies between 1.30-1.50 m. The walls and arches are constructed of brick. The dimensions of individual units vary between 5-5.5x27x27 cm for bricks and 4-4.5x12.5x26 cm for half-bricks, while the joints are roughly 2-2.5 cm in thickness. The mortar contains a mixture of white lime and small pieces of stone and brick. The interior faces of the walls are plastered and painted, as observed during the fieldwork (Fig. 6). Holes are attested for tie bars that must have connected the arches. Parts of the squinches of the octagonal dome are still standing. The tall dome and the triangular-prism roofs attached to it have collapsed.

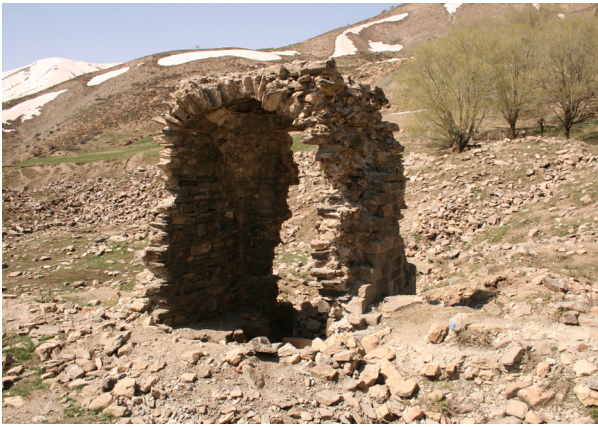
Fig. 7 - Remains of the belltower

246-7; HSH 1981, 658; Maranci 2016, 125). The ground floor has survived; the dimensions of its plan are approximately 4.40x4.40 m (Fig. 7). Its ceiling is a groin vault. The exterior faces of the walls are ashlar masonry, while the interior faces are rubble masonry. Pilasters are attested adjacent to the main entrance. At the highest elevation of the façade, there is eave moulding that protrudes from the structure in a layered manner.

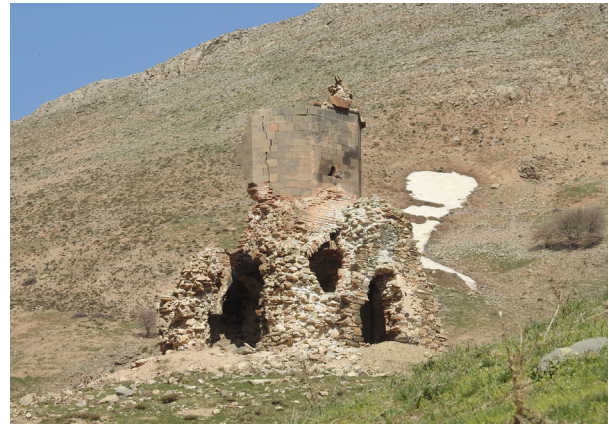
Fig. 9 - Surp Tateos Chapel

Surp Tateos Chapel is situated outside the monastery, 300 m to the northeast. It has a single nave and a cross-in-square plan (Fig. 9). It is thought that the building was constructed between the 12th and 16th centuries (Thierry 1976, 251). The muqarnas on its squinches suggest an affinity with the architectural style of the Late Artuqid Period (Kertmenjian 2014, 12). The reliefs decorating the exterior of its dome are shaped in floral forms, crosses, and lions. It could also have been constructed in the 13th-14th

Surp Tateos Chapel is in better condition compared to Surp Arakelots Church and the other buildings on site. Traces of construction techniques and original details are more legible.

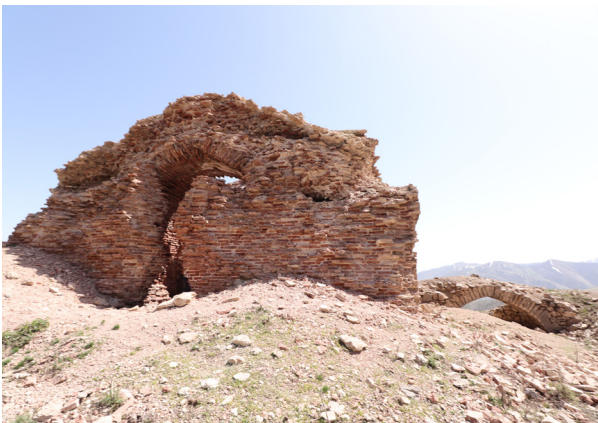
Fig. 8 - Western façade of Surp Arakelots Church and arch of Surp Stepanos Chapel

It adjoins the southern wall of Surp Arakelots Church. Sources indicate that it was built in 1663 above the remains of an older church that had been destroyed by Timur's forces at the end of the 14th century (HSH 1981, 658). The chapel has a single nave and a barrel vault (Thierry 1976, 246-7). Today, most of the structure is buried underground; only the arch at the start of its barrel vault is visible above ground (Fig 8).

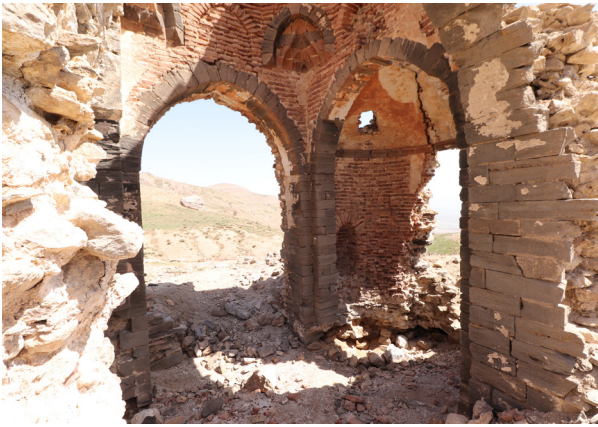
Fig. 10 - Ashlar-stone and brick masonry units

The dimensions of the bricks used to construct Surp Tateos Chapel vary between 5x20x30 cm, 5.5x19.5-20x32 cm, and 5.5x14x27 cm. The horizontal joints are 2-2.5 cm in thickness, similar to Surp Arakelots Church. The mortar is made of white lime.

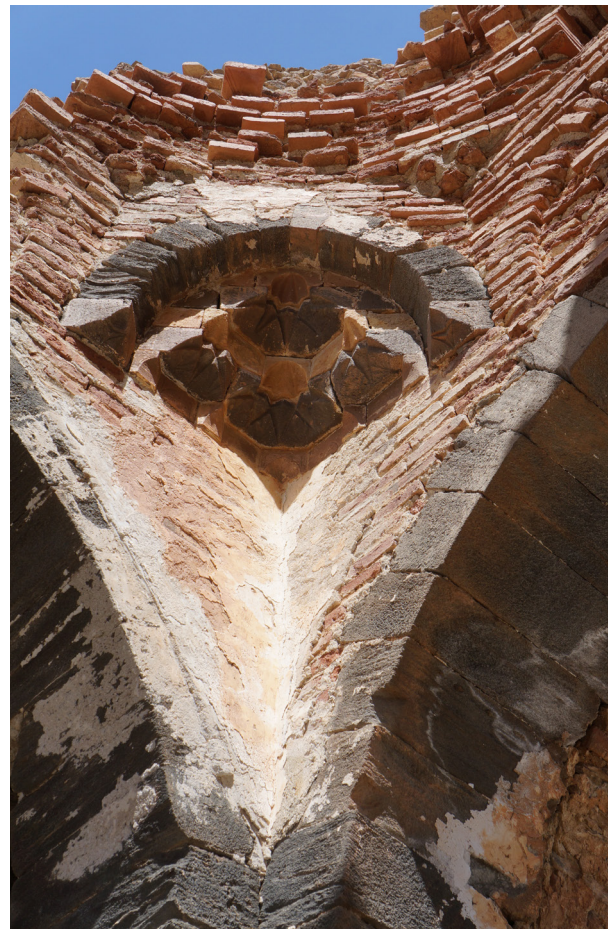
Fig. 12 - Window and interlocked brick masonry

There is a window located in the upper part of the dome. The craftsmanship of the brick coursing above the window differs between courses, it is interlocked at certain parts (Fig. 12). The exterior of the dome is octagonal and clad with ashlar stone. The apse is 3.11 m in width and 2.05 m in depth. There are two symmetrical niches (50x42 cm) to its north and south. The brick walls of the apse are plastered.

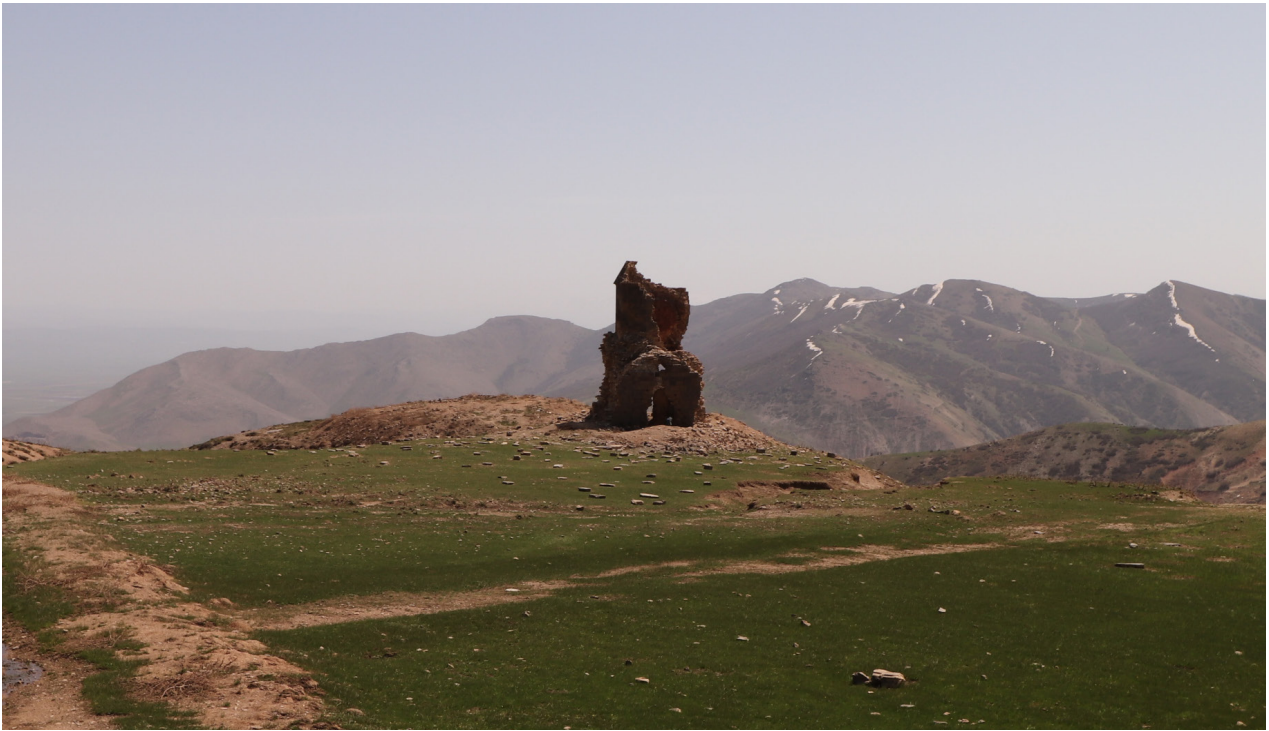
Today, the site is reached through Kepenek (Arag/Arak) Village. The monastery is located on a wide flatland at the top of a steep slope. Surp Arakelots Church is in the western part of the area — which is slightly inclined — and on a small hillock (Fig. 1). Surp Tateos is in the eastern part, which is relatively flat; it has a commanding view over the Mush Plain (Fig. 13).

Fig. 13 - Surp Tateos Chapel and the flatlands surrounding it

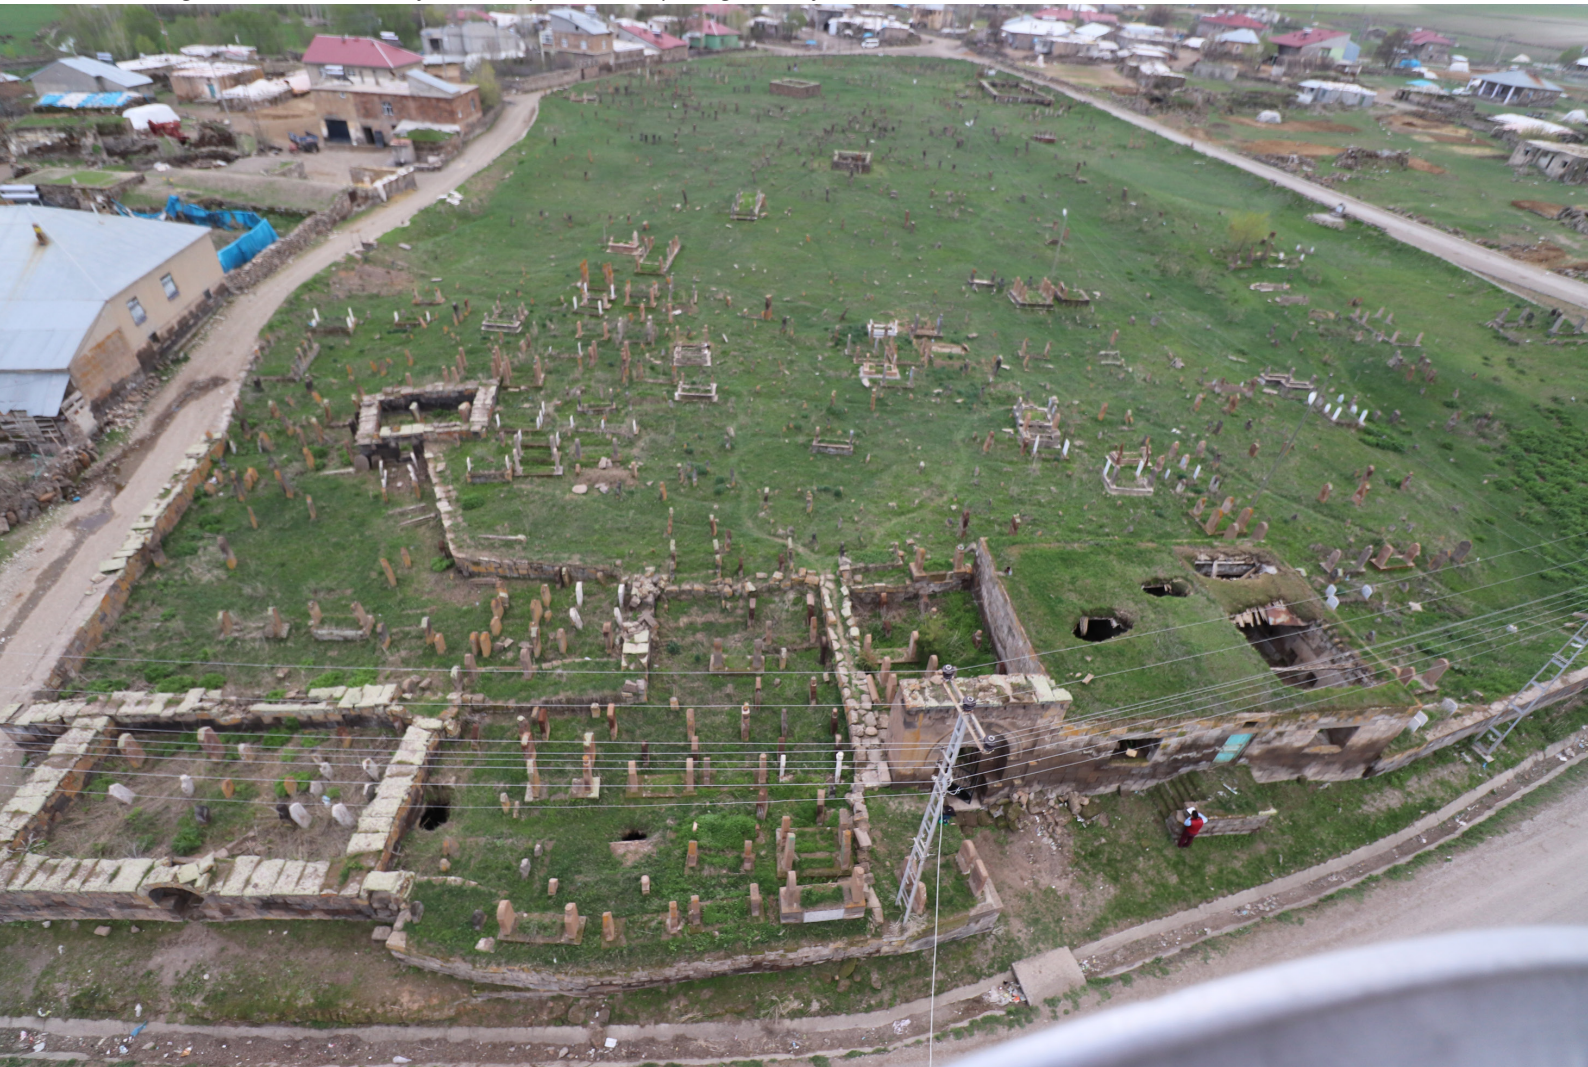
Fig. 1 - Mollakent cemetery, entrance portal, and adjoining masonry structure

Any traces that may have contributed to an accurate evaluation of the portal's original condition have been damaged in recent repairs and interventions. The masonry coursing and details have lost their original form on the eastern edge and southern façade of the structure, so it was not possible to determine the larger layout of which the portal was a part. It was also impossible to make observations regarding the original layout of the structure, which no longer exists, since the area beyond the portal was eventually filled with graves. Another complication is that written sources about the cemetery and the other structures are very limited. Currently, the greatest issue regarding the cemetery is its security. The village muhtar mentioned that grave stones and inscriptions have previously been stolen from the site and that thefts occur.

Efflorescence was attested on the ashlar coursing of the portal, most likely because inappropriate materials were used during previous repairs. The same issue was seen on the façade of the masonry structure. The water that has entered its walls was thought to have been due to insufficient drainage around the building as well as its damaged roof. The piles of rubble in front of the structures present another obstacle to the removal of water in addition to harming their aesthetic authenticity.

The collapsed roof of the masonry structure is one of the most critical issues here. As a result, the structure is open to the elements; any deteriorations and damages quickly worsen. The interior spaces are filled with wooden roof elements and mounds of earth. Additionally, the lack of casings around the windows created security issues.

It is possible to enrich data about the cemetery, structures, and entrance portal in Mollakent Village through an extensive literature review based on archival research. Suggestions to improve security around the cemetery must be discussed and implemented in coordination with the muhtar. Moreover, a comprehensive inventory must be taken of the gravestones in the cemetery including three-dimensional documentation, evaluation of their ornamentations and inscriptions by experts. The results of such a project must be widely disseminated and shared with the community. Furthermore, it is recommended for a visitation route to be defined for the cemetery in order to prevent accidental damage to the gravestones. This route must be drafted to protect the uniqueness of the cemetery and its surroundings as well as adhering to conservation and design principles.

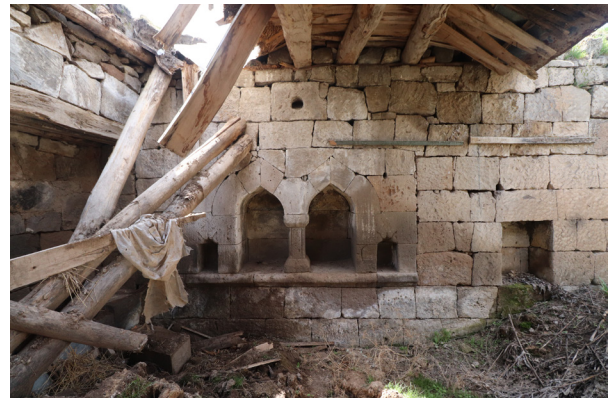
Fig. 4 - The masonry structure in Mollakent cemetery, the organization of niches among the ashlar coursing

A straight staircase with seven steps leads to the landing in front of the entrance. Here, the single-winged iron door leads to a long, rectangular hall (interior dimensions: 1.95x7.20 m), which has two openings leading to two other spaces (interior dimensions: 3.55x7.20 m) on the sides. The building's layout is symmetrical and lies on a north-south axis. Its main walls are 94 cm, while the separation walls are 78 cm in thickness. On the interior, the walls appear to be of roughly-worked stone. The earth roof is supported by wooden beams with circular cross sections (diameter: 20 cm) that are placed along an east-west axis at 40-45 cm intervals. Wooden cladding is attested above the beams on the ceiling, followed by a thick layer of earth. There are traces of a series of pointed-arched, ashlar-stone niches on the walls (Fig. 4).

The masonry structure has evidently been neglected for a long time; a protective roof must be implemented within the framework of a conservation project in order to slow down / prevent further deteriorations.

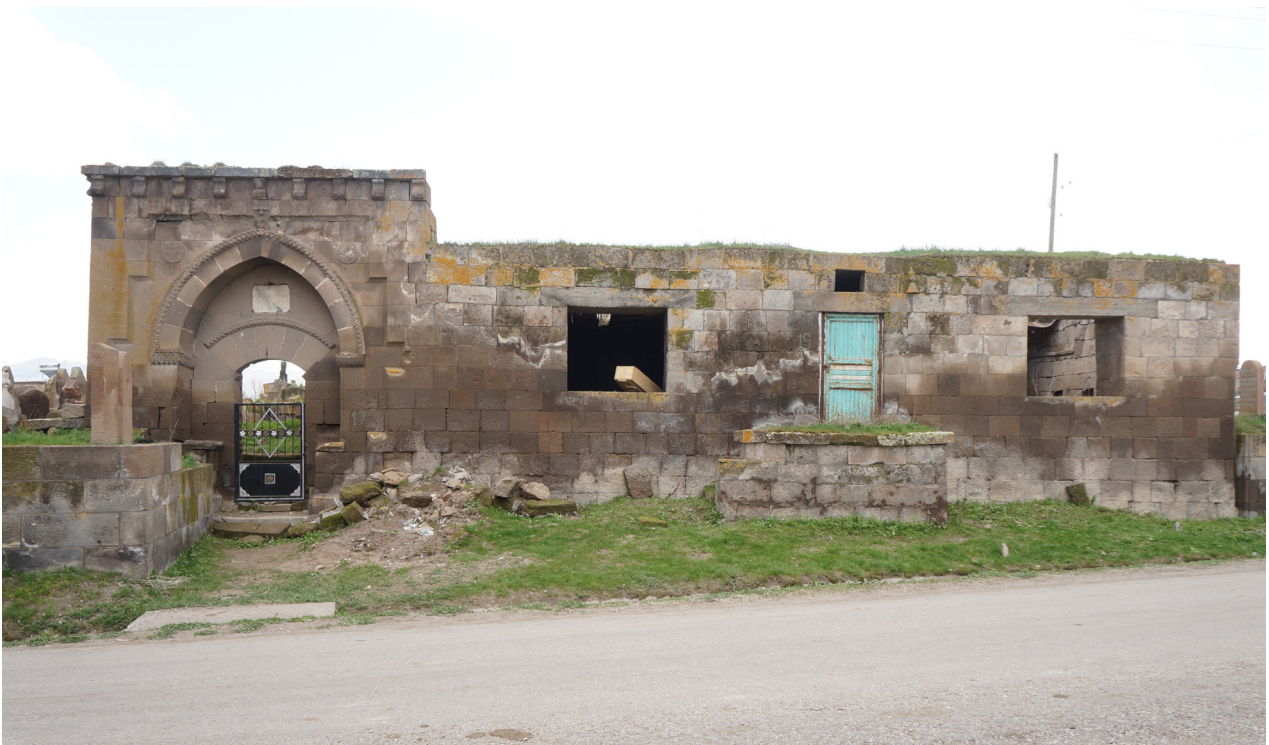
Fig. 3 - Mollakent cemetery, entrance portal and adjoining masonry structure, northern façade

on the northern edge of the cemetery (Fig. 3). The asphalt road that continues along the northern edge of the lot lies between the group of structures and the mosque. The entrance portal and the structure are adjacent to the road on the west, but slightly recessed from the road on the east. Consequently, a small pocket has been formed in front of the entrance.

The front façades of the entrance portal and the masonry structure are flush. Both feature ashlar coursing with andesite; the craftsmanship in the portal is immaculate. The shape of the ashlar stones as well as the sensitivity and precision regarding both the horizontal and vertical joints in the masonry structure are far from perfection. This situation suggests that the two structures may have been constructed at different periods. The reinforced-concrete lintels above the window openings must be related to later interventions.

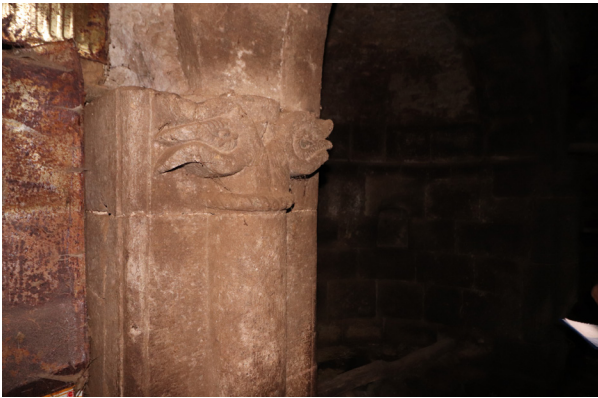
Fig. 10 - Refectory, relief featuring a bishop's staff

There was a furnace with supporting spaces on the ground-floor level of the southern part of the complex, with a large hall to its west. This structure (H) was used as the refectory (Vosgiyan 1953, 144-145). The rectangular hall, whose western section is used as a haymow/barn, extends east-west and has interior dimensions of 5.58x20.14 m (Fig. 9). The hall is reinforced with ten semicircular arches — comprising an arch of ashlar stone under a wider, protruding arch of brick — that are supported by ten pilasters. The space is covered by a brick barrel vault and the walls are rubble masonry. The wall thickness is 63 cm. Entrance to the hall is via an opening to the south. The windows that repeat at regular intervals along the southern wall are arched and have ashlar-stone jambs. There are three niches in the western wall. The jambs of the larger niche in the middle are each decorated with a bishop's staff styled like a pilaster (Thierry 1983, 395). The head of each staff is embellished with two mirrored horizontal tulip motifs (Fig. 10).

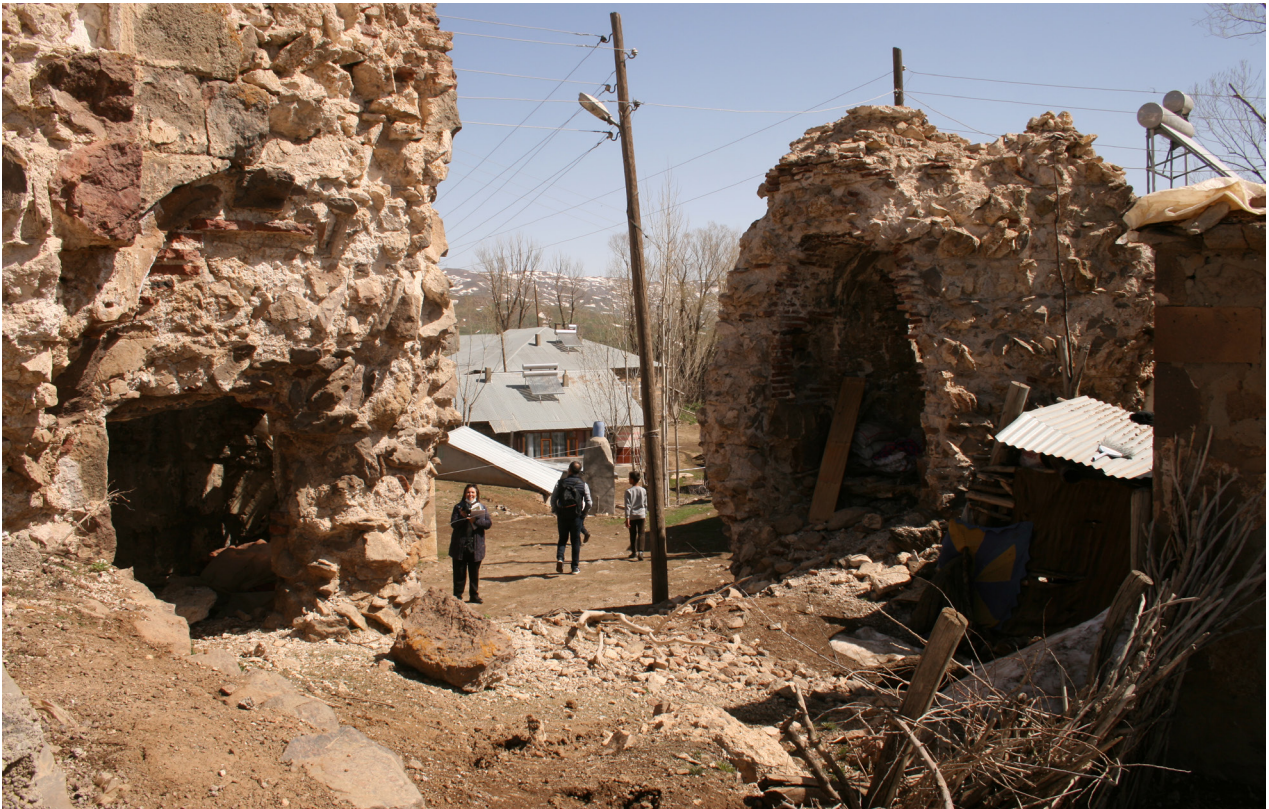
Fig. 12 - Surp Stepanos Church, remains of northern cell

The cells that are located on either side of the apse open up to the side aisles (Fig. 11). A part of the northern cell is extant (Fig. 12). The nave is connected to the side aisles and narthex via ribbed arches. The arches meet the walls

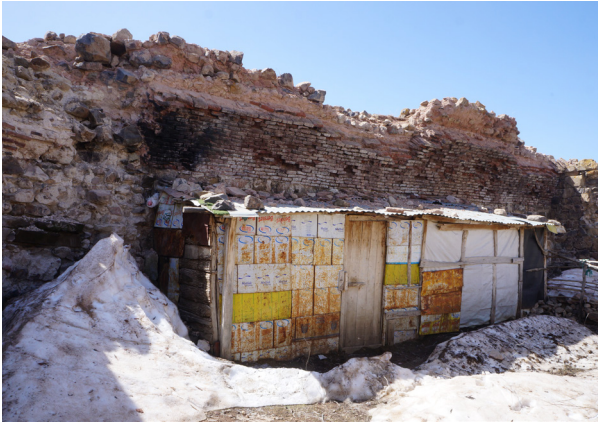
Fig. 13 - Surp Kevork Church, southern wall, view from the northeast

The entirety of the southern wall, part of the western wall, and the southern part of the apse are still standing. It appears that the interior dimensions were approximately 6x13 m. The thickness of the western wall is 95 cm. Roughly-worked stone coursing is visible on the interior, while the infill between the interior and exterior faces is filled with rubble and mortar. The southern wall provides clearer information about the masonry techniques used (Fig. 13). The grooved, brick, pointed arches join the pilasters. The original floor plan indicates that access to the seclusion chamber of Surp Grigor Lusarovich —no traces of which remain— is provided via the opening to the north (Fig. 11).

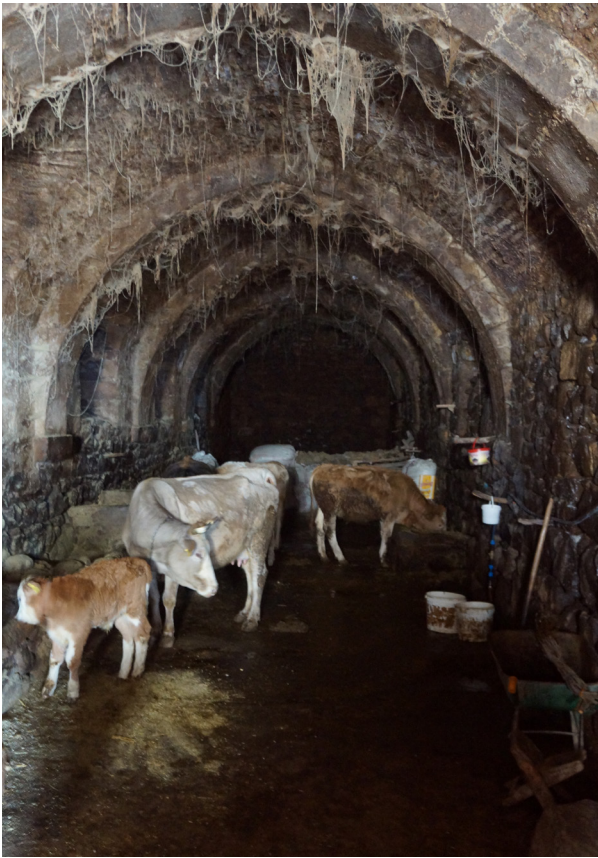
Fig. 14 - The old guesthouse building, currently used as a barn

The refectory in the southern part of the site was one of the service buildings near the monastery. It was buried underground and adjoined by a village house from the east. A measured drawing was drafted for this structure. Moreover, the guesthouse —one of the service buildings east of the monastery— was being used as a barn during the fieldwork (Fig. 14). This area was documented through photographs, but it could not be measured.

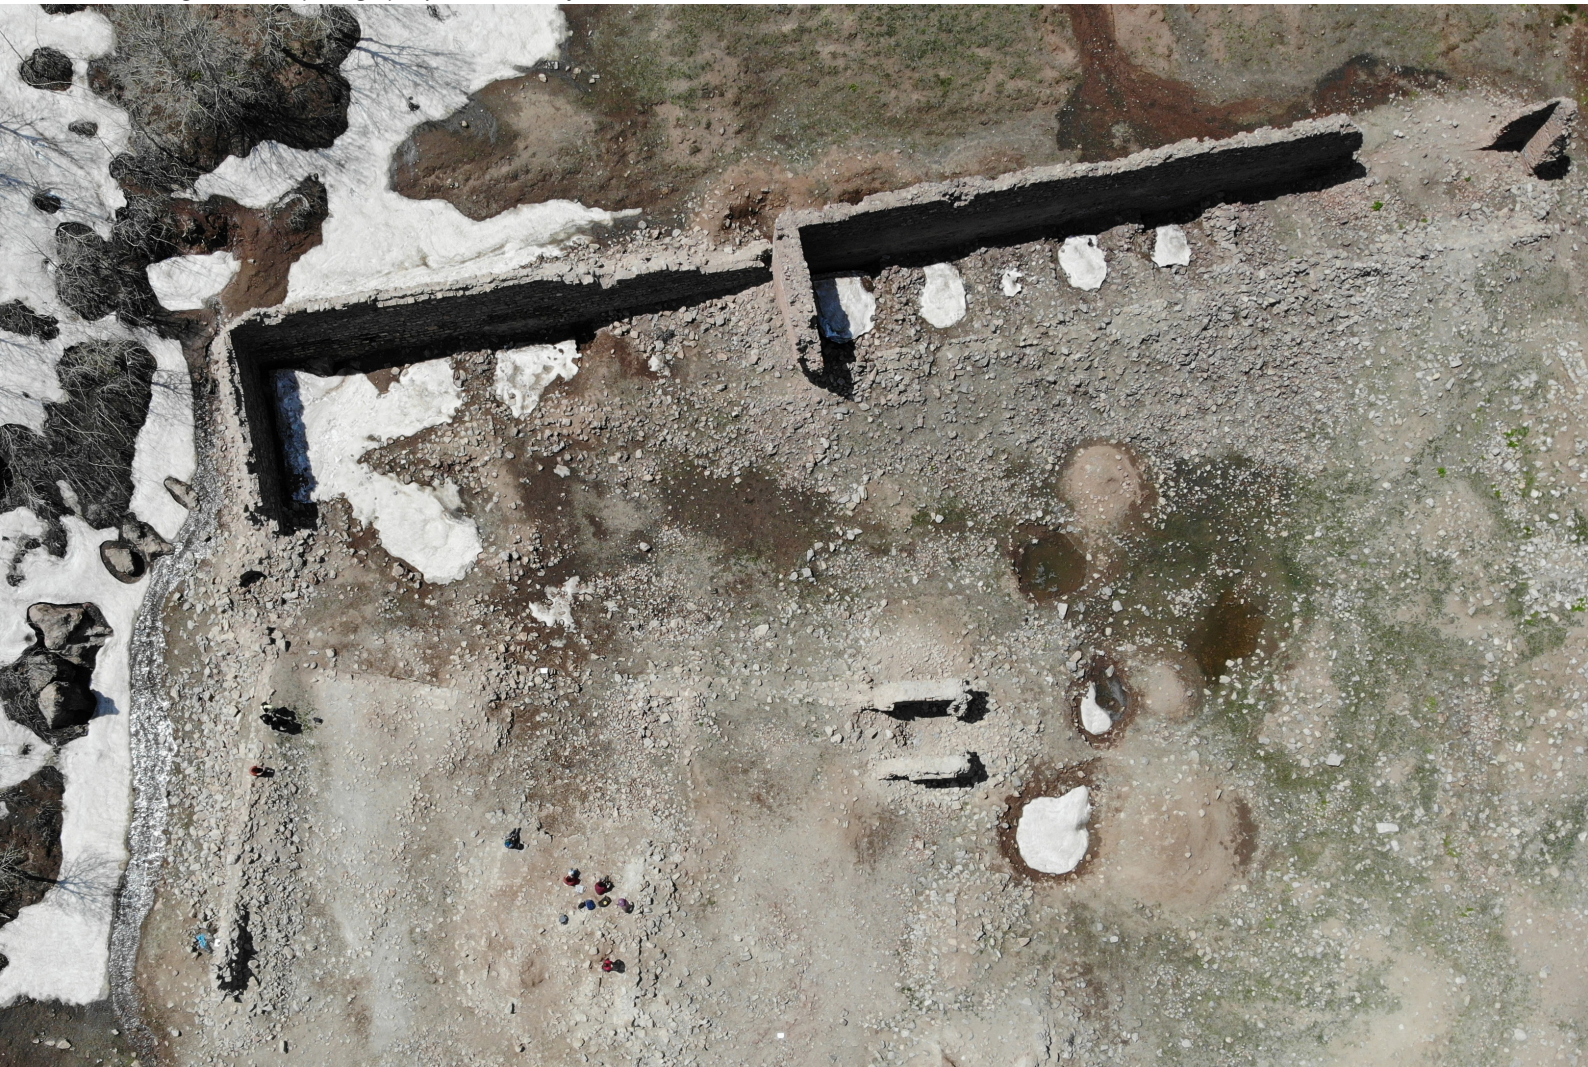
Fig. 1 - Aerial photograph of the monastery ruins

Yeghrdut Surp Hovhannes Monastery, also known as Red Church, is located approximately 3 km west of Suluca Village. It is 1860 m above sea level. Only the ruins of the monastery are visible today. The use of various stone and brick coursing methods are evident in the masonry buildings of the complex. The main walls of its western façade, facing the slope, are partially erect, all other remains are only traceable at a foundation level. Hence, it is quite difficult to read the whole layout of the complex (Fig. 1).

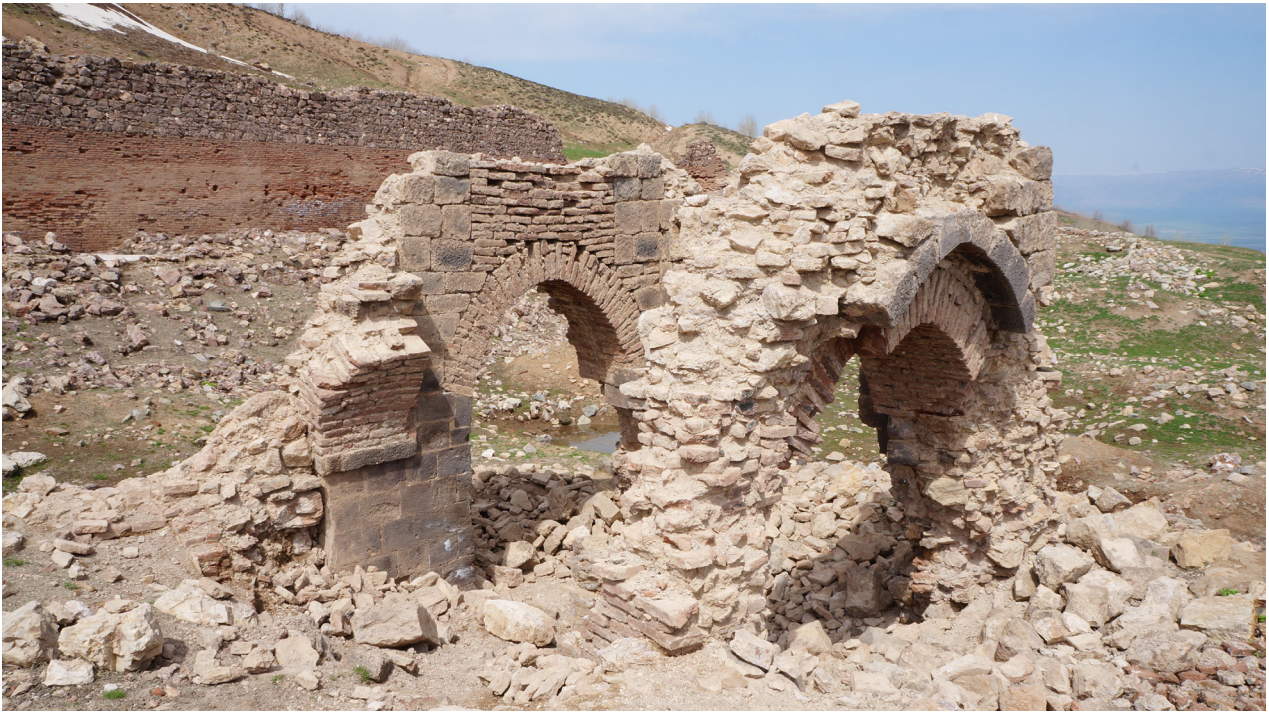
Fig. 3 - Transition space with arches

The only part of the monastery where the ceiling/roof is still perceivable is the area containing two parallel arches that extend along the north-south axis. There is evidence of other arches (on the east-west axis) between the pillars supporting these ones, in the stones at the level of the springing line (Fig. 3). This area is thought to have been a transition space with external (plan) dimensions of 4.5 m. The wall adjoining the southern pillar continues for approximately 16 m at the foundation level.

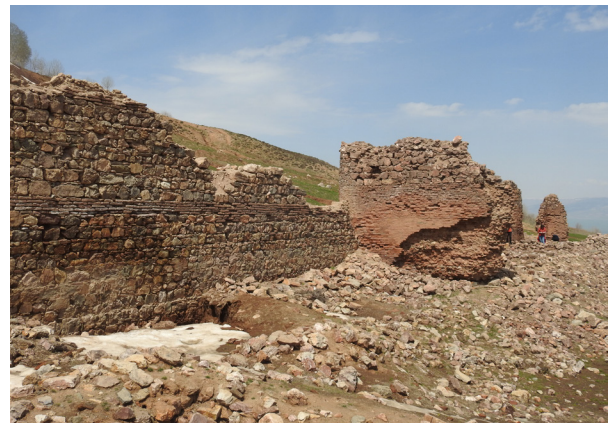
Fig. 4 - Western fall extending north-south, various coursing methods

The buildings utilize ashlar stone, roughly-worked stone, and brick using different construction methods. The instances where different masonry-coursing techniques can be observed at varying elevations of the same wall indicates that the building was repaired during different periods (Fig. 4). The remains to the north of the monastery are brick masonry at the ground-floor level, where rubble and brick are used together for the infill between the two faces. There is another, shorter story above the brick wall that was constructed using roughly-worked stone. The walls of the adjoining structure to the south begin with roughly-worked stone; brick lacings consisting of 7-8 courses are visible at two levels. The distance between two lacings is approximately 2.5 m. In brick walls, the brick (thickness: 27-28 cm) is used for the interior and exterior faces, while rubble and pieces of brick are used for the infill (thickness: 40-60 cm).

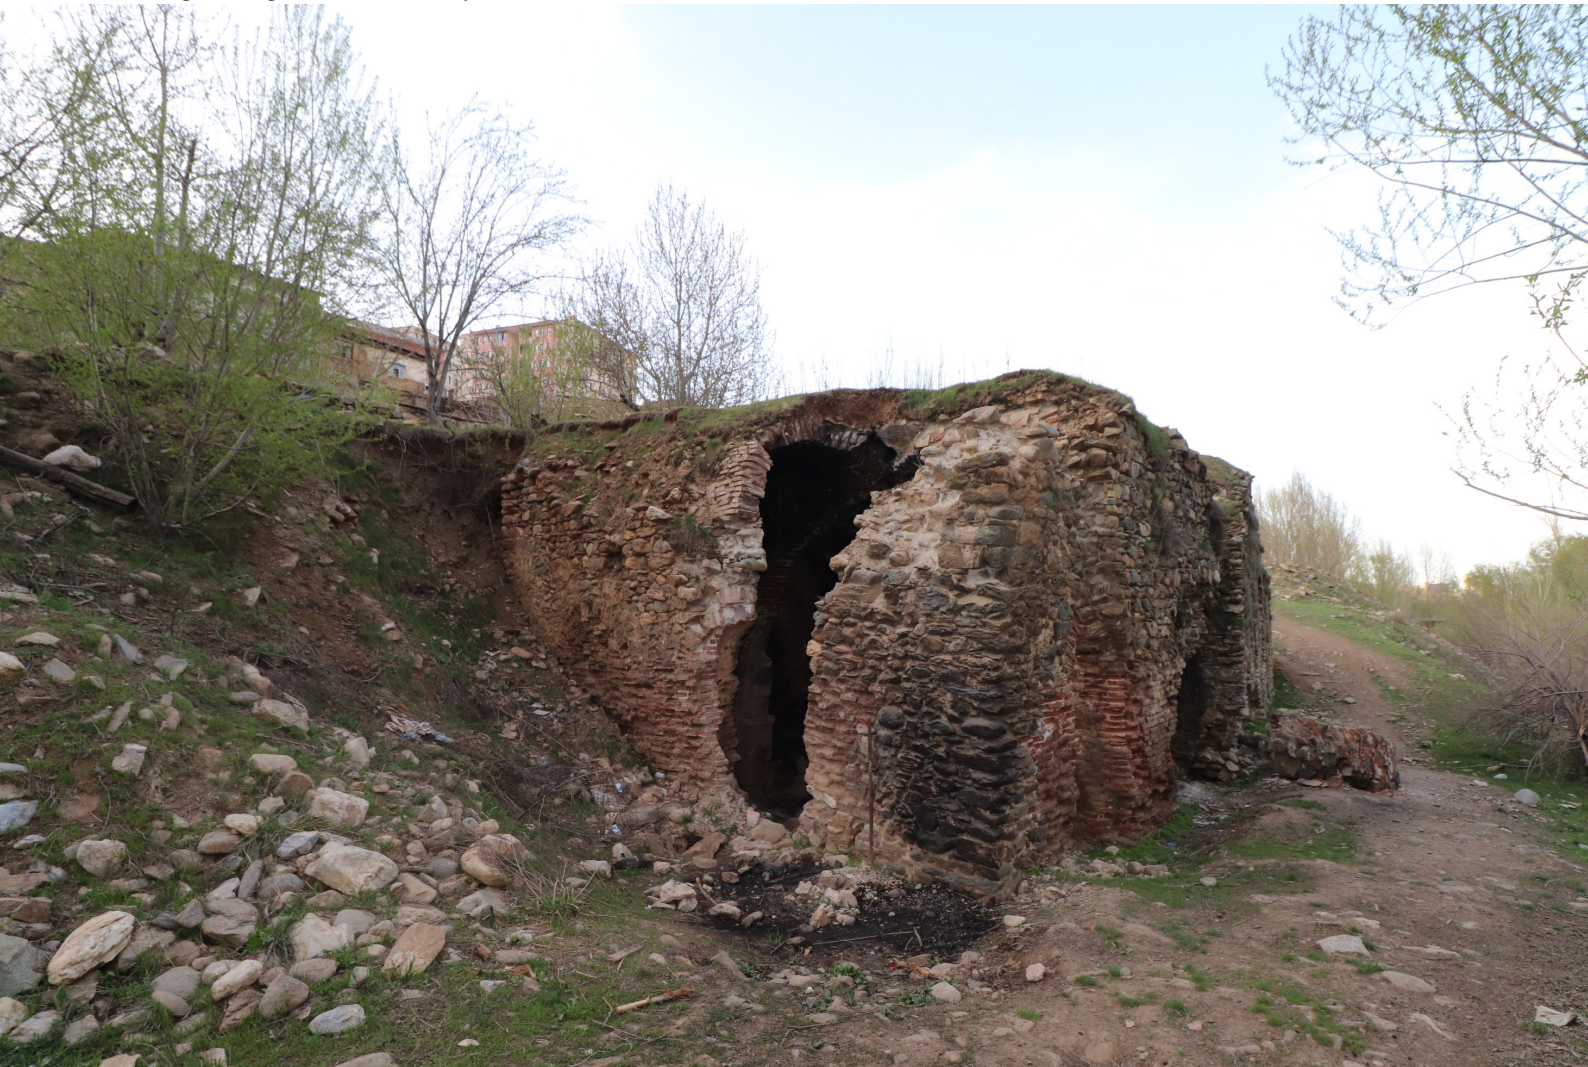
Fig. 1 - Migre Bathhouse, view from the southeast

The bathhouse comprises a divided changing hall (*apodyterium*) leading to a warm hall (*tepidarium*), steam hall (*caldarium*) with two private bathing chambers – which all have direct connections to the exterior – in addition to the water storage. The furnace is most likely in the northern part of the building, but it is impossible to make further comments due to the current inaccessibility of the façade (Fig. 1).

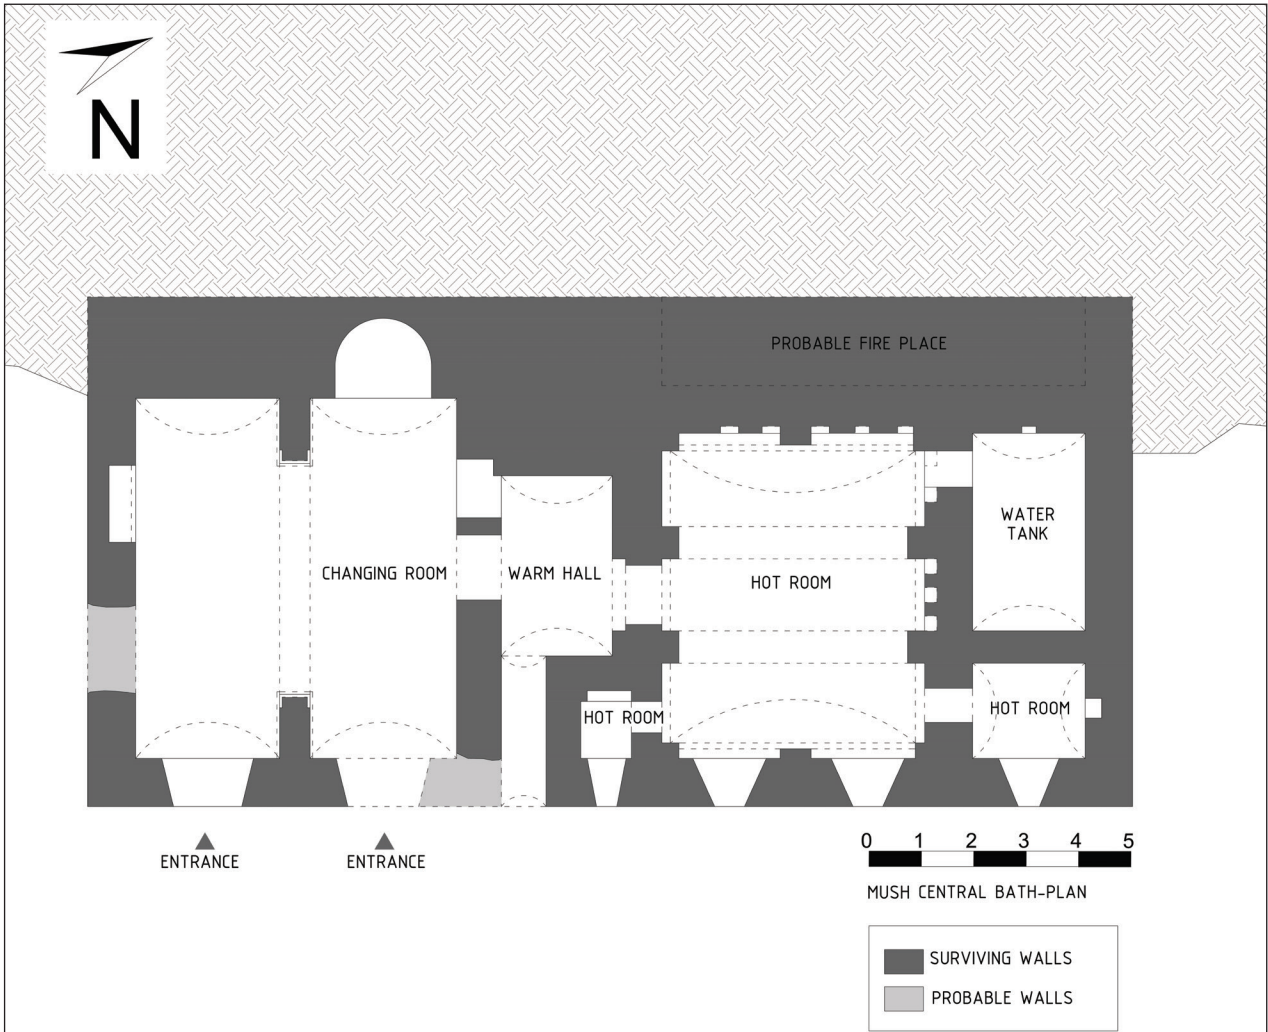
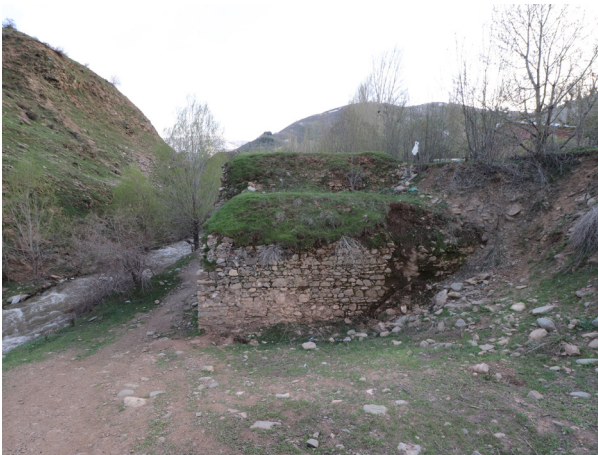
Fig. 2 - View from the north; roof covered by soil and vegetation

Migre (Dere) Bathhouse, located on the western shore of Dere Stream in the historic centre of Mush, may be considered an atypical example of this building typology because its plan layout and spatial organisation are dissimilar to the traditional bathhouse architecture in this region (Öztürk 2020, 263). The structure is in an uneven area. Its northern façade is completely underground, while its eastern and southern sides are only partially buried. Although the roof is completely covered in soil and vegetation, the building still stands with a layout and main walls that are mostly intact (Fig. 2).

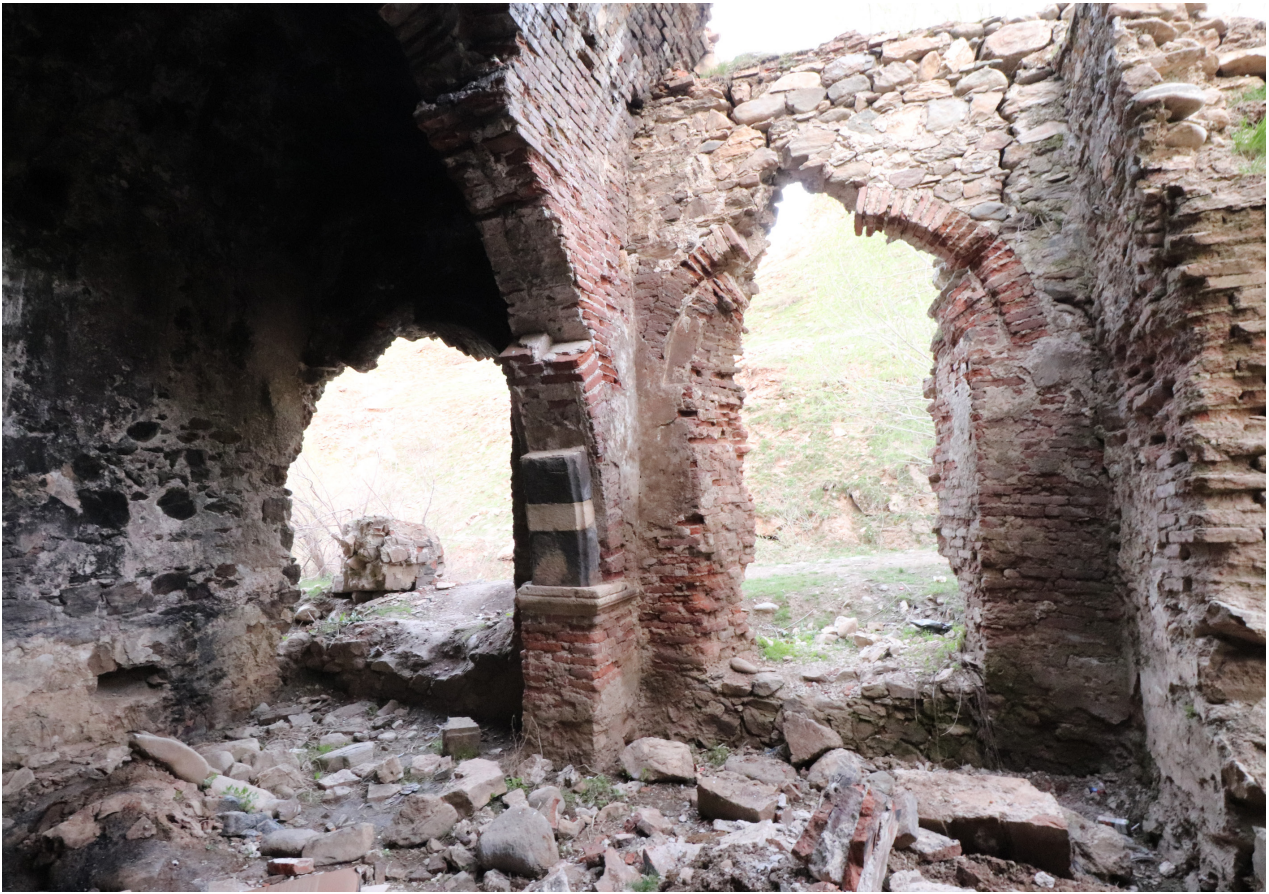
Fig. 3 - Coloured-stone and brick masonry

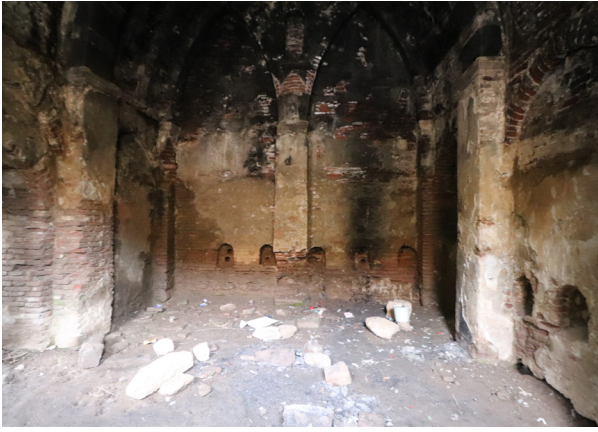
The steam hall is divided into three areas by two parallel, pointed arches (width: 61 cm) made of ashlar stone that extend in the north-south direction. The pointed vault following the form of these arches is constructed in brick. There are two embrasures to the east, which must have been built for natural lighting. This situation is unprecedented in a bathhouse due to privacy issues, but it may be explained by the presence of Dere Stream in front of this façade. The western wall of the steam hall contains a pilaster at the centre of the wall and two pointed half-arches that are perpendicular to the arches supporting the vault. This decorative and symmetrical arrangement is articulated by the three identical niches on either side of the pilaster. These arches have the springing line at the same elevation as the load-bearing ones. There is also an arched niche placed on the axis of symmetry on the spandrel (Fig. 4). The vault above this space contains several 'aks-ı seda' (Ottoman for sound echo), a decorative and acoustic element featuring amphorae arranged in a one-three-six pattern, examples of which

Fig. 4 - View of the steam hall

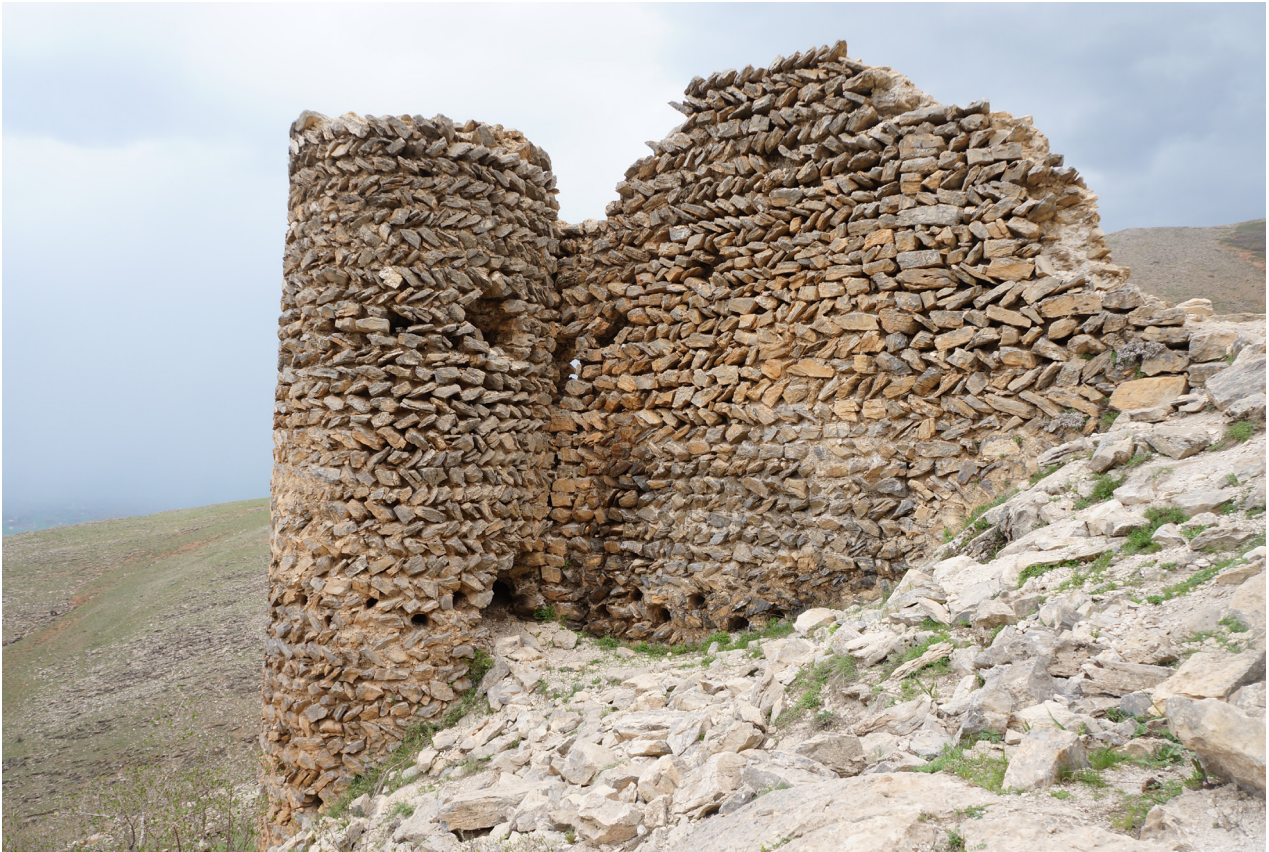
Fig. 2 - Herringbone masonry in the Fortress of Haspet

The stones in the structure's walls are laid in a herringbone¹ pattern², which is attained by repeatedly laying one course of stones tilted to the right, and the next course tilted to the left (Fig. 2). It is possible to see stone courses with horizontal joints only at a few locations near the walls' corners and in the jambs of the openings. The stone walls are approximately 1.0 m thick in the bastions and 1.10-1.30 m thick in the fortification walls. A white, lime-based mortar is visible in the joints. The bastions and fortification walls are connected to the bedrock (Fig. 3).

The bastions are circular in cross section, with a conic form (Fig. 2 and Fig. 4). The southeastern bastion has a diameter of 1.8 m. There is an original opening on its eastern side, whose jambs are of roughly-worked stone with horizontal joints. Due to losses of material around the opening it is not possible to determine the exact construction technique; it probably had a flat lintel. The upper sections of the bastions'
