MUSH

Architectural Heritage at Risk

This study, in which the historical structures of Mush are considered, primarily aims to assess the architectural history in the province, identify the current conditions of at-risk architectural works, and contribute to their continued existence through scientific suggestions. We believe that this book may be beneficial in the decision-making processes of relevant persons, institutions, and conservation boards since it contains information about settlement history, buildings' history, architectural analysis, legal status, risk assessment, and potential future scenarios. We hope that it may also help to transfer cultural heritage to future generations and create awareness.

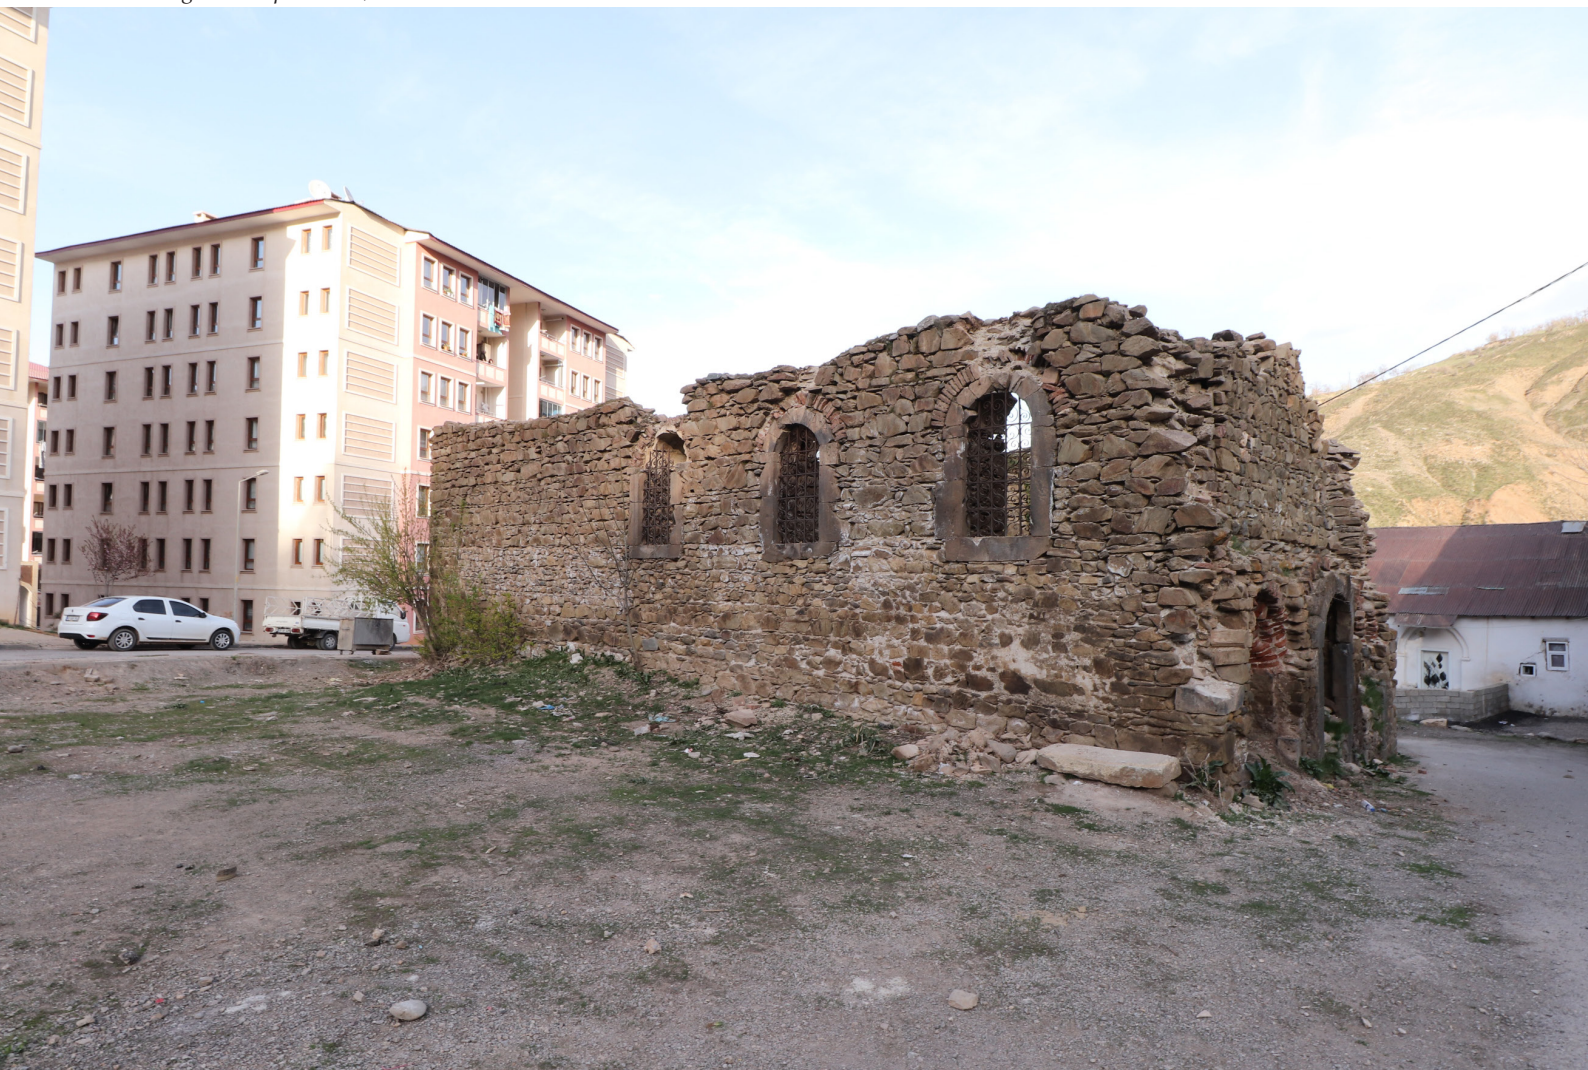
Fig. 1 - Surp Marine, western view

The structure is at Mush city centre. It lies on a northeast-southwest axis on the lot between Fabrika and Değirmenler streets, in the former Armenian neighbourhood (Surp Marine) to the south of Kale Locality. Its interior dimensions are 15.17x8.00 m. It is an elegant structure considering its style of stone masonry, the brick arches of its doors and windows, and ornate iron window bars (Fig. 1, Fig. 2).

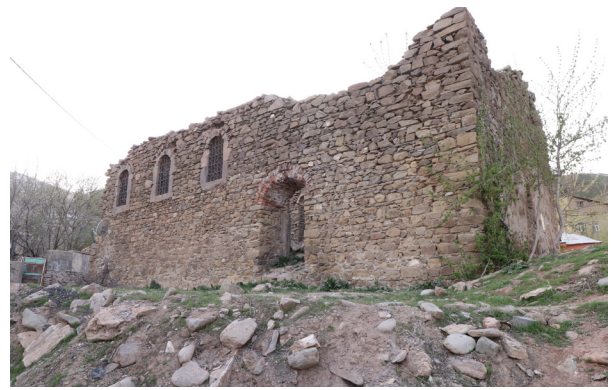
Fig. 2 - Surp Marine, southeastern façade

The church walls are made of rubble masonry, while the door and window casings are of white ashlar stone. The arches are of brick. Each brick measures 5x17-18x31 cm. Wood is used for the flooring, ceiling, roof, and above the door. Putlog holes are visible. The main walls have the same rhythm and technique on the

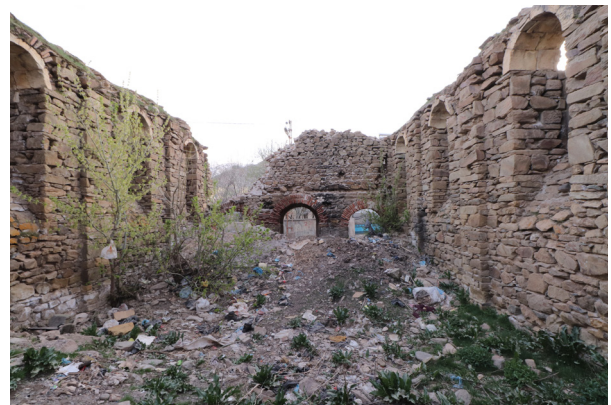
Fig. 3 - Surp Marine, southwestern view of the interior

The structure encloses a single space with longer walls on the northwestern and southeastern sides. These walls each have a single window between pilasters. There are three windows and three pilasters along the same axis on each window (Fig. 3). On the interior, the windows begin at the same elevation as the arch above

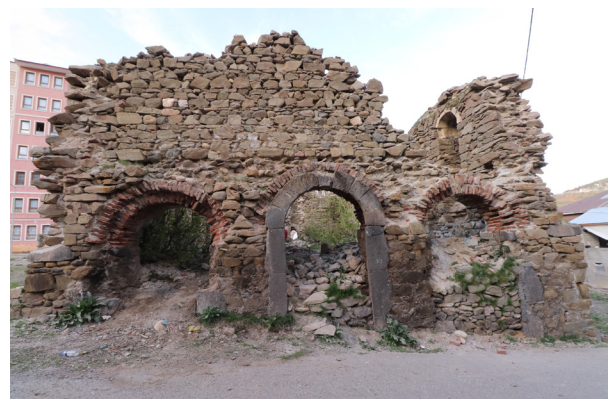
Fig. 4 - Southwestern entrance and traces of lacing

the door and rise along the remaining height of the wall. On the exterior, the window height is approximately 2/3 of the height of the interior walls. Both walls have a niche near the north-eastern wall. The niche in the northwestern wall is arched with two rows of brick and covered by a small, brick semi-dome. Its complete height is indiscernible and its base is broken. The southeastern niche is smaller, but similar to the other niche in construction. The base of the smaller niche is covered with a single piece of limestone. The entrance is visible nearby. The ashlar-stone casings around the wall have dentils. The opening for the door is topped with a single-row brick arch on the interior and a double-row brick arch on the exterior.

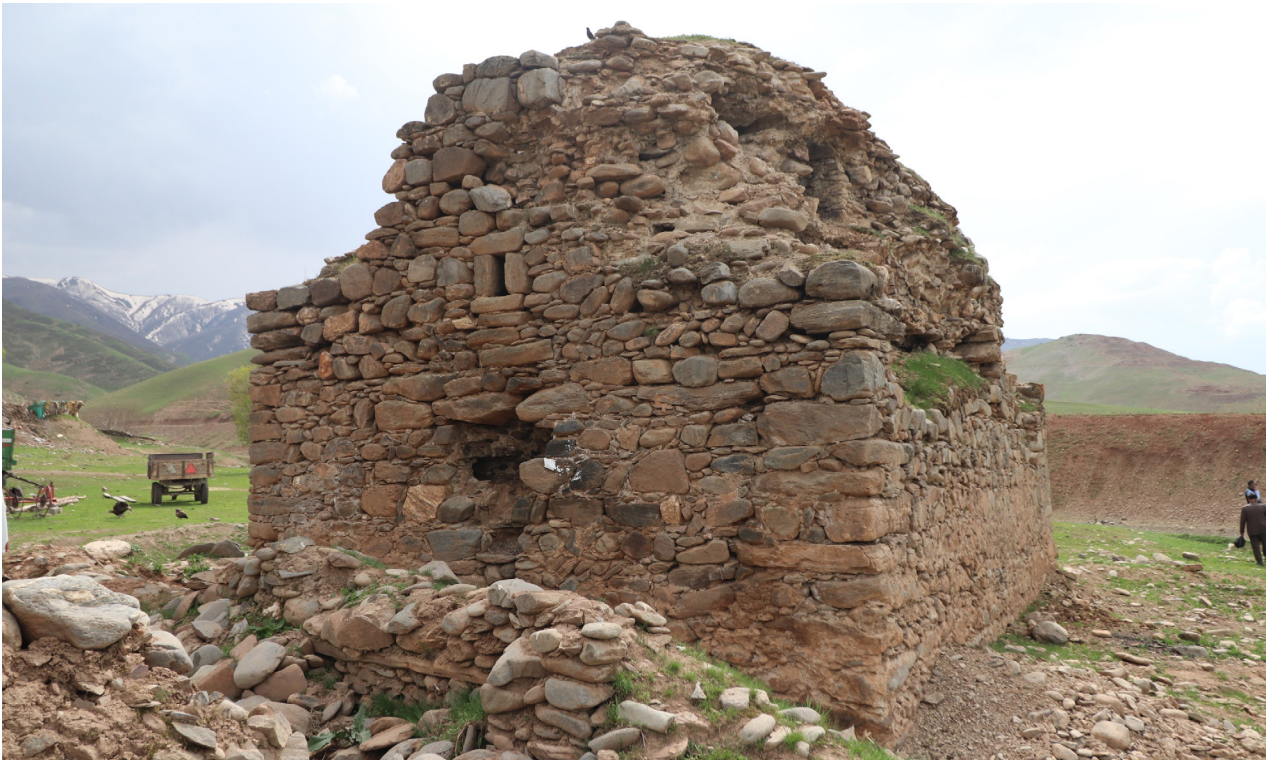
Fig. 2 - Eastern and northern façades

rectangular layout (external dimensions: 6.55 x 9.55 m) is covered by a barrel vault (Fig. 2). The apse (width: 3.75 m, opening: 2.50 m) is semicircular on the interior, but does not project this form outward. On the interior, there is a series of two arches on the northern and southern walls (Fig. 3). The parts under the arches are recessed by roughly 30 cm to create wide niches on the wall. The northeastern niche is deeper; an architectural organisation related to water is attested in it. The columns that support the two arches on the wall are connected via a brick arch that is perpendicular to the direction of the barrel vault, on a north-south axis. The outline of this arch is also visible on the southern, exterior façade. There is an embrasure on the apse wall as well as above the entrance on the western façade; the northern and southern façades are blind (Fig. 3). Channels are attested at two different levels within the cross-section of the apse wall (height: 28 cm and width: 28 cm for lower channel; height: 29 cm and width: 37 cm for lower channel). The upper channel is exposed through the damaged wall of the eastern façade.

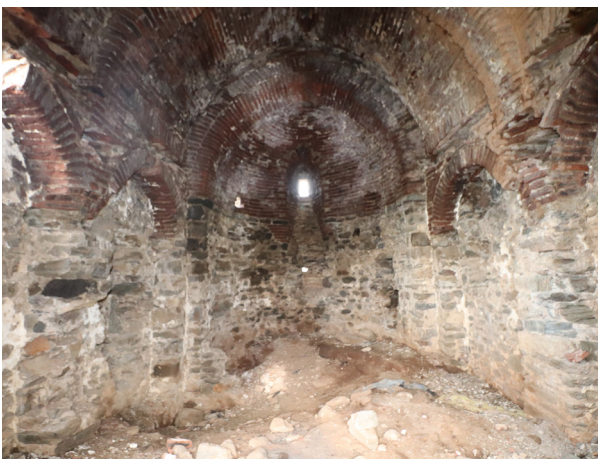
Fig. 3 - The apse

higher elevations of this façade. The window immediately below the arc of the vault also has a brick arch.

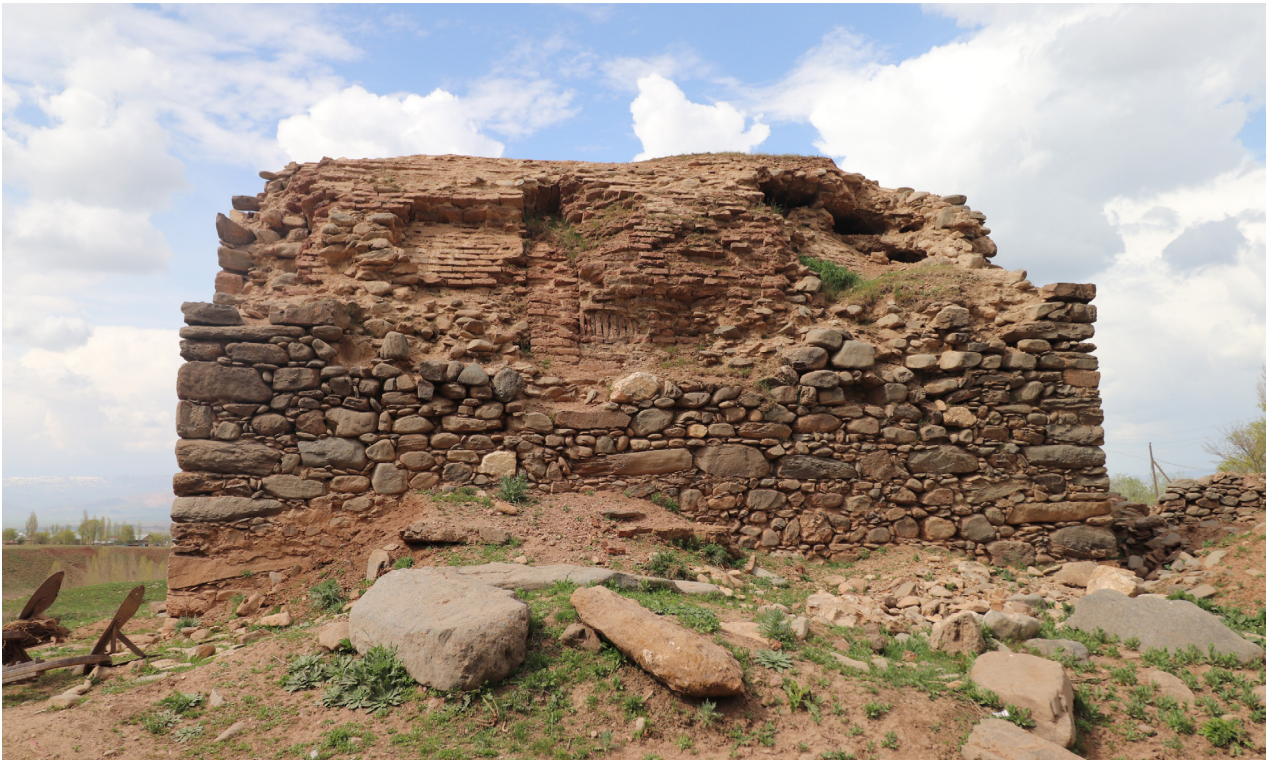
The façades are constructed in rubble masonry. Larger and smaller rubble are used together in the courses. The geometric features of the stones suggest that they have been sourced from the bed of the stream. It is attested that the walls' corners were built using larger stones. The vault, arches, and openings on the interior are constructed with brick (6x16x26 cm), while the rest of the interiors are of rubble. Holes are attested at the springing lines of the northern and southern walls, which must have been left by wooden elements (cross-section: 17x17 cm) that were placed both perpendicular and parallel to the surface of the wall.

Fig. 4 - Southern façade

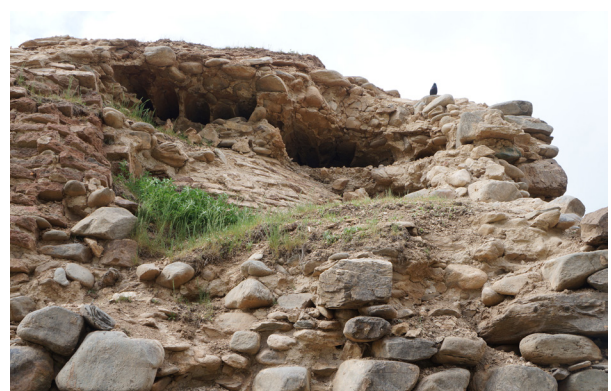
Fig. 5 - Detail, infill of the hemispherical dome above the apse

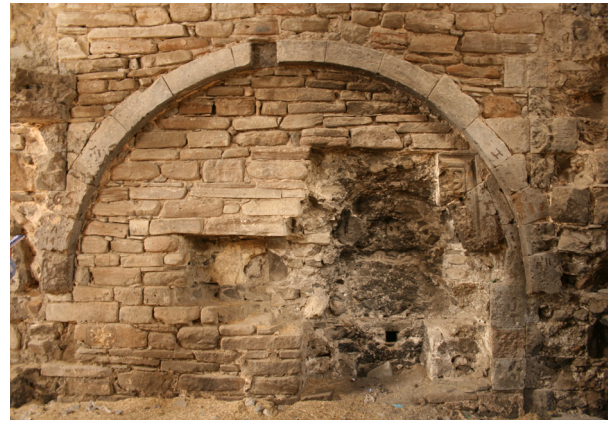
Fig. 4 - The area thought to have housed the baptismal font

There is another niche (width: roughly 80 cm) within the eastern one of the arched niches on the northern wall. The smaller niche is in the half that is closer to the apse. Even though some parts of the faces of this smaller niche are in good condition, most of its constituent elements are lost. Consequently, it could not be measured during the fieldwork. It is nevertheless thought possible that this niche could have been the baptismal font because of its location within the layout, its features, and its approximate dimensions (Fig. 4). Some traces of ornamentation on the stones that framed this niche are observable. There is also moulding on the outer frame.

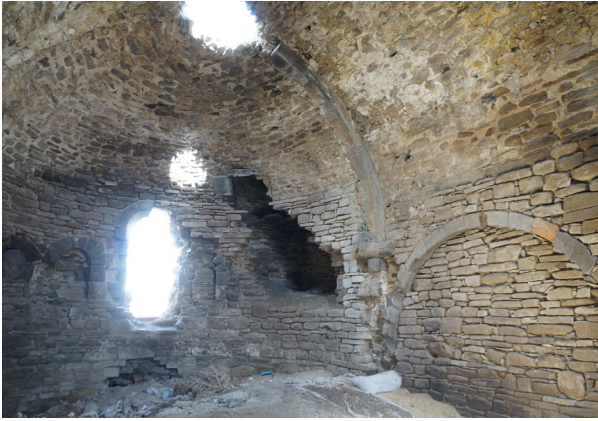
Fig. 5 - The apse and the area with stairs to its south

to the exterior face of the wall (Fig. 5). This space tends towards the top of the apse window. Two of the basalt blocks that must have defined its jambs are extant in the upper left corner. The top of this small room has been covered with a thin slab of stone. There are smaller thin slabs that are cantilevered from the main wall; it is thought that these may have been related with stairs.

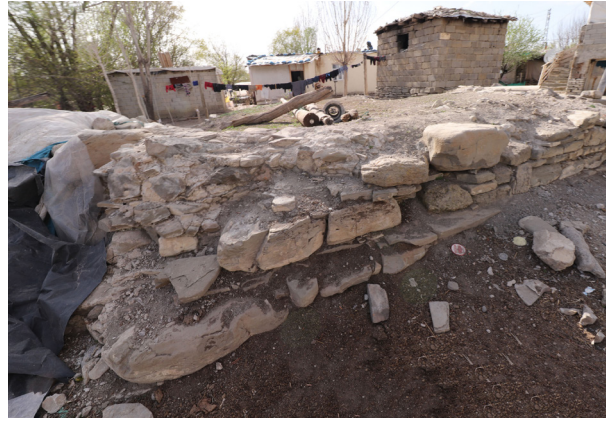
Fig. 6 - Remains of Surp Hagop Church

Only the traces of foundations remain of Surp Hagop Church, one of two churches in Tsrnk Village. According to data from Houshamadyan, both churches were built in the same year (1151). The weathered stone masonry construction of Surp Hagop was renewed in 1664, and Surp Sarkis in 1678. It was recorded that there were two other churches prior to 1915, one of which was Surp Kevork. It was also noted that the names of the clergy at this time were father Musheg Mikayelyan, father Hovhannes Der-Hovhannisyan and father Nerses Asdvadzaduryan (URL 12).

The original level of flooring could not be determined at any location during the fieldwork. The village is home to another church dedicated to Surp Hagop, of which the only remains are walls that are 50-60 cm from the level of the foundation. The information gathered about Surp Hagop during the fieldwork is described towards the end of this report.

The remaining traces of Surp Hagop Church should be documented as soon as possible. Urgent interventions are necessary to conserve its current condition. The results of any research or study about these two churches would increase the value of Kırköy as a whole.

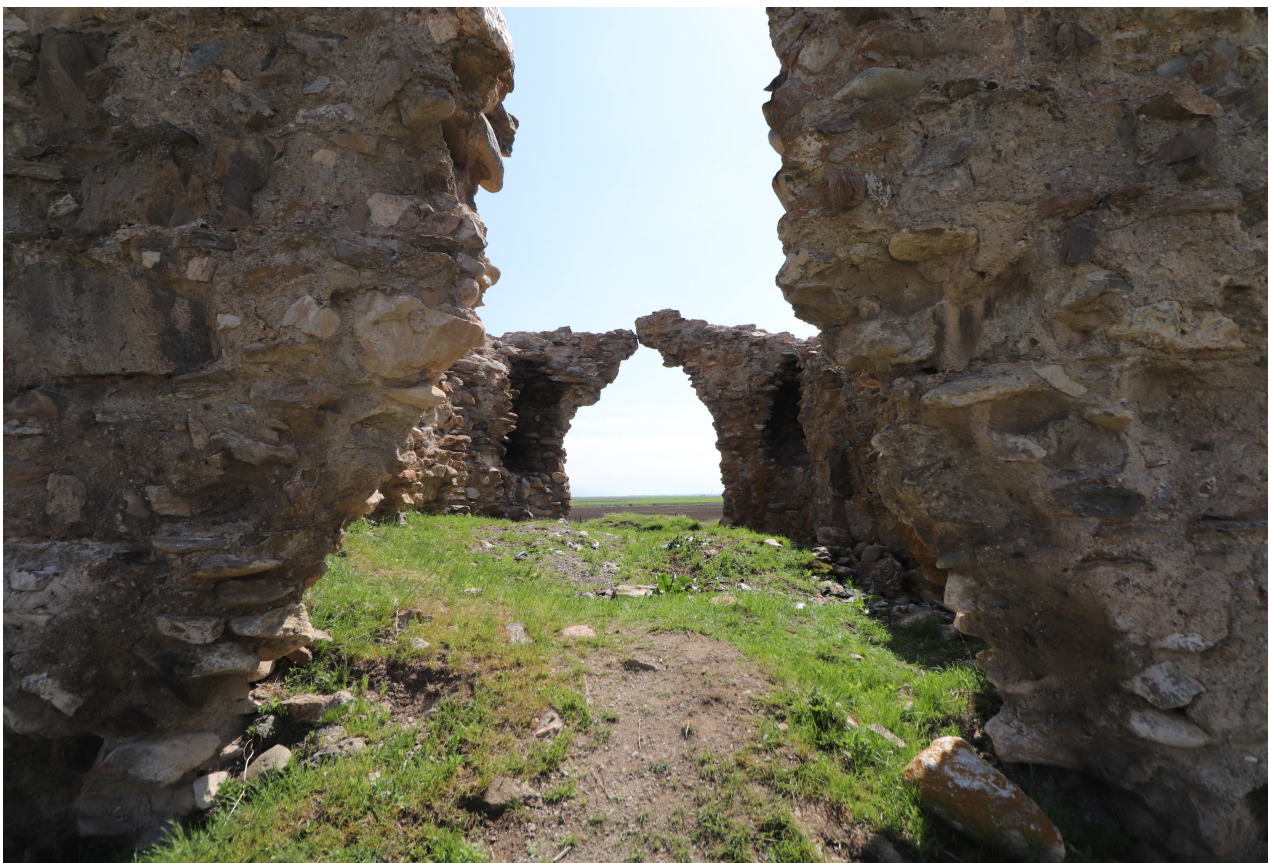
Fig. 2 - View of the interior from the western entrance, the collapsed western and eastern walls

The church has a basilica-type plan layout with a single nave. The collapsed portion of the western wall is thought to have housed the entrance. There are two pilasters on the interior of the northern and southern walls. To the east, the wall of the semi-circular apse has collapsed and split (Fig. 2). The pieces to the north and south of the semicircle have coffered to decrease the structural load as well as niches.

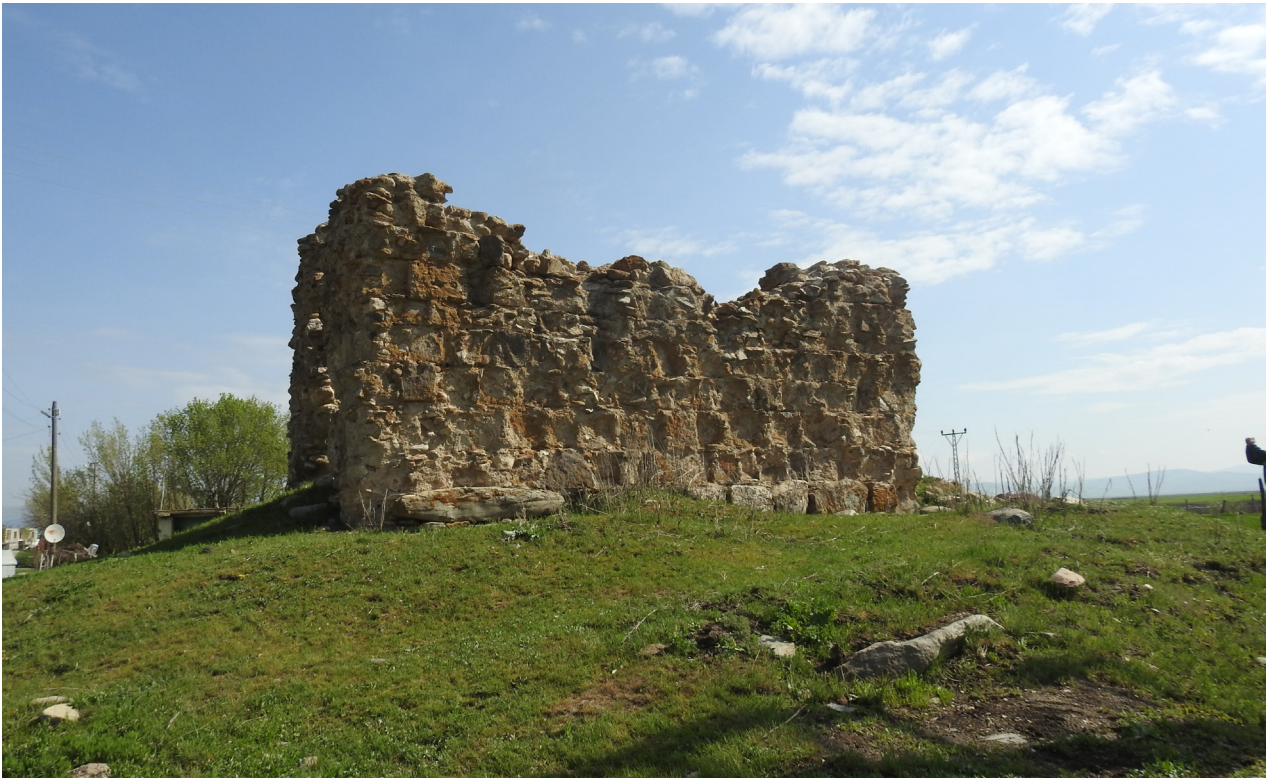
Fig. 3 - Southern façade

rough-worked stone and rubble. The courses of rubble frequently indicate the use of slate and a white lime mortar. Traces on the wall reveal that the removed exterior cladding units were 42-55 cm in width and 40-50 cm in length (Fig. 3). The main walls are situated on large stone blocks that widen towards the exterior by 30 cm.

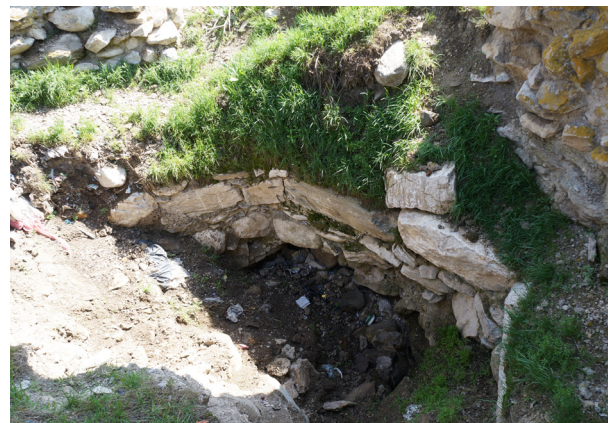
The structure is vulnerable against all types of damage. The roof has completely collapsed, and walls on two sides (east and west) have mostly collapsed. This leads to losses of material, rapid deteriorations, and loss of texture.

Fig. 4 - An illegal excavation pit.

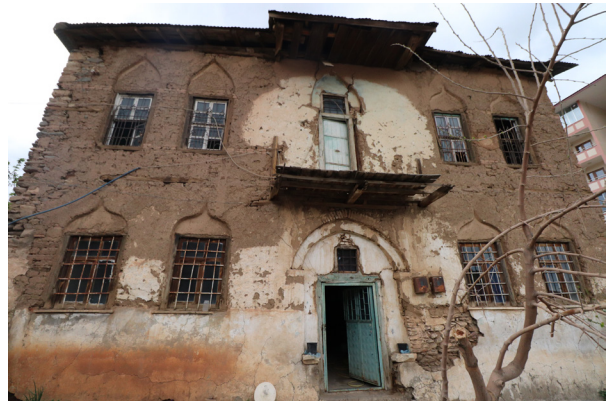
Fig. 5 - Entrance (eastern) façade

The entrance is at the centre of the eastern façade. The door is enveloped in a double arch. Where the plaster has fallen off, it is visible that the arch is built of brick. There are two small platforms, whose capitals are embellished using moulding, on either side of the door. A metal door was placed inside the wooden casing around the entrance opening during a later intervention. There is a small window above (Fig. 5).

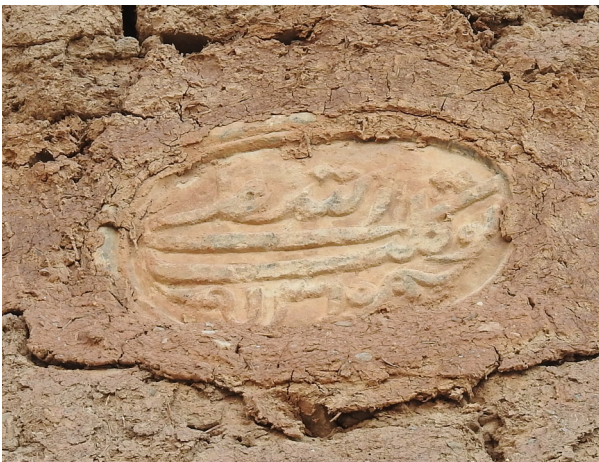
Fig. 6 - The Ottoman inscription on the eastern façade

windows each on the ground and upper floors. All of these windows were embellished with ogee arches, which are thought to have been made with plaster. The arches on the upper floor are taller than those on the ground floor. The jambs and casings of the windows are wooden. They all have window bars. There is an inscription in Ottoman between the two northernmost windows on the upper floor (Fig. 6).

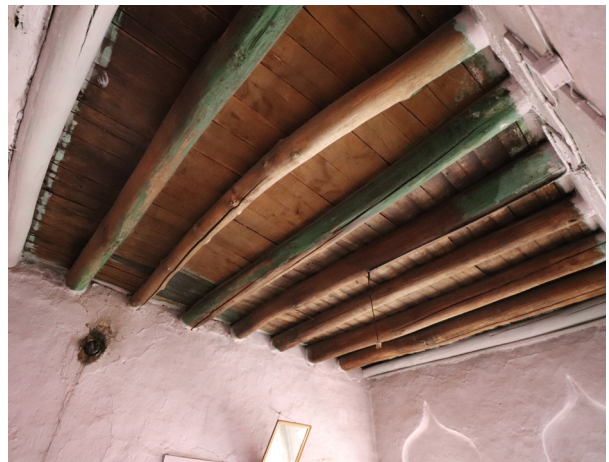
Fig. 7 - Circular, wooden beams supporting the flooring

are circular, wooden beams in the north-south direction on the ceiling that have similar dimensions and intervals to those on the ground floor.

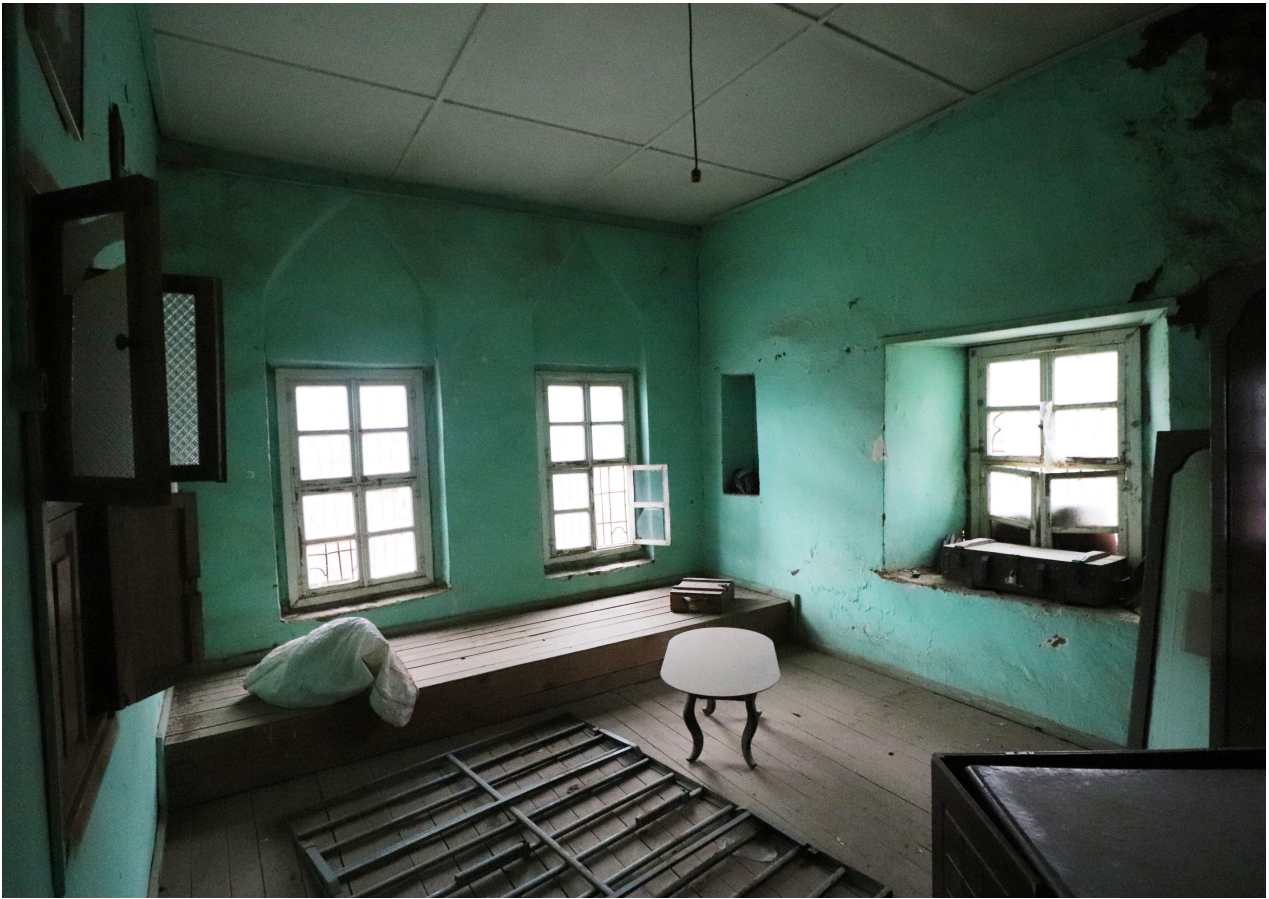
Fig. 8 - General view of the southeastern room on the upper floor

Two of these are at the centres of the platform's shorter edges and measure 40x50 cm. The third is on the northern wall and measures roughly 50x70 cm. This room also has a tapered window on the southern wall whose width is 1.93 m on the interior and 1.06 m on the exterior (Fig. 8). The closet in the western wall is 50 cm deep and 153 cm wide.

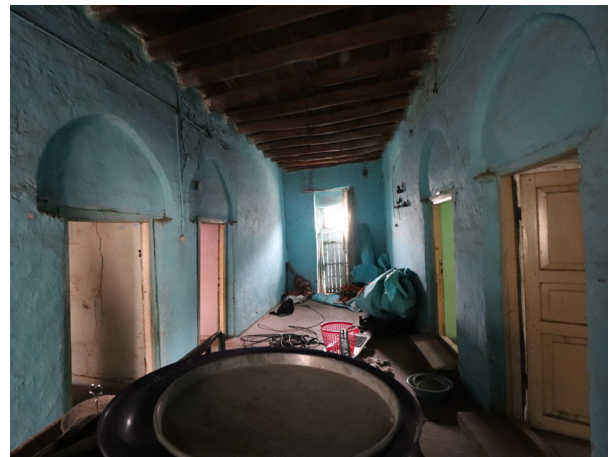
Fig. 9 - View of the sofa, looking eastward

All of the rooms on the upper floor have a semicircular arch (thickness: 5-6 cm) above their doors that lead to the *sofa* (Fig. 9). A window opening has been created (width: 1.24 m) to the west of the sofa. The door in the middle of the *sofa's* eastern wall leads to the balcony. Currently, only the wooden flooring remains of the balcony, which measures 95x325 cm. The eaves follow the form of the balcony. The shape of the roof suggests that this projection may have been a *cumba*, but there are no traces on the exterior façade to support this theory.

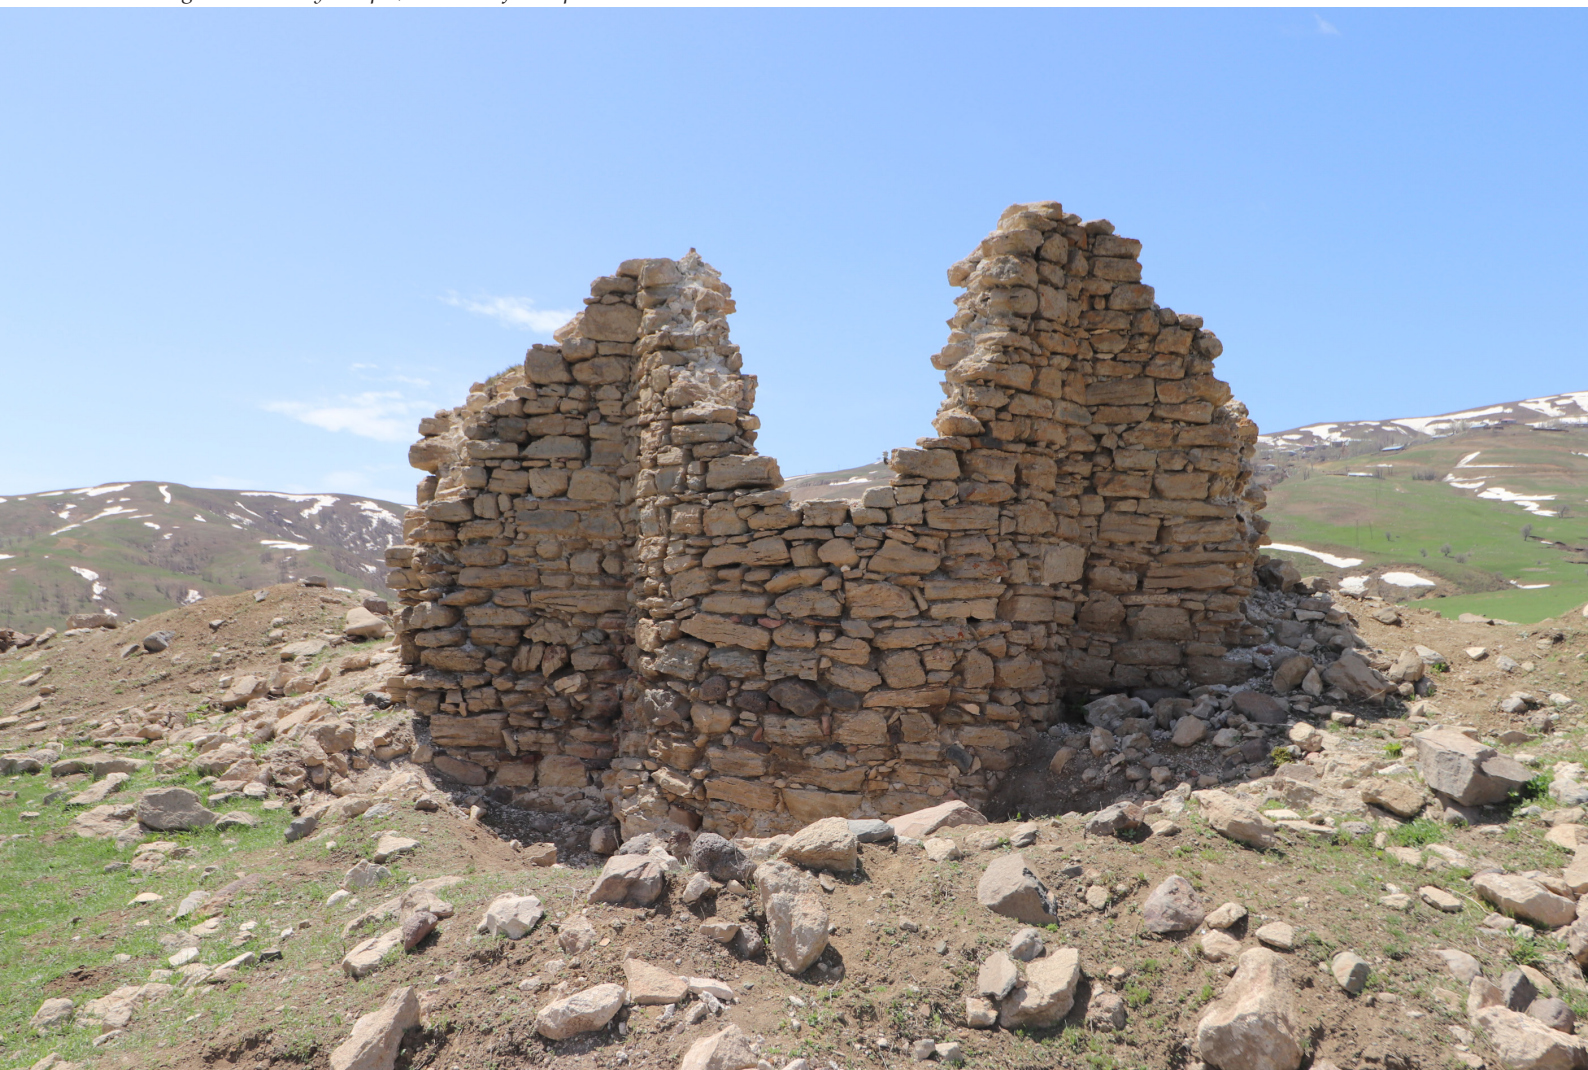
Fig. 1 - St. Mary Chapel, remains of the apse

is traceable. There are a few brick coursings at the beginning of the vault of the above the apse, which indicates that the vault was of brick (Fig. 1). The side walls of the apse each contain a niche, but the dimensions of these could not be taken due to extensive loss of material.

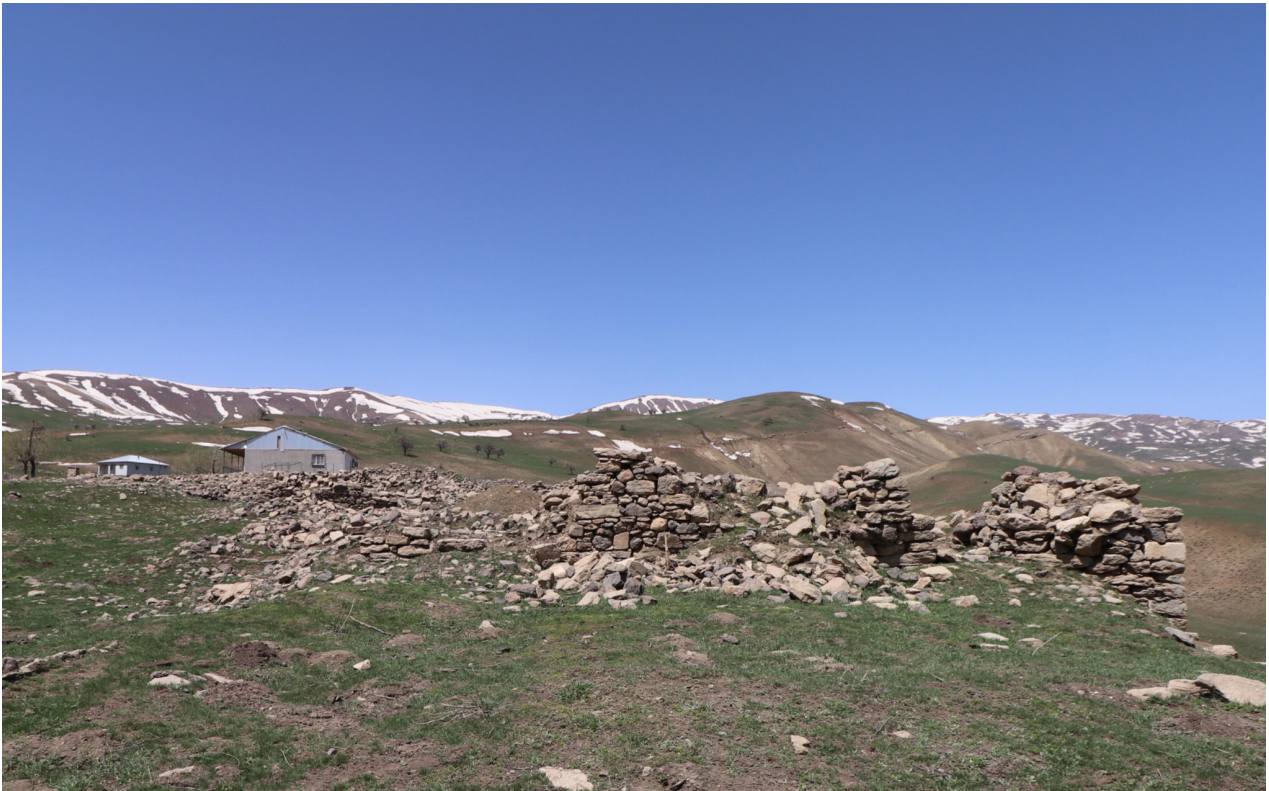
Six workshops were observed during the field-work; the three of these that are closest to the chapel each contain two interior spaces (Fig. 3). To their north, there are two more buildings that each contain three spaces. These are all adjacent. However, the remains of another workshop containing three spaces lie 50 m away. A few openings were attested in the walls of these buildings, and it was possible to measure one of the window openings, but most of them are currently underground. The part of the measured window that is above ground is 57 cm wide and 36 cm tall. Its side jambs are 16 cm, while its head jamb is 13 cm in thickness. The latter is 65 cm in length.

Fig. 3 - Remains of the workshops, southern view

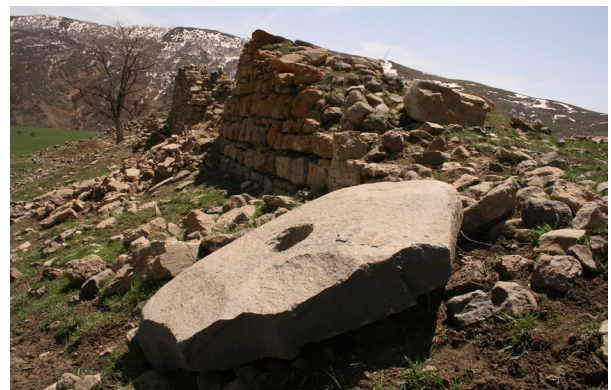
Two pieces of a large mill stone were attested to the east of the workshops, aligned with the retaining wall (Fig. 4). The diameters of these stones were approximately 1.5 m. Their existence may support the theory that this site hosted regular production/lodging activities. No traces were found of the cemetery mentioned by written sources.

Fig. 4 - Retaining wall and mill stone near the workshops

The rate of deterioration for the remains of the chapel and workshops will accelerate as they continue to be neglected. It is recommended for rescue

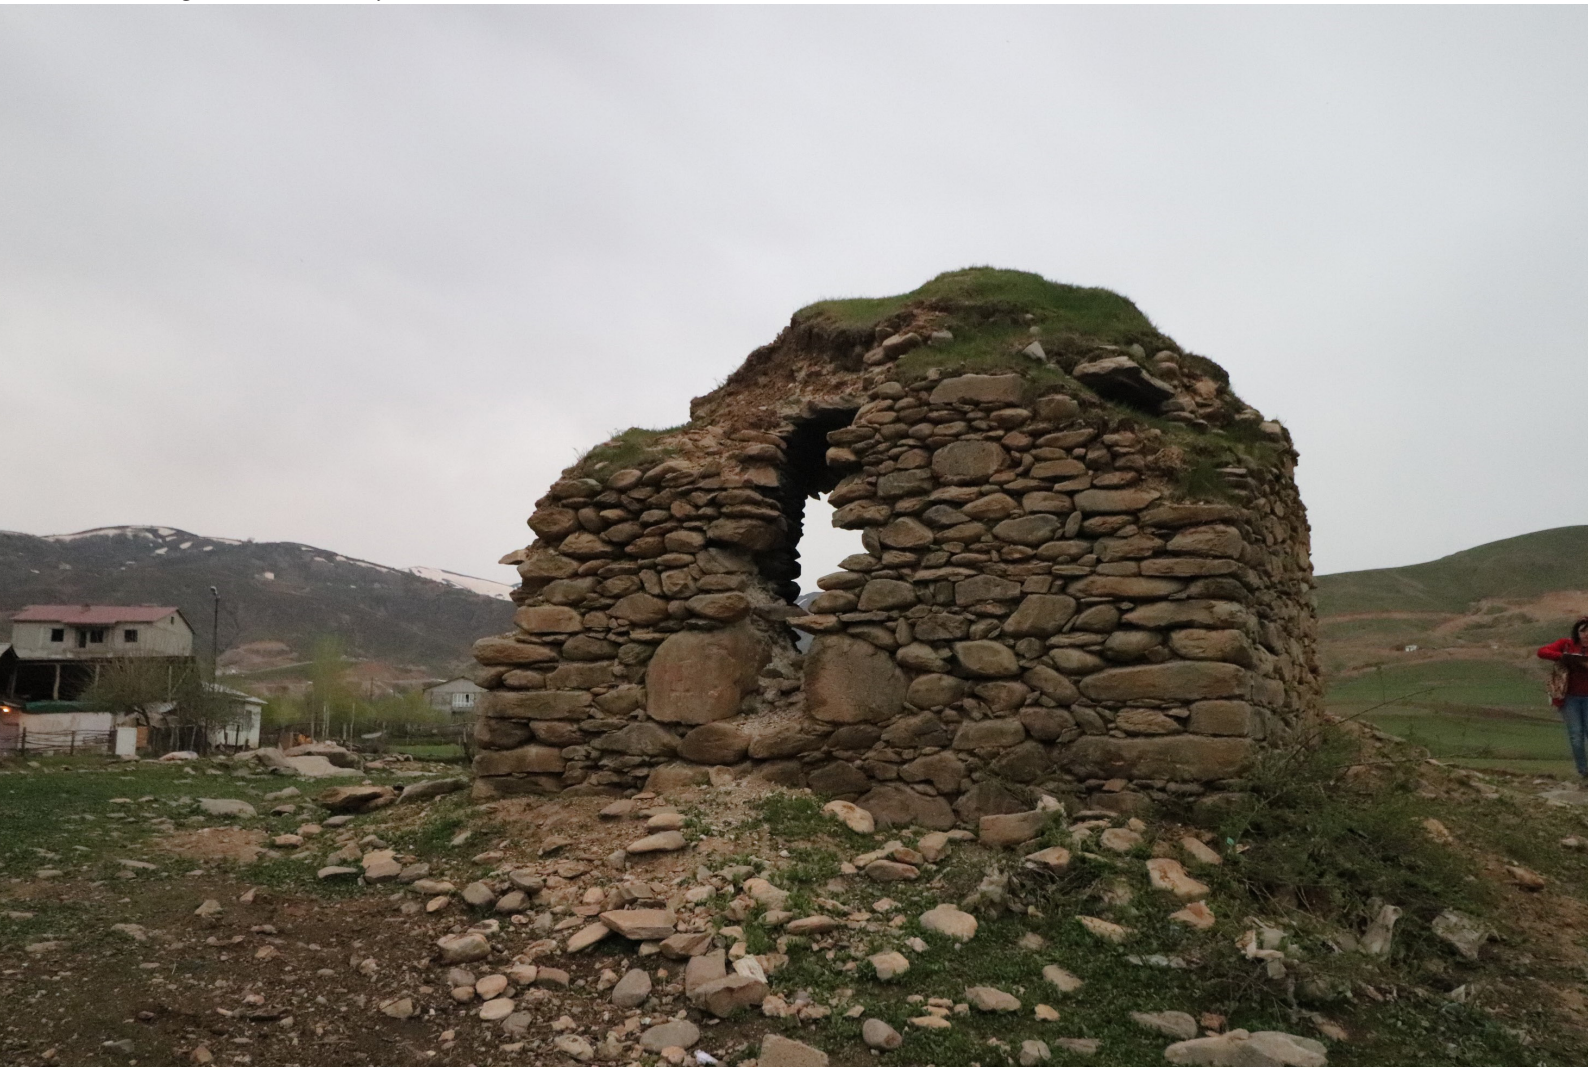
Fig. 1 - Eastern view of the structure and environs

away from the province's center, to the north of the Centrum. Surp Kevork Church is unattached to the village houses. It is situated in a field to the east of the land rumored to be a cemetery and lies on an east-west axis (Fig. 1). Only the apse (*madur*) of the church has survived. The remains of the structure comprise the barrel vault above the apse and the walls that support it, which are situated on a pile of earth and rubble (Fig. 2). The foundations of the collapsed portions of the church are traceable at the ground level. The external measurements of the rectangular structure are 482x760 cm. The walls are constructed of

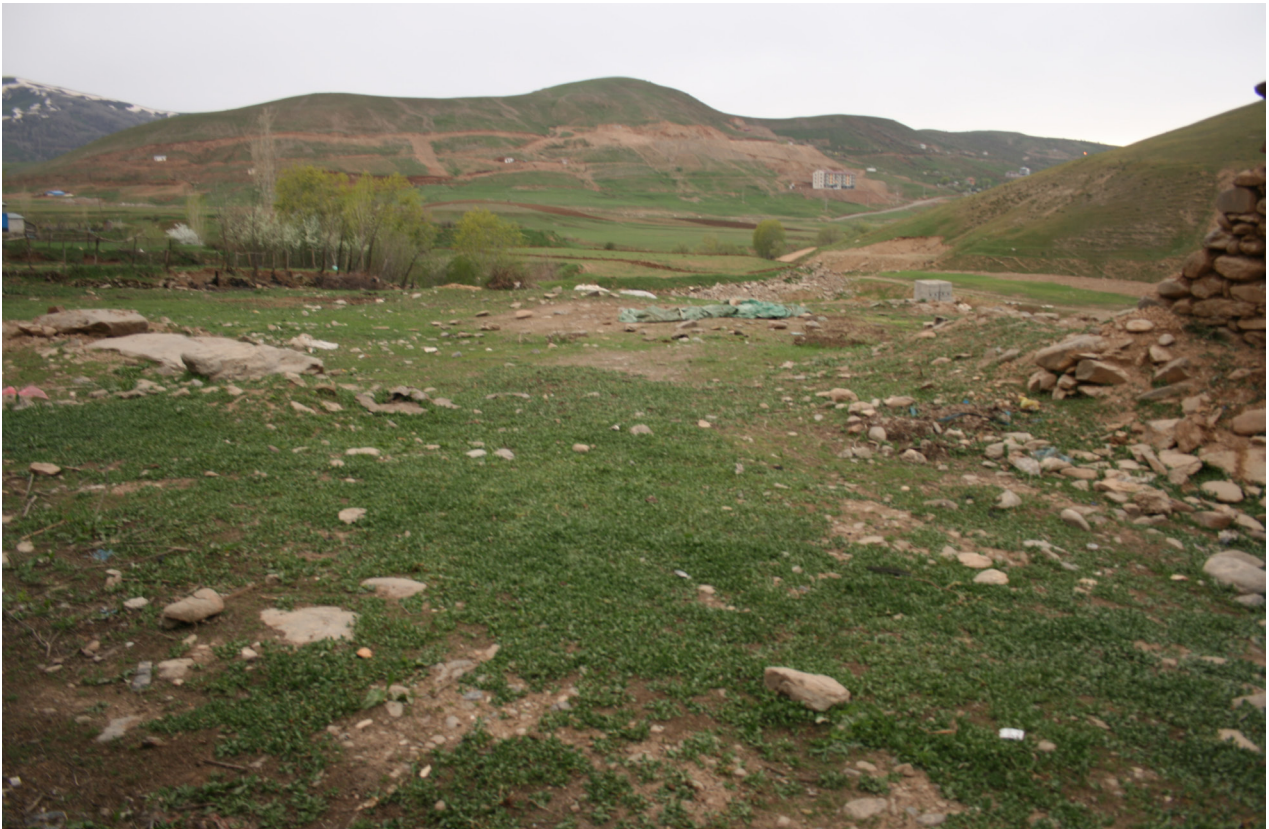
Fig. 4 - Rubble scattered around the site

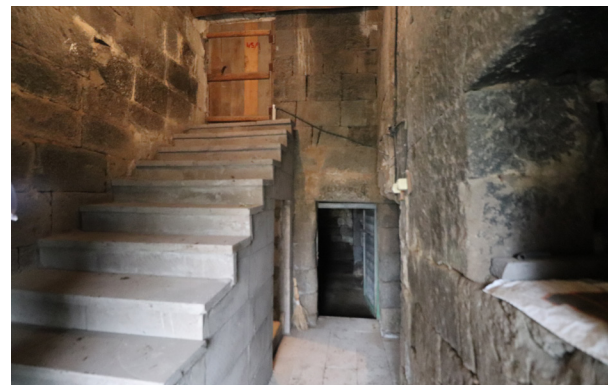
Fig. 2 - The *taşlık* and modern staircase

to the *taşlık* (entryway) – which is connected to a kitchen area with two spaces to the north, and to storage-pantry spaces to the west— on the ground floor. A recently-added, modern, straight staircase immediately to the south of the entrance provides access to the upper floor (Fig. 2). A climb on the staircase leads to the rectangular *sofa*, which is the central space that the three other rooms on this floor are organised around. The longer, eastern edge of the *sofa* has openings to two of the rooms, while its shorter, northern edge has the entrance to another. The southern of the two rooms on the east is reached through a small staircase with four risers and three steps. This is probably the result of an attempt to re-organise the original height of the building's staircase. The rooms on the upper floor, unlike

The *taşlık* space immediately encountered after the main entrance has a rectangular plan of 2.42x3.88 m. The modern, reinforced-concrete staircase that is immediately to its south has a width of 1.41 m. The space under the staircase has been walled off to be used for storage. A door (width: 1.14 m) to the north of the *taşlık* leads to the kitchen, which comprises two spaces that are separated by an arch (width: 94 cm). Of these, the eastern space contains an elliptical cooking pit (*tandır*) whose major and minor axes measure 91x114 cm. This is still functional and in good condition (Fig. 3). There is a blocked door (width: 1.01 m) in the northern kitchen wall, whose outline is still traceable. The spaces beyond this door were inaccessible.

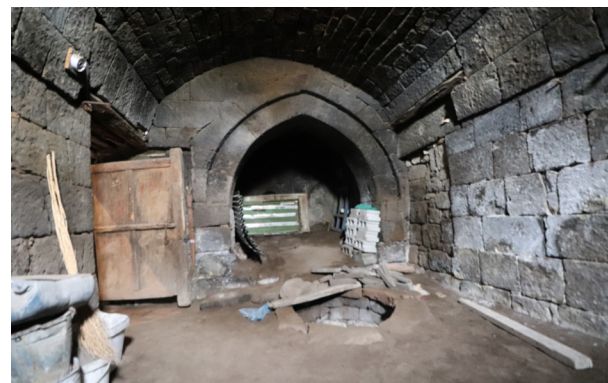
Fig. 3 - The kitchen and cooking pit, ground floor

the neighbouring structure. It is thought that the original design of this space may have included an opening leading directly to the exterior, depending on the construction timeline of these two buildings. The ceiling above the kitchen is a brick barrel vault, while the ceilings of the two other spaces on the ground floor are composed of wooden beams.

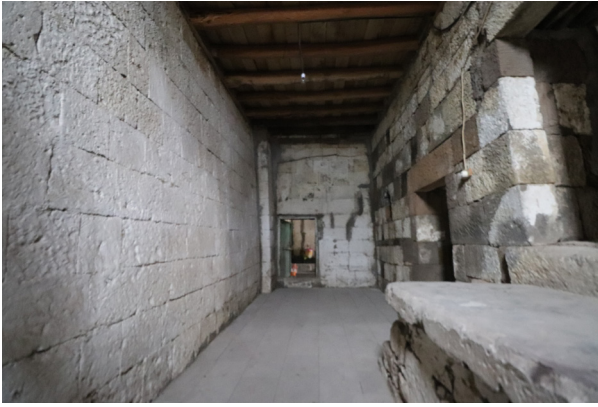
Fig. 4 - Southern view of the sofa, upper floor

The spaces to the east of the upper-floor sofa are bedrooms (Fig. 4). Both rooms are reached through doors (width: 90 cm) in the sofa and they each have a window with bars looking onto the entrance façade as well as various niches on their walls. The third room on this floor is the rectangular principal room that measures 4.06x8.14 m. It is reached through a door (width: 85 cm) in the sofa. There is a window on its western wall and two windows on its eastern wall. The room's northern and southern walls contain niches that have remarkable ornamentations (Fig. 5). There is a platform in front of the eastern windows, which are enveloped in a decorative band. There are two marble inscriptions on the walls. All of the ceilings on this floor are supported by wooden primary beams and perpendicular, secondary, log-shaped wooden elements.

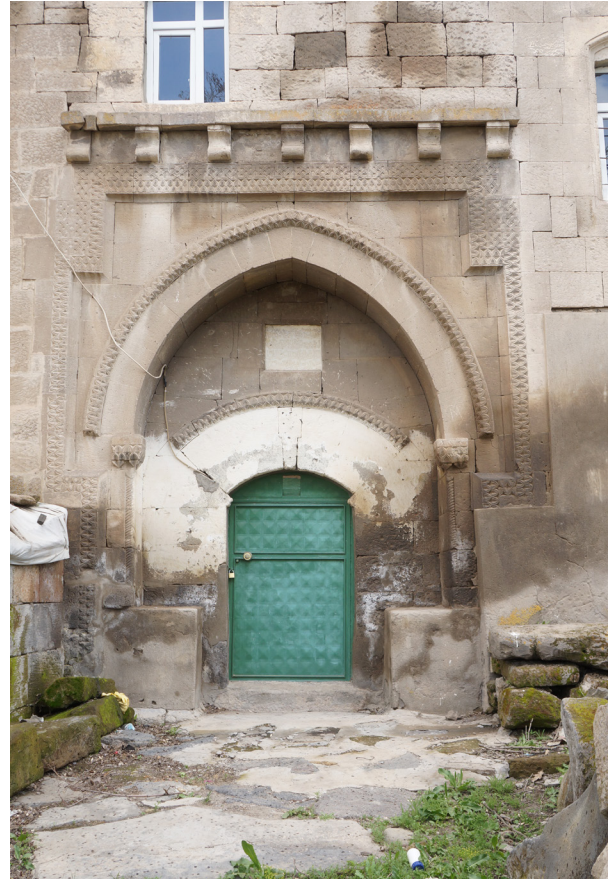
Fig. 6 - Entrance and marble inscription, eastern façade

The main entrance of the mansion is embedded in a segmental arch, which is encapsulated in a pointed arch. There is a marble inscription on the wall area between these two arches (Fig. 6). There is an embellished, inverse-U-shaped band that surrounds the door immediately above the pointed arch, on which seven stone brackets are visible. This detail suggests that there was

originally a projection; the theory is supported by the difference between the current wall coursing above this section and that in the rest of the structure. There is elaborate stone moulding above the door that follows the arc of the segmental arch. There is also a capital and hourglass motifs carved into the stone — embellished with muqarnas — at the level of the springing line on either side of this arch. The eastern façade is quite plain, with the exception of the entrance; there is one window on the ground floor and four windows on the upper floor that were placed in accordance with the interior layout. A significant portion of the eastern façade at the ground-floor level has been plastered with a cement-based material. Ashlar masonry is visible on the rest of the façade. The three segmental-arched windows towards the north on the upper floor are embellished with moulding that follows the shape of the opening. There are no eave mouldings on this façade; it ends with a wooden gable roof. The gable wall has been built with modern concrete masonry units (Fig. 7). At the ground-floor level of the main façade, there is wooden lacing underneath plaster, which joins the unplastered and continuous wooden lacing seen throughout the façade (Fig. 8). Eave moulding is attested on
