MUSH

Architectural Heritage at Risk

This study, in which the historical structures of Mush are considered, primarily aims to assess the architectural history in the province, identify the current conditions of at-risk architectural works, and contribute to their continued existence through scientific suggestions. We believe that this book may be beneficial in the decision-making processes of relevant persons, institutions, and conservation boards since it contains information about settlement history, buildings' history, architectural analysis, legal status, risk assessment, and potential future scenarios. We hope that it may also help to transfer cultural heritage to future generations and create awareness.

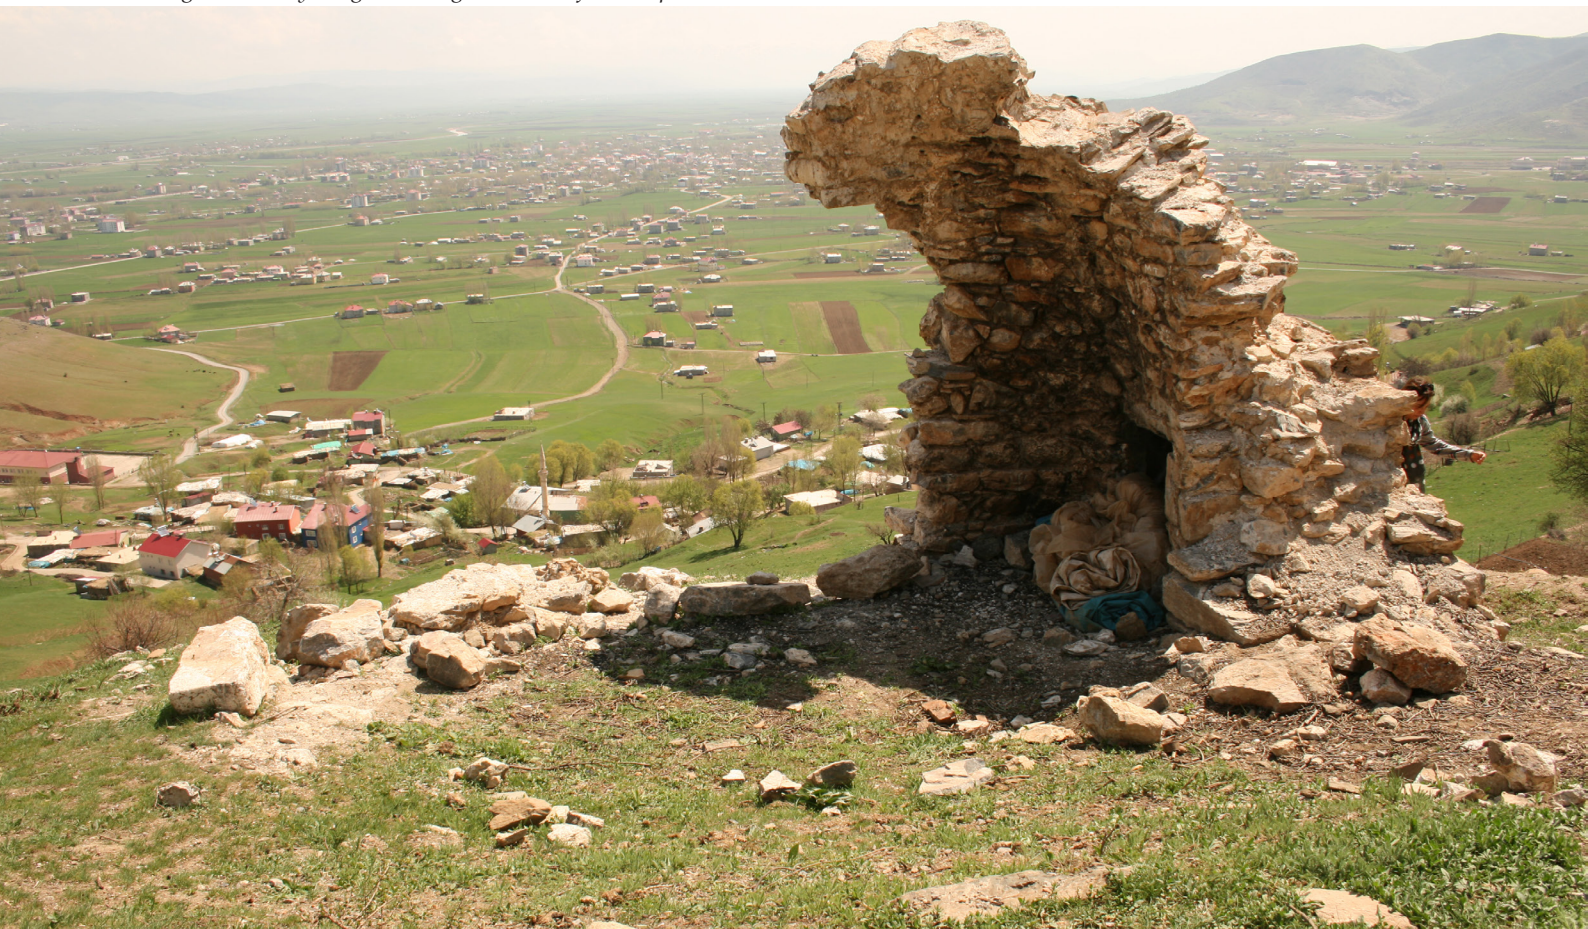
Fig. 1 - Hasköy, Dağdibi Village, remains of the chapel

Dağdibi Village Chapel is a masonry structure, whose apse has partially survived (Fig. 1). The chapel was built on a steep slope overlooking the plain to the west of Dağdibi Village (Fig. 2). It is thought that the structure had a rectangular plan (external dimensions: 6.10 × ... m) and a single nave; there is no information about its roof system. Its western wall is underneath the dirt road, so the lengthwise external dimension could not be measured. The surface of the apse is curved on the interior; the space does not protrude on the exterior façade as is the case in other chapels and churches in the region

Only a small portion of the chapel has survived. It was understood that the structure is in its current condition because it was not used or maintained after it was abandoned; the construction and expansion of the dirt road to its west was also thought to have caused further damage and losses.

Dağdibi Village Chapel is in a process of rapid deterioration. Unless urgent conservation measures are taken, it is likely that it will be completely destroyed in the coming years. It is necessary for a complete survey to take place and for a restoration project to be prepared while the structure is consolidated through conservation methods. It is recommended for access to the site be restricted and for an information panel to be prepared for the structure in the interim.

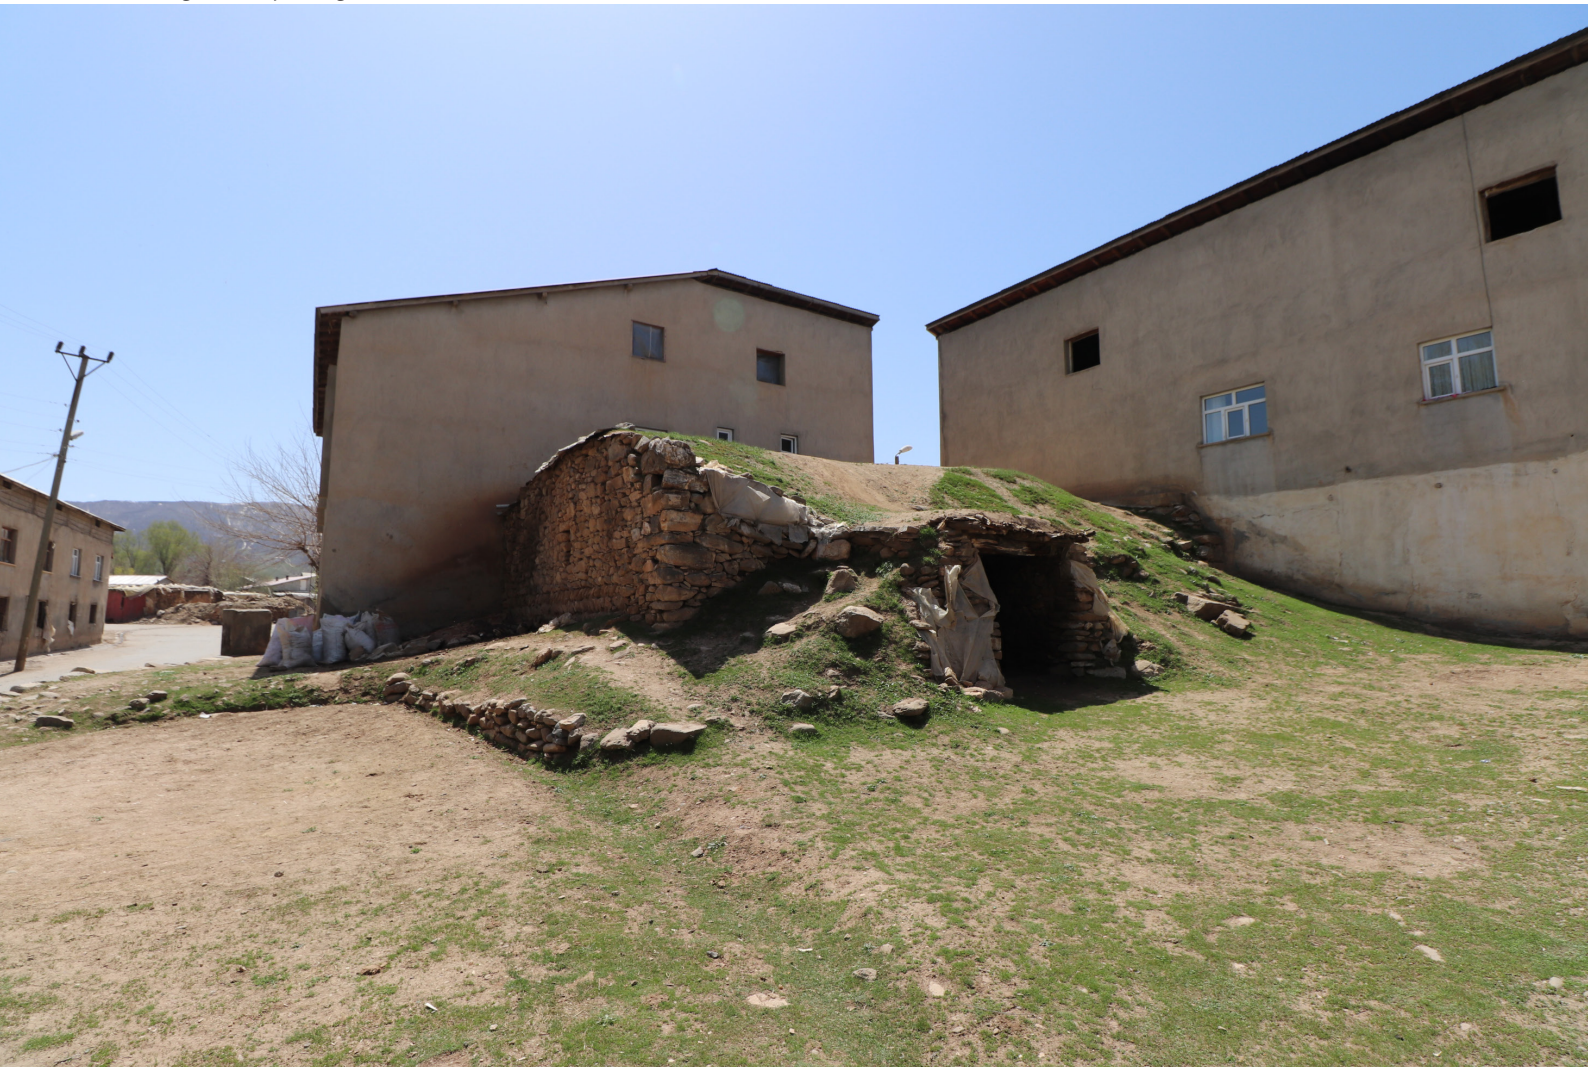
Fig. 1 - Surp Giragos Church, northeastern view

Surp Giragos Church is situated within a vernacular texture in Mush Merkez (Centrum) District, Kepenek Village, Köyiçi Locality (Fig. 1). Its remains are currently used as an barn/haymow by the villagers. The church retains its architectural composition despite neglect and misuse. It is adjoined by modern structures to the south and west. The site is described as a single-story,

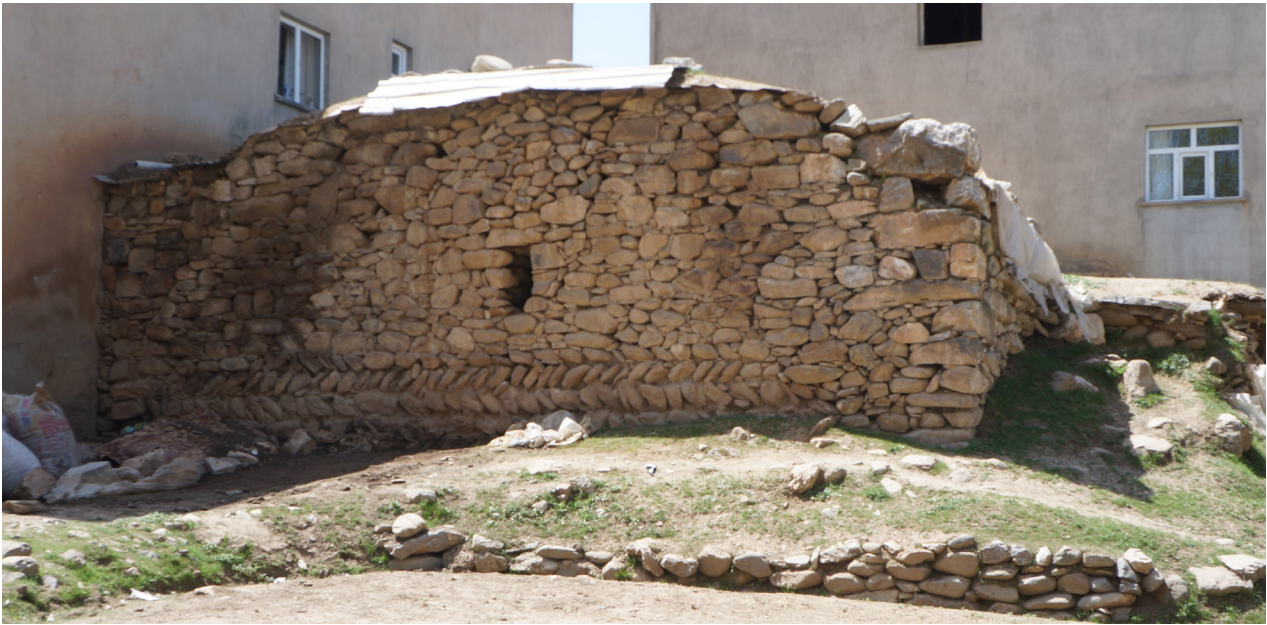
Fig. 3 - Eastern façade and rubble coursing with herringbone pattern

The building was constructed using rubble masonry. The exterior façade was articulated by two courses of finer-cut stones that create a herringbone pattern (Fig. 3). No embellishments or decorative elements were attested either on the interior or the exterior. However, traces of plaster were found on the interior wall surfaces. It is likely that these surfaces were originally covered by frescoes, however, it was impossible to determine if any tangible traces still exist due to the accumulation of dirt and soot.

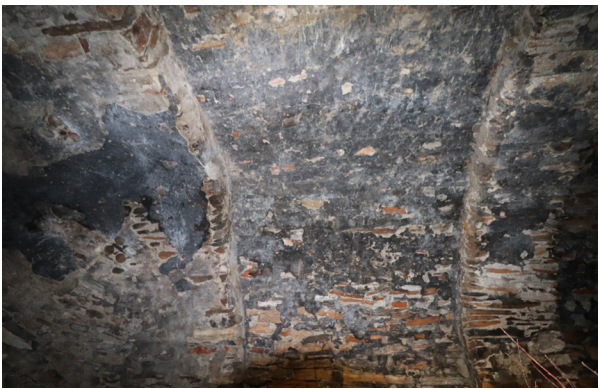
Fig. 4 - Interior walls, accumulation of soot

Critical structural issues were not observed in the building. Much of the interior walls have undergone dense accumulation of dirt and soot (Fig. 4). Consequently, it was not possible to make observations regarding potential traces of fresco remains on the wall surfaces.

The mounds of earth around the building must be eradicated so that the existing walls and roof may become visible. Technical evaluations should follow this process, after which preventative methods must urgently be taken to prevent further deteriorations. The building must be liberated of inappropriate additions and loads, consolidated, and protected from the elements. Efforts to document the building and draft a restoration project should lead to a systematic and scientific series of coordinated interventions.

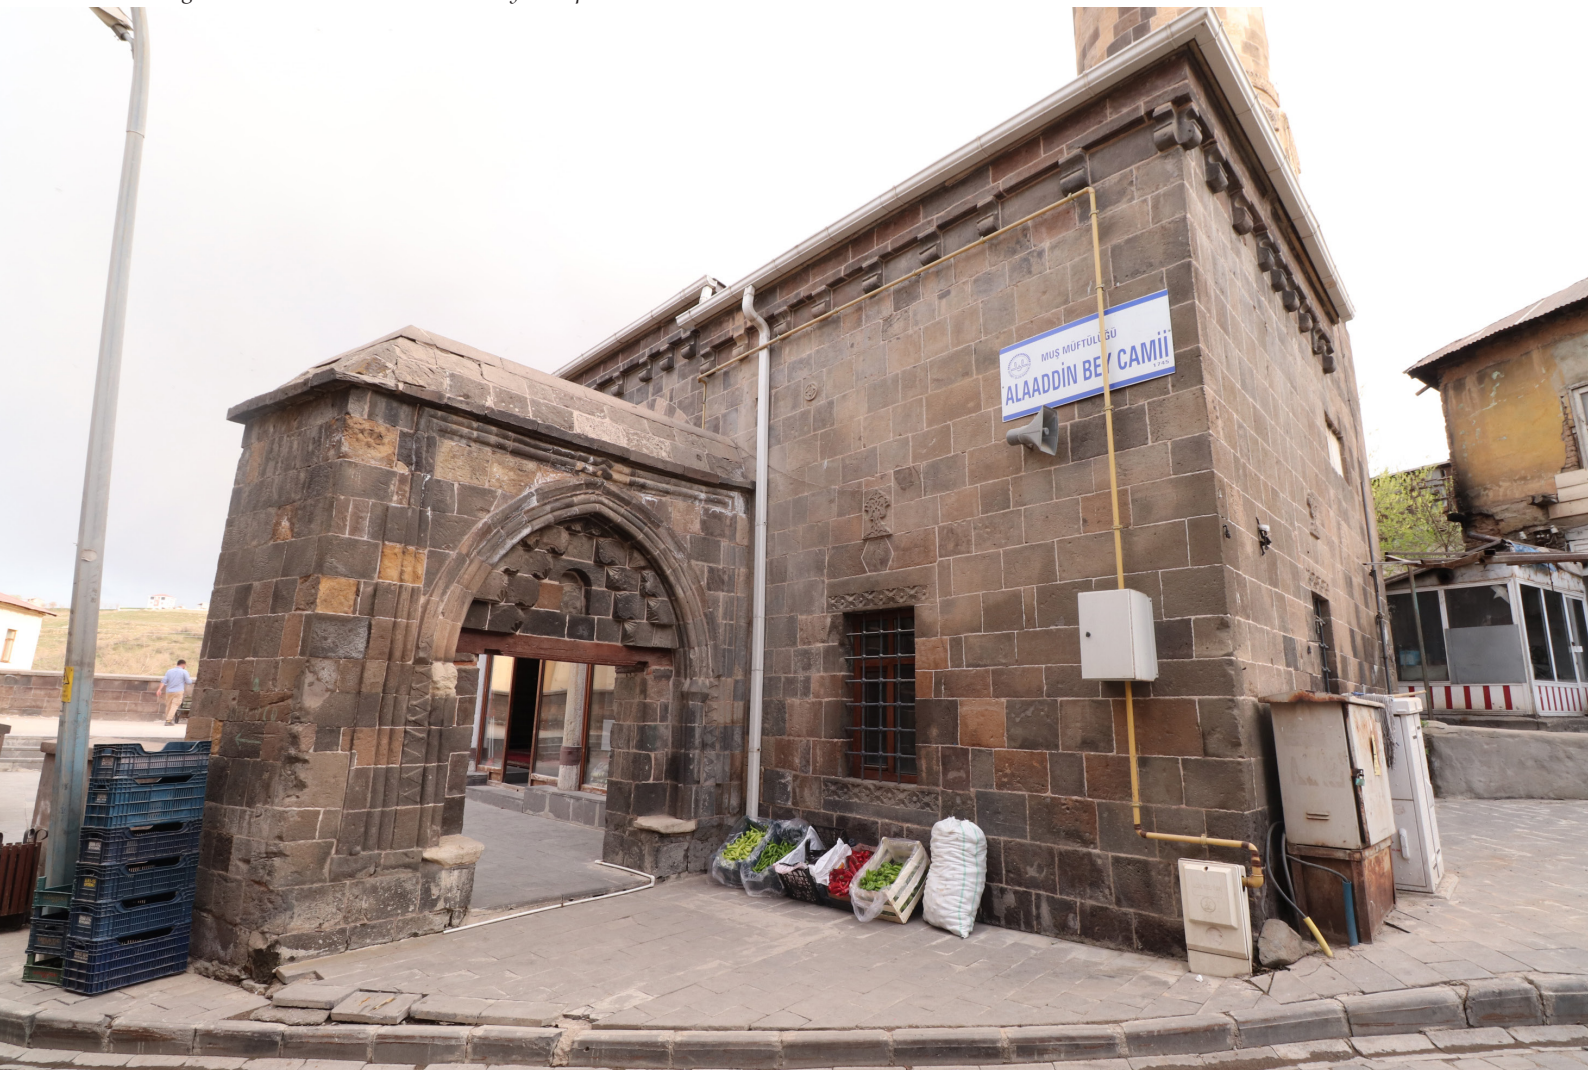
Fig. 1 - Entrance to the Alaeddin Bey Mosque and the monumental shrine

The monumental entrance from Atatürk Boulevard leads to the courtyard (Fig. 1). The entrance portal consists of a rectangular frame — defined by a double-row of moulding with semi-circular profiles— in which there is a pointed arch decorated with more moulding. The pointed arch houses a rectangular opening, defined by a flat lintel, that has a small platform on either side. An arched niche that is surrounded by ornamentations carved into stone is visible above the wooden lintel of the door. This niche probably housed an inscription at some point.

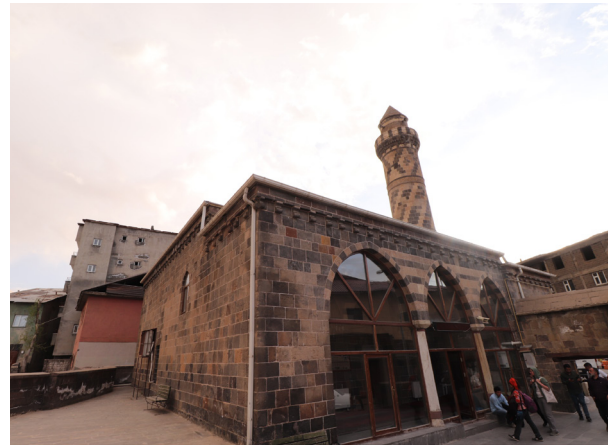
Fig. 3 - Last prayer hall of Alaeddin Bey Mosque

The flooring and walls of the courtyard, which lies in front of the last prayer hall and eastern façade, were recently repaired. A step from the courtyard leads to the last prayer hall, which is thought to have originally been a semi-open space (*revak*) with its three arches (Fig. 3). The western wall of the courtyard contains a door with a flat lintel that leads to the monumental shrine of Alaeddin Bey. The monumental shrine is affiliated with the church, but its entrance as separated from the façade of the last prayer hall by the portal; the shrine's character as a standalone structure is emphasized through its direct connection to the street (Fig. 1). There is stone moulding, eaves, and a roof parapet above the pointed arches of the *revak* on the façade of the last prayer hall. The main walls and roof of the main space are visible behind this façade.

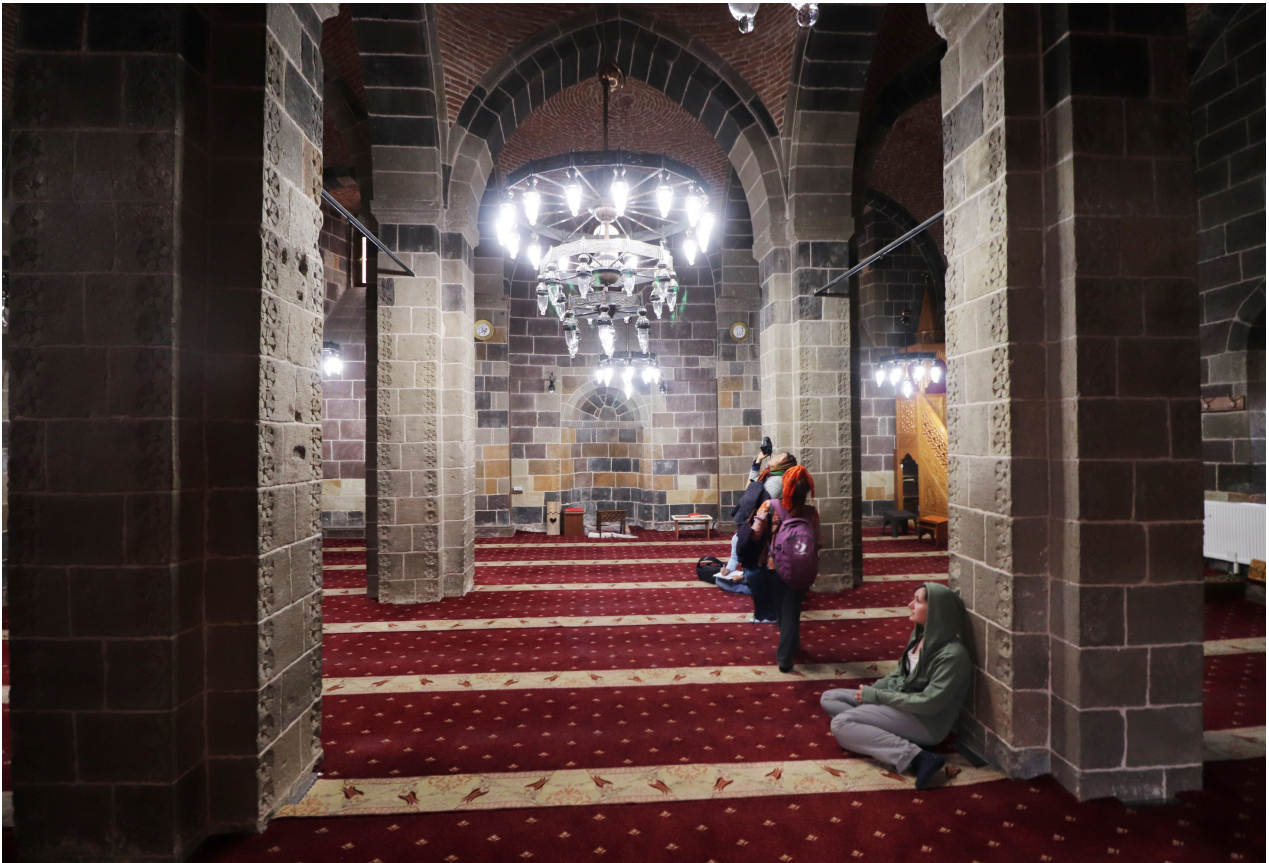
Fig. 4 - Sacred area (*harim*) and mihrab in Alaeddin Bey Mosque

symmetrical organization; there are four pillars with cross-sections shaped similar to a cross (Fig. 4). The arches placed between the main walls and pillars in both directions divide the space into nine vaulted¹ bays. The vault covering the central bay is taller than the others, it protrudes from the roof and ends in a conical roof with an octagonal drum.

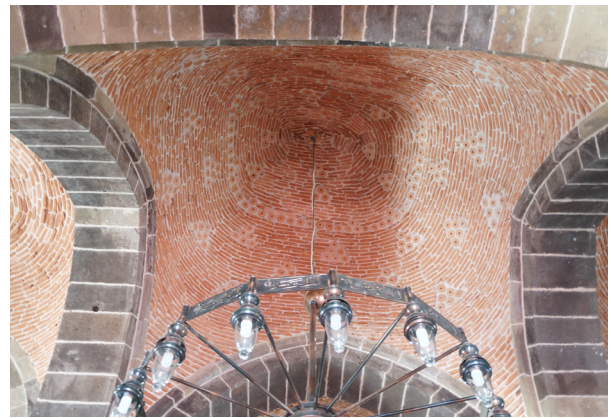
Fig. 5 - Sacred area (*harim*), vault covering the central bay

1. The roof structure above the building is essentially a sail vault. The transition from the rectangle defined by the arches to the circular or elliptical drum, as well as the roof above, displays geometric and structural continuity. The brick courses in the masonry follows the same direction/line without interruption.

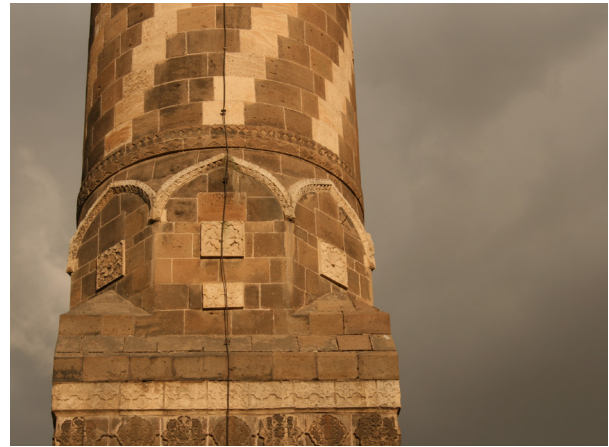
Fig. 6 - Minaret and Inscriptions

The monumental shrine of Alaeddin Bey has a lot of disturbing visual clutter due to the conduit boxes, pieces of the natural-gas system, inappropriate additions of rain spouts and gutters, a speaker, and the sign for the mosque. These damage the overall aesthetic authenticity of the building.

It is recommended for the recent additions of equipment for heating, cooling, and ventilating Alaeddin Bey Mosque to be removed and for smarter solutions for interior comfort to be implemented such that the building's aesthetic authenticity is not damaged. It will be beneficial for information panels to be prepared in different languages and placed at various points to inform visitors about the building's history and architectural features. The vaulted structure and its fountain, located on the same lot as the mosque, must be repaired before deteriorations worsen. It is also recommended for the additions to the façades of the monumental shrine to be removed in order to eradicate the visual clutter, and for infrastructure equipment to be moved to more appropriate locations.

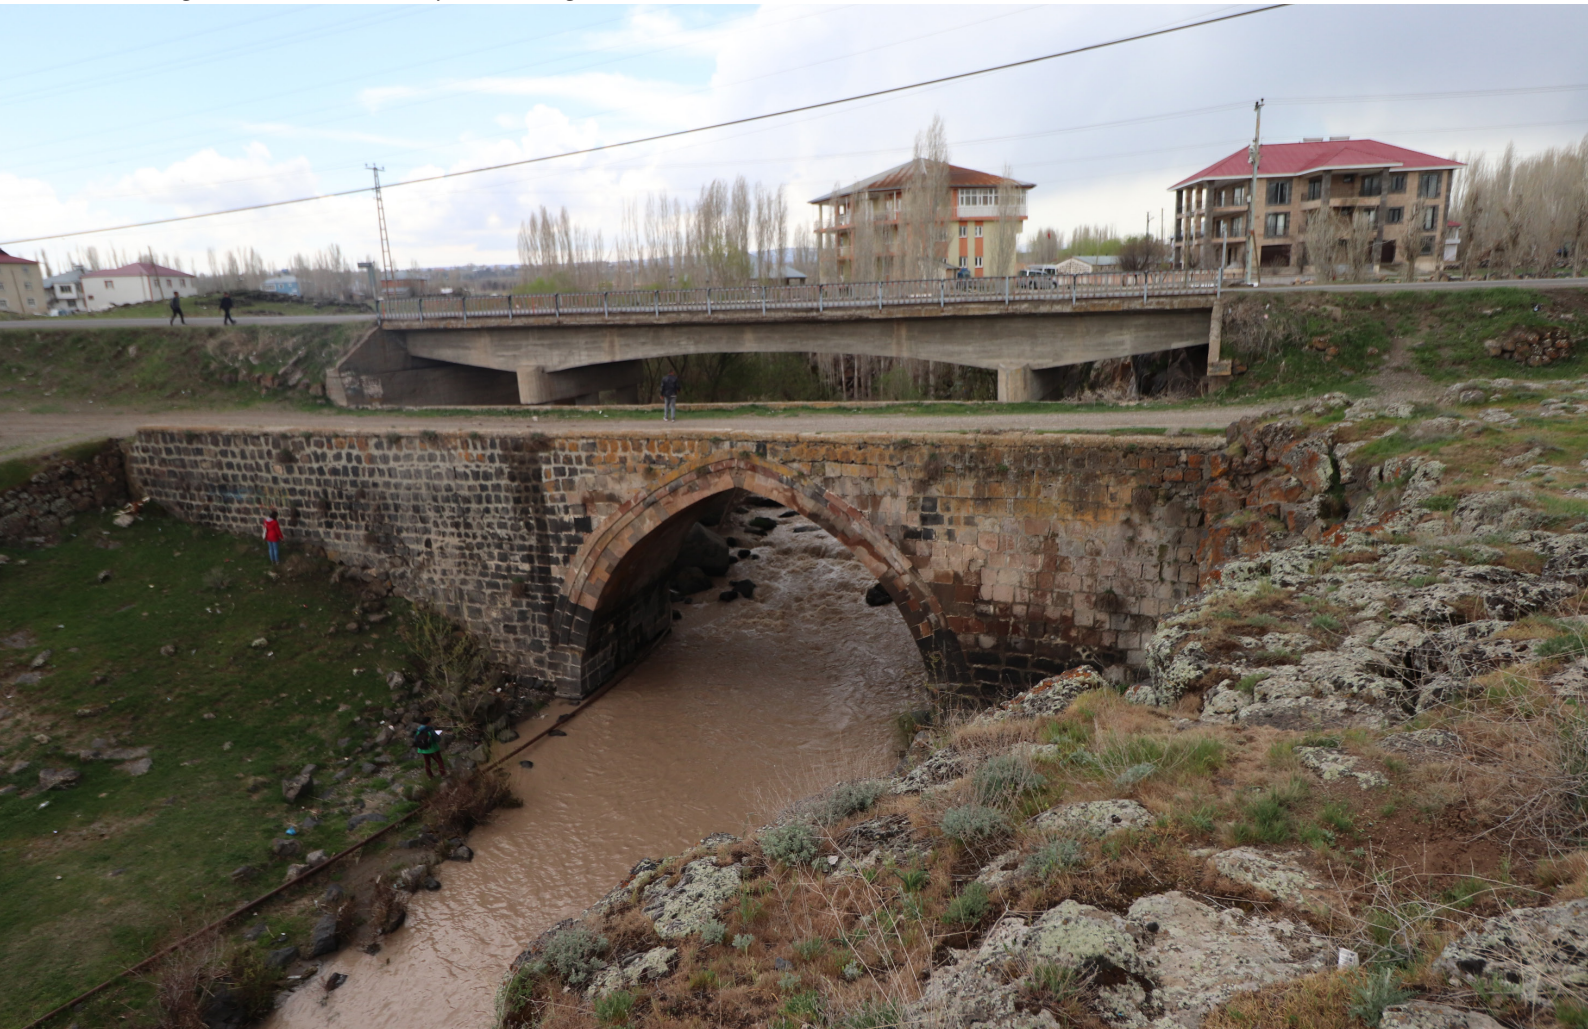
Fig. 1 - Northwestern view of Hatun Bridge

A new, reinforced-concrete highway bridge was built next to Hatun Bridge (Fig. 1). The piers of the new bridge abut those of the historic bridge. This situation is harmful for the relationships between the bridge, which is a cultural asset, and its surroundings as well as the streambed.

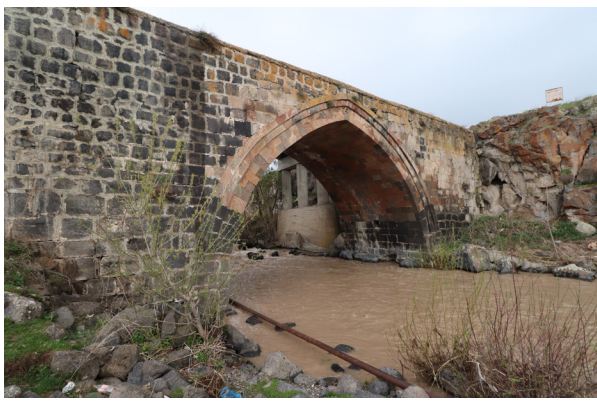
Fig. 2 - Downstream direction of Hatun Bridge

The streambed is narrow near the bridge; it is quite steep and rocky to the west, while it has a softer incline to the east (Fig. 2). Hence, the western pier of the arch is shorter while its eastern pier is taller. The piers rise above the bedrock in the streambed. The ashlar-stone arch has three layers in both the upstream and downstream directions. The first 5-6 voussoirs from the springing line are basalt, the remaining ones are of a volcanic stone with a pinkish colour. This difference in material is indicative of the damages mentioned in the archival documents; it could be that the first few voussoirs

above the springing line are original while the rest are the result of repairs. There is similar evidence of repairs in the western pier. However, the situation is more complicated on the eastern pier where there are variations in material, block sizes, and coursing methods. A small section near the arch is considered to be original; the rest are attested to be the result of repairs and interventions.

Hatun Bridge is a neglected structure that carries evidence of past repairs. The new, adjacent bridge has removed some of the traffic load from the historic structure, but it has also made it less noticeable and observable. It is recommended for the reinforced-concrete bridge to be removed, at least at the end of its lifespan, and a new one to be built in a further location. The mills near the bridge could be investigated, documented, and conserved. Following such a process, the visibility and conservation of both the bridge and the mills may improve through a joint project to make the site visitable.

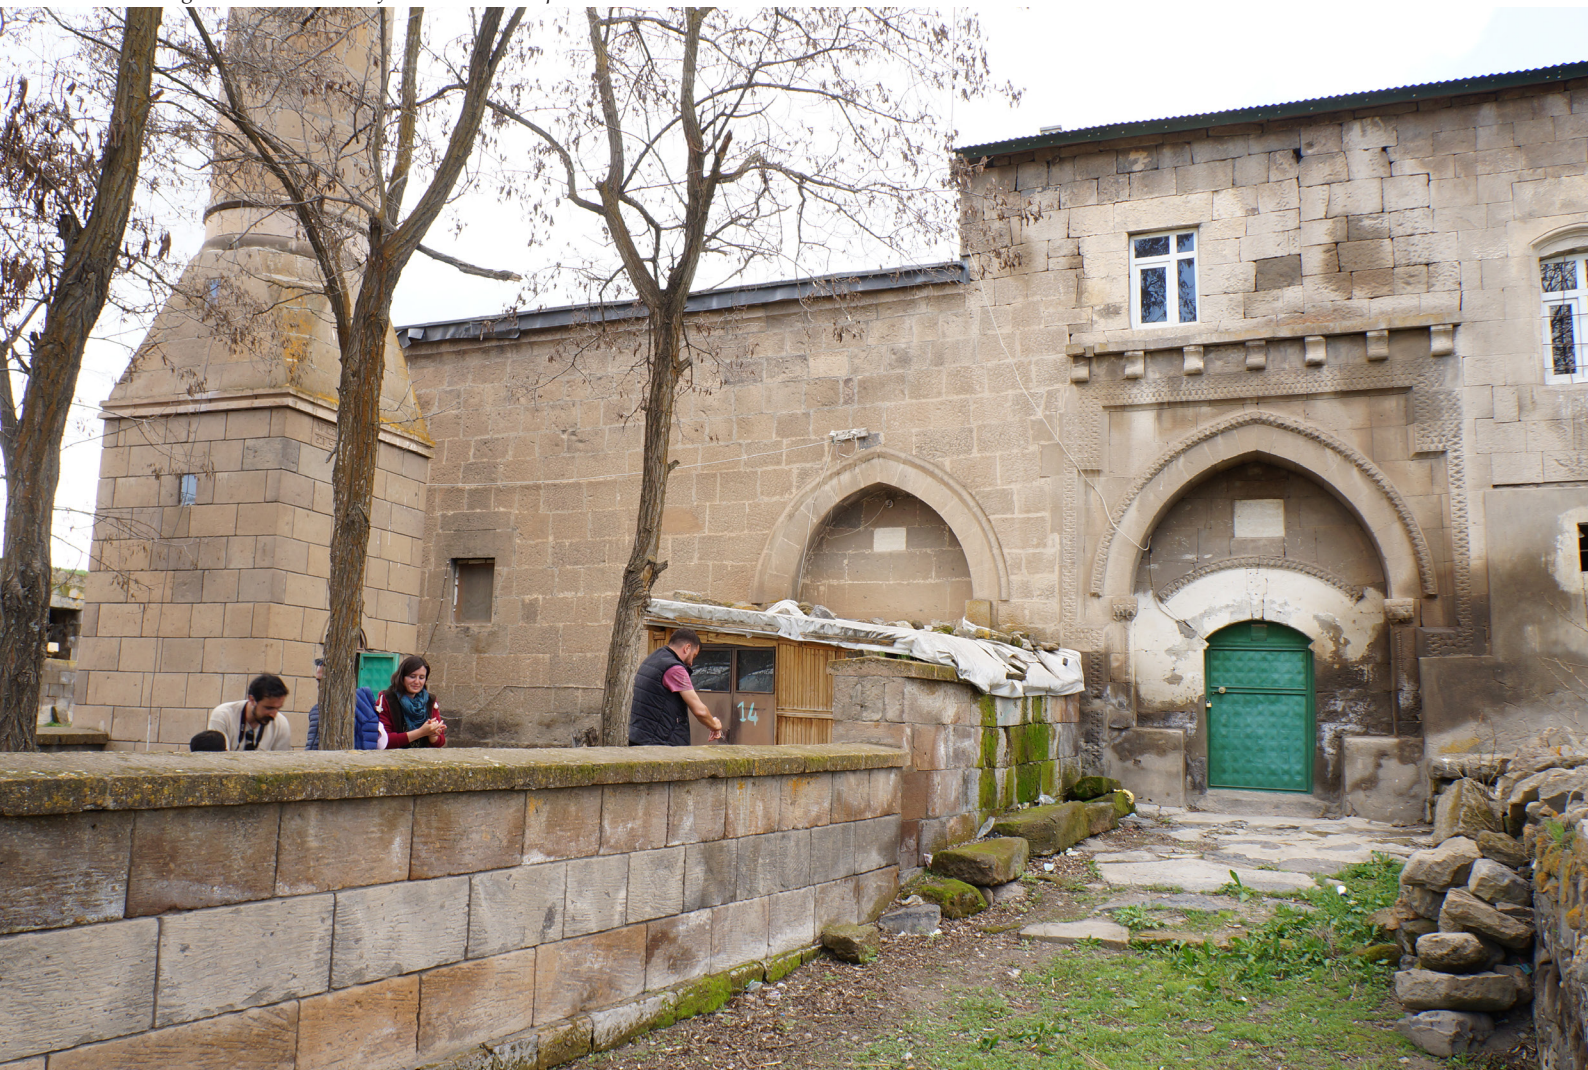
Fig. 1 - Eastern view of Mollakent Mosque and Divan Mansion

The lengths of the interior walls are approximately 8 m. The entrance of the mosque is through an opening on the eastern façade. An inappropriate, wooden addition to the opening was attested during the site visit, which appears to function as a vestibule (Fig. 1). The form of the original entrance is not legible from the exterior, but it appears to have been situated in a deep niche with a pointed arch.

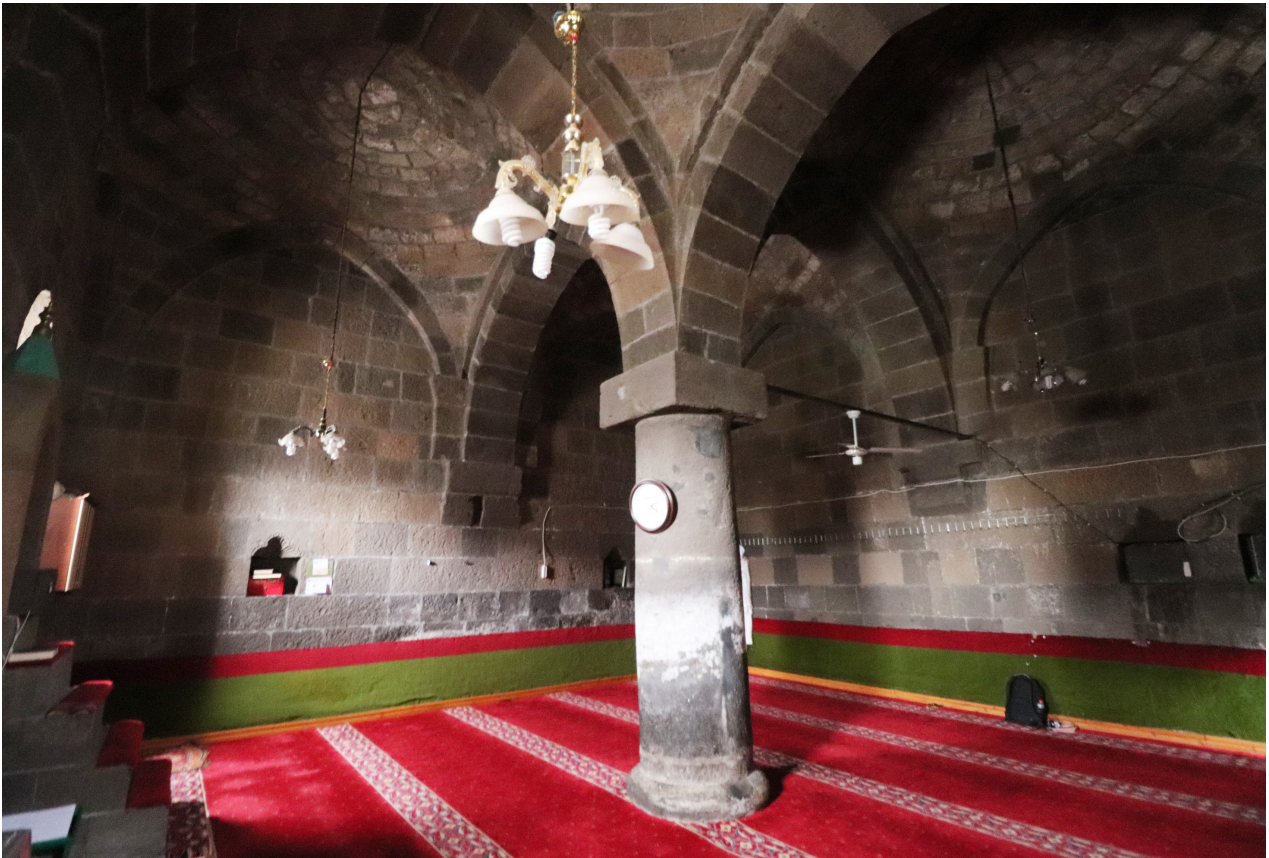
Fig. 2 - The interior, with the column supporting the four domes

A marble inscription is located on the second row of stones under this arch. The four arches that support the four domes are connected to a column with a circular cross-section and an 80 cm diameter on the interior. The width of the arches is approximately 70 cm (Fig. 2). The column capital has a square cross-section and it is roughly 40 cm in thickness. The connections between each arch and main wall are marked by two rows of stone blocks, with the upper row comprising a single stone and the lower row consisting of two stones. The transition from the walls to the domes is attained through pendentives (Fig. 3). The column consists of three tambur. Its pedestal is circular and protrudes 10 cm from the shaft. The domes are below a flat roof and the space between is filled with earth, but this detail is not visible from inside the building (Evren 1997, 7).

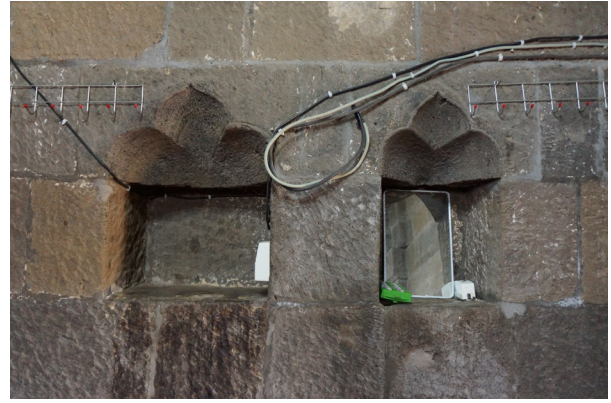
Fig. 4 - Niches

Mollakent Village Mosque is still open for worship and in very good condition. Critical structure issues or deteriorations of materials were not attested during the fieldwork. The largest feature marring the authenticity of the building is the vestibule added to the entrance on the southern façade. This inappropriate addition was constructed of wood and covered with tarp,

which is held in place by large stones on the ground. This addition hinders the understanding of the original façade organisation and damages the building's monumental quality. Moreover, there is cladding material laid on the roof for improvements, but these prevent the legibility of the eaves. Also, the cables, panels, and lighting fixtures that were placed on the interior and exterior surfaces as part of the mechanical and electrical systems affect the perception of the building's historical significance.

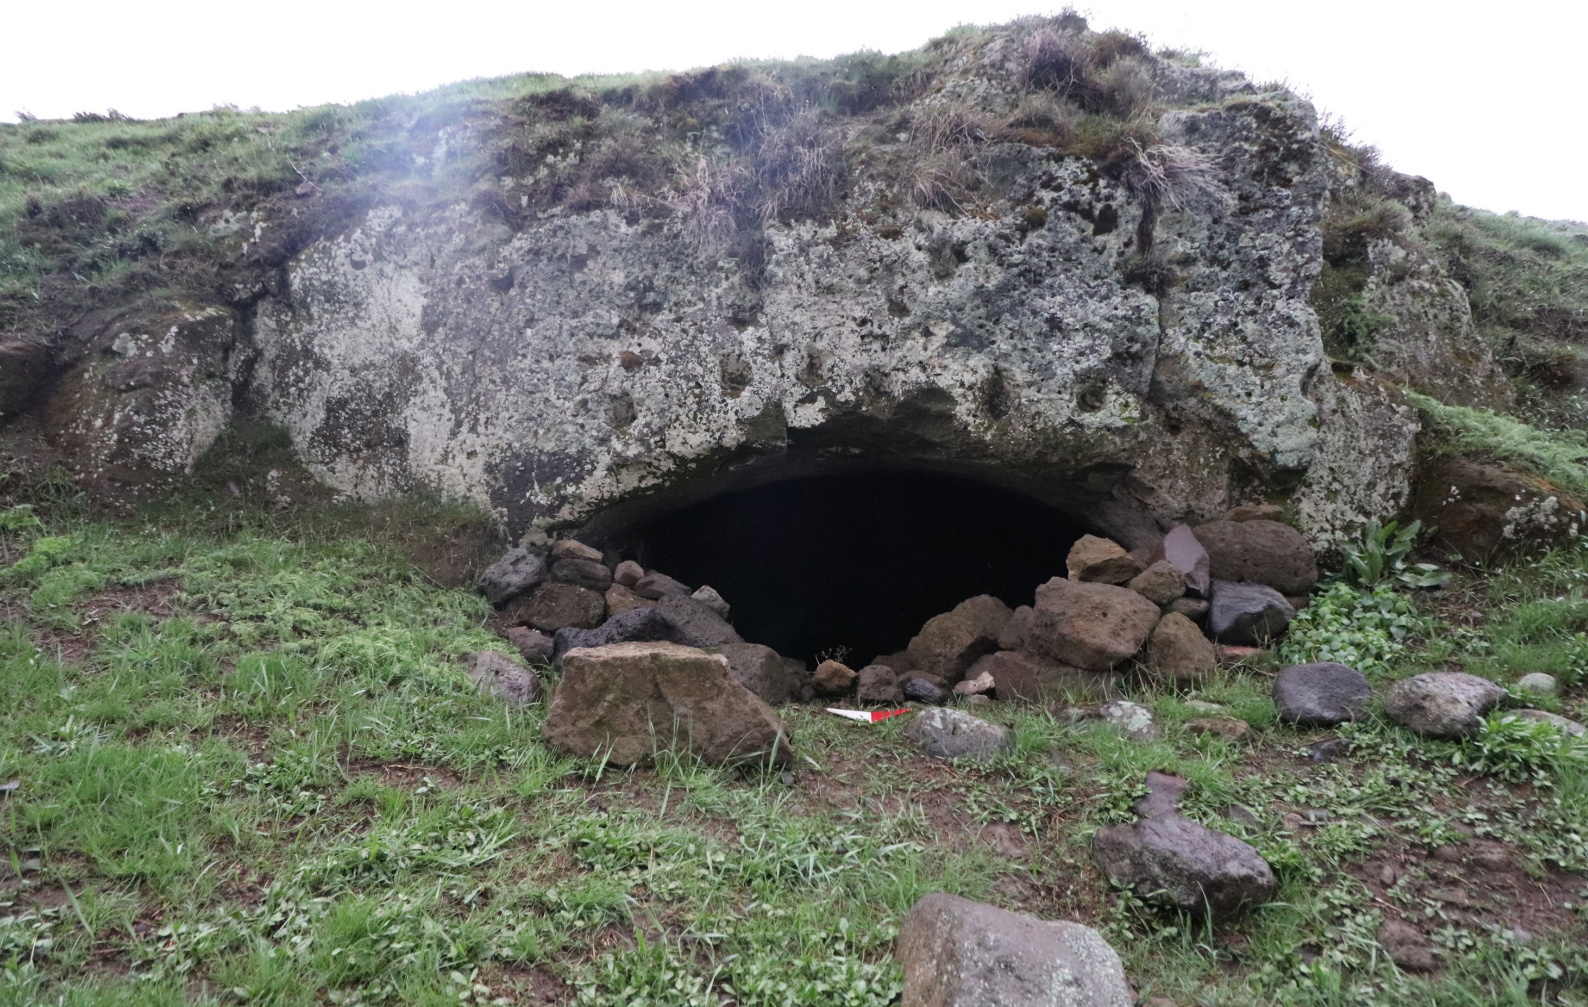
Fig. 1 - Uzgörür Rock-Cut Tomb Chamber, general view

to it (Fig. 1). Its rectangular, almost-square plan lies on a southeast-northwest axis. The entrance is through a northwestern opening that is 3.50 m in width. The rural area containing the rock formation and the floor of the tomb's entrance has gradually been covered by earth as a result of natural occurrences such as floods and landslides. Hence, it is not possible to glean information about the original level or material of the flooring. It is attested that the height of the space has decreased to 1.10 m at the entrance (Figs. 1 and 2). The chamber has a rectangular plan that measures 3.50x4.10 m; its ceiling has been carved to resemble a barrel vault. Chisel marks are visible on the side walls. Some cracks that appear to be structural are attested on the surface of the

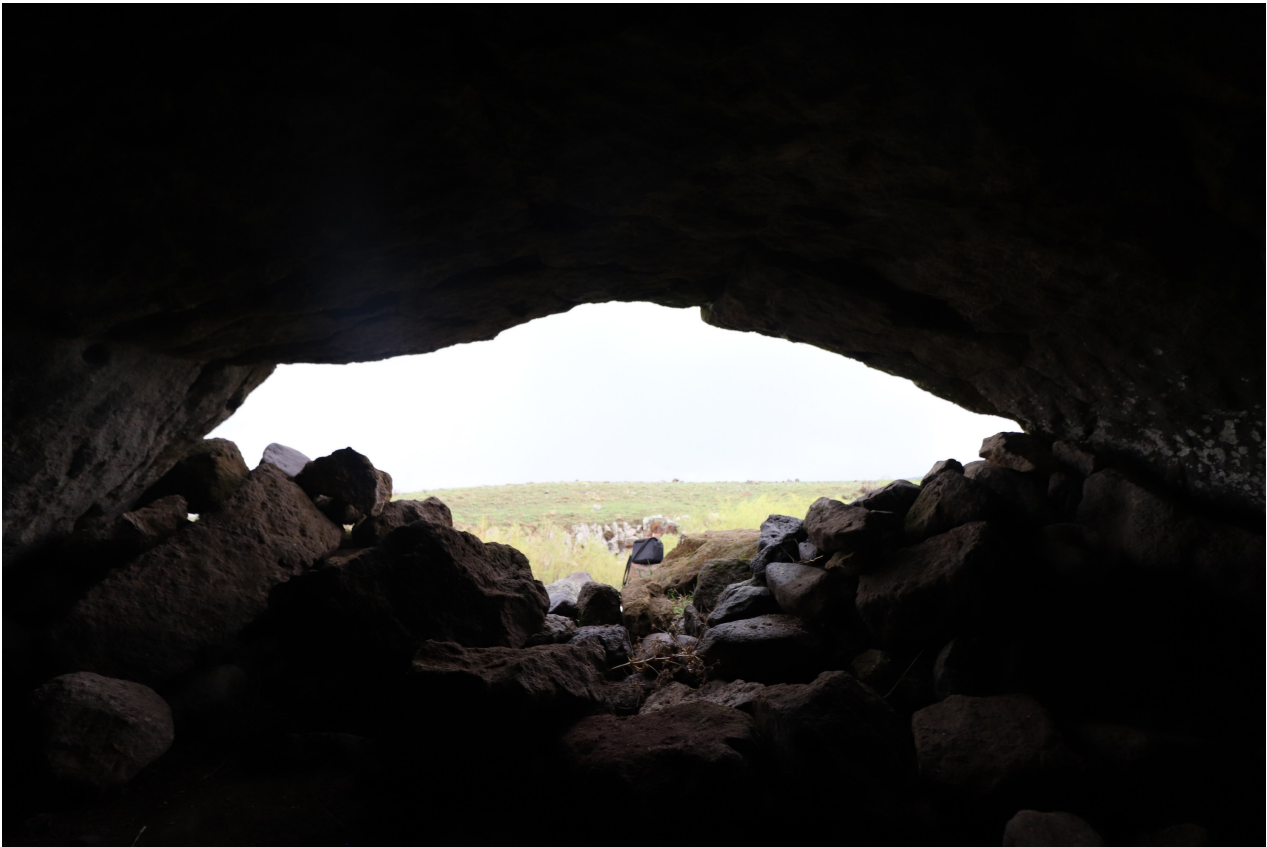
Fig. 2 - Uzgörüür Rock-Cut Tomb Chamber, level of infill at the entrance

barrel vault. There is a niche (roughly 55 cm in depth and 80 cm in width) in the southeastern corner of the chamber. The surface of the western wall indicates that there is another niche that continues below the earthen infill. However, it is not possible to gather any more information on this because of the dense infill and the limited availability of light on the interior.

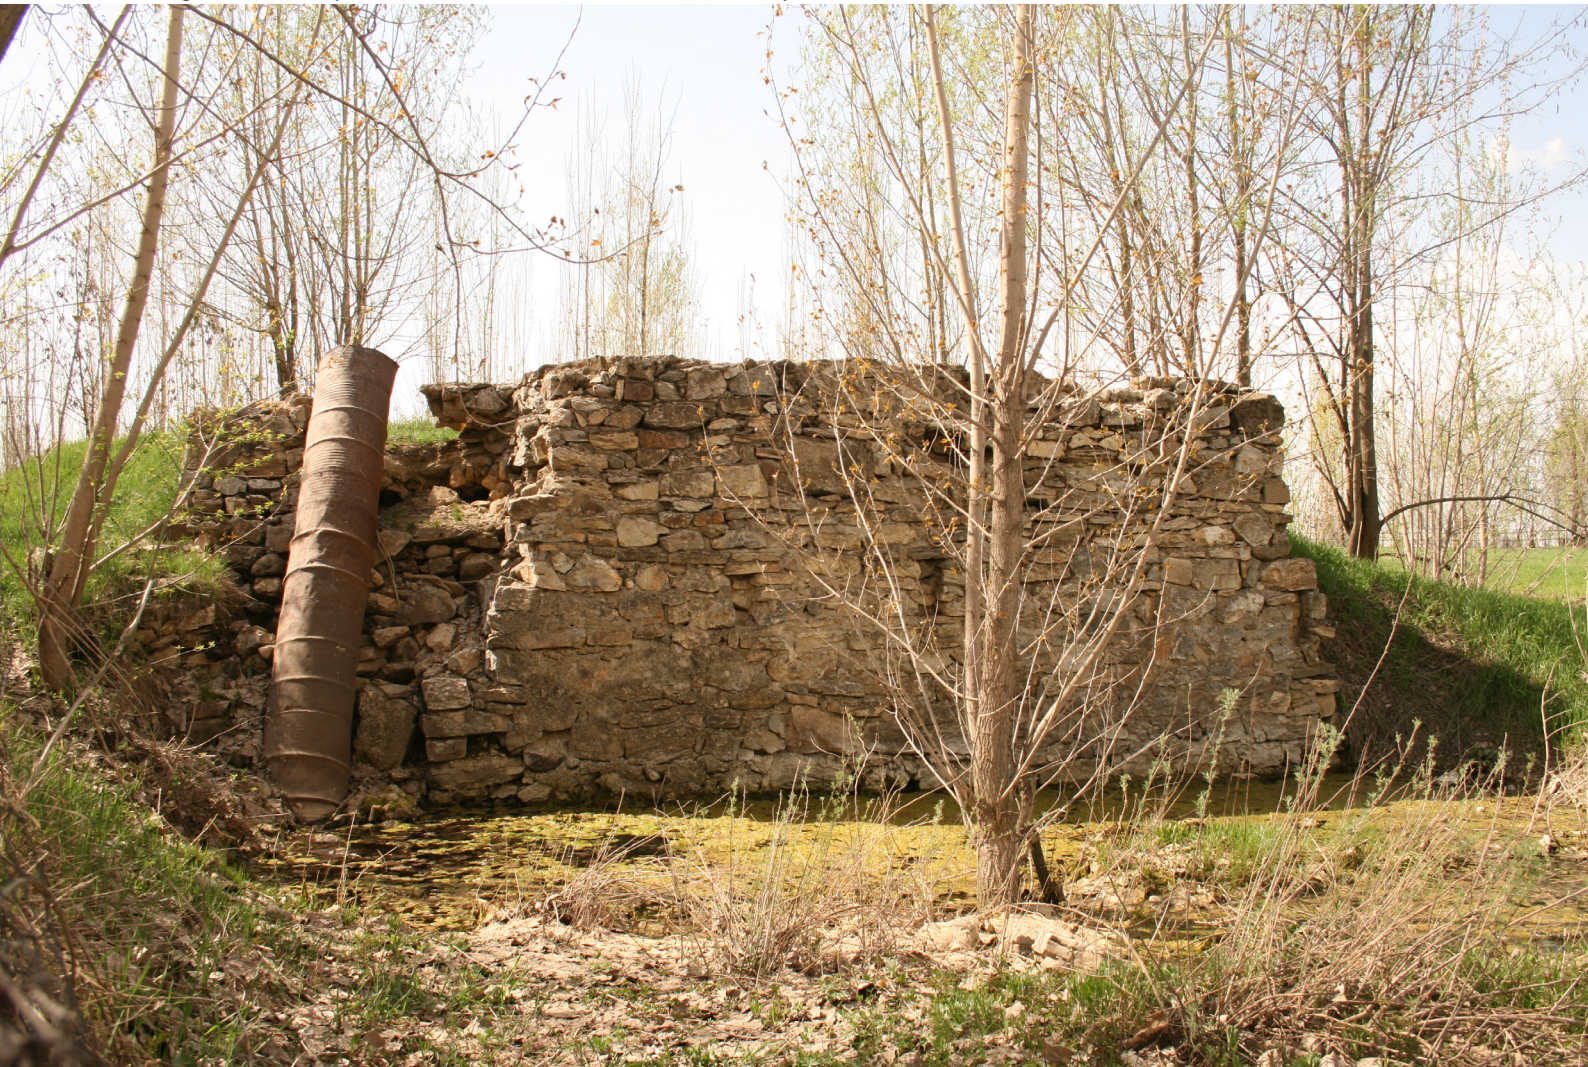
Fig. 2 - The Mill of Bedros, northeastern view with the marsh in front

The mill has lost its function since the amount of water in the river has decreased. The main interior space is no longer accessible. The structure is roughly 4 m tall and has two wells. It has a floor area that is situated on a northeast-southwest axis and measures 5.45x10.80 m. The part of the mill that receives the water from the upstream direction is now covered with cement-based screed; this intervention has hidden the original texture and most of the masonry. Nevertheless, it is visible from the northern and northeastern sides that the masonry structure was constructed using rubble (Fig. 2).

It is known that Sungu / Norşen Village, which was historically important for agricultural activity as well as being prosperous and cosmopolitan, was home to many mills because of the strong flow of Karasu River. 'The Mill of Bedros' is the only surviving example of these, so it must be part of a study that considers them in a holistic way. It is also recommended for this structure, which may be considered as industrial heritage, to be purged of inappropriate interventions as well as being made accessible and visible through pertinent cleaning works. A conservation study must be formulated in coordination with efforts to detect and preserve other historic mills in the area; this mill must be made suitable to exhibit its original function.

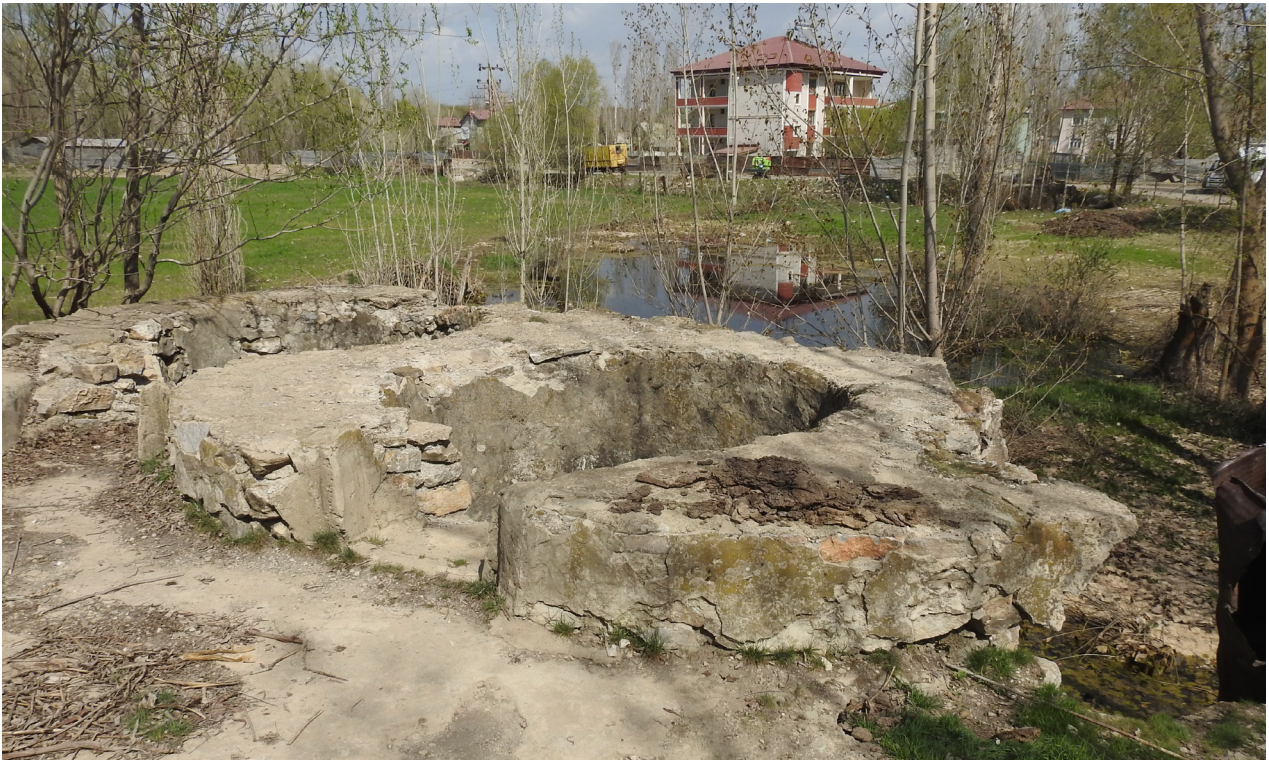
Fig. 4 - Elliptical well and a part of the screed-covered platform

The two elliptical wells are located northeast of the mill. The larger one is 2.00x1.79 m, while the smaller one is 1.96x1.66 m. They are 73 cm apart. The section that contains these two wells has been covered using a cement-based plaster (Fig. 4). To its south, there is a metal pipe with a diameter of 75 cm that may have been placed there to drain excess water at the upper level in its natural direction of flow. This pipe may have allowed excess water to flow between two planes that have a 4 m difference in elevation (Fig. 5).

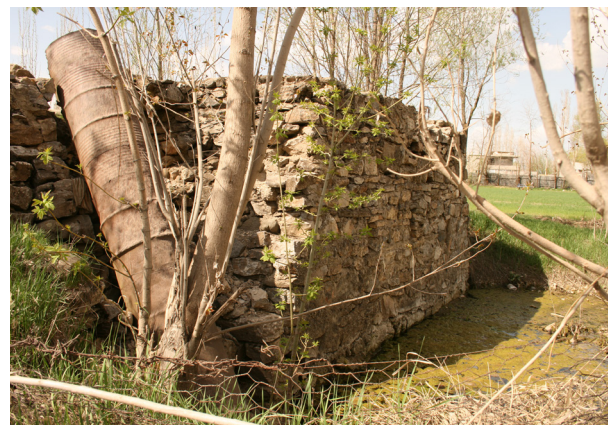
The mill is no longer in use due to insufficient water flow. The date of its abandonment is unknown, however, heavy interventions using cement-based materials suggest that it was functional until relatively recently. Currently, the structure is hardly visible and difficult to access. The heavy use of cement-based plasters during interventions, the uncontrolled growth of vegetation around the structure, and the marshy surroundings make it challenging to reach the structure.

Fig. 5 - Drainage pipe, eastern view
