MUSH

Architectural Heritage at Risk

This study, in which the historical structures of Mush are considered, primarily aims to assess the architectural history in the province, identify the current conditions of at-risk architectural works, and contribute to their continued existence through scientific suggestions. We believe that this book may be beneficial in the decision-making processes of relevant persons, institutions, and conservation boards since it contains information about settlement history, buildings' history, architectural analysis, legal status, risk assessment, and potential future scenarios. We hope that it may also help to transfer cultural heritage to future generations and create awareness.

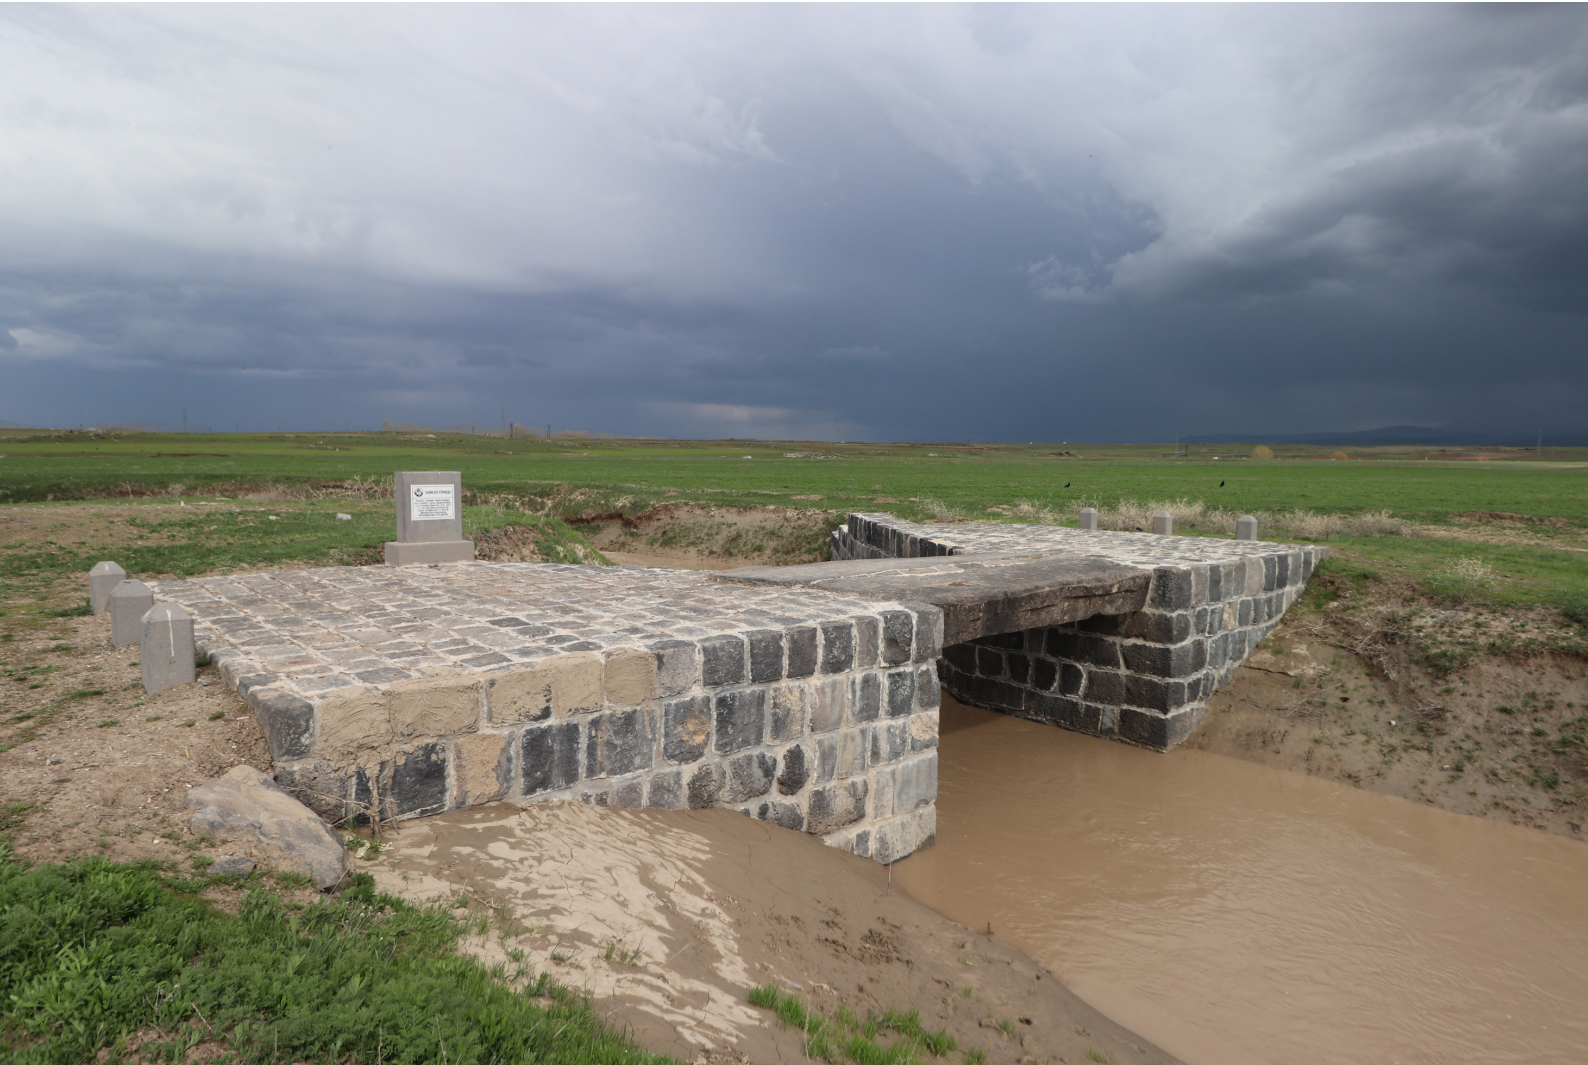
Fig. 1 - Southeastern view of Kız Bridge

The stream lies on a northwest-southeast direction and its 4.32 m-width as traversed using two basalt megaliths that are 55 cm in thickness. The length of the stones is approximately 4.60 m, while their widths are 1.26 and 1.14 m. During the restoration in 2019, the bridge was placed on walls made of rubble on either side of the stream, and a stone platform measuring roughly 6.00 x 5.50 m was built in both directions (Fig. 2). These platforms were closed to vehicular traffic through the use of stone balusters. The joints between the basalt stone blocks were filled with rubble and mortar; any dents or gaps were covered to fit the overall shape created by the original stones.

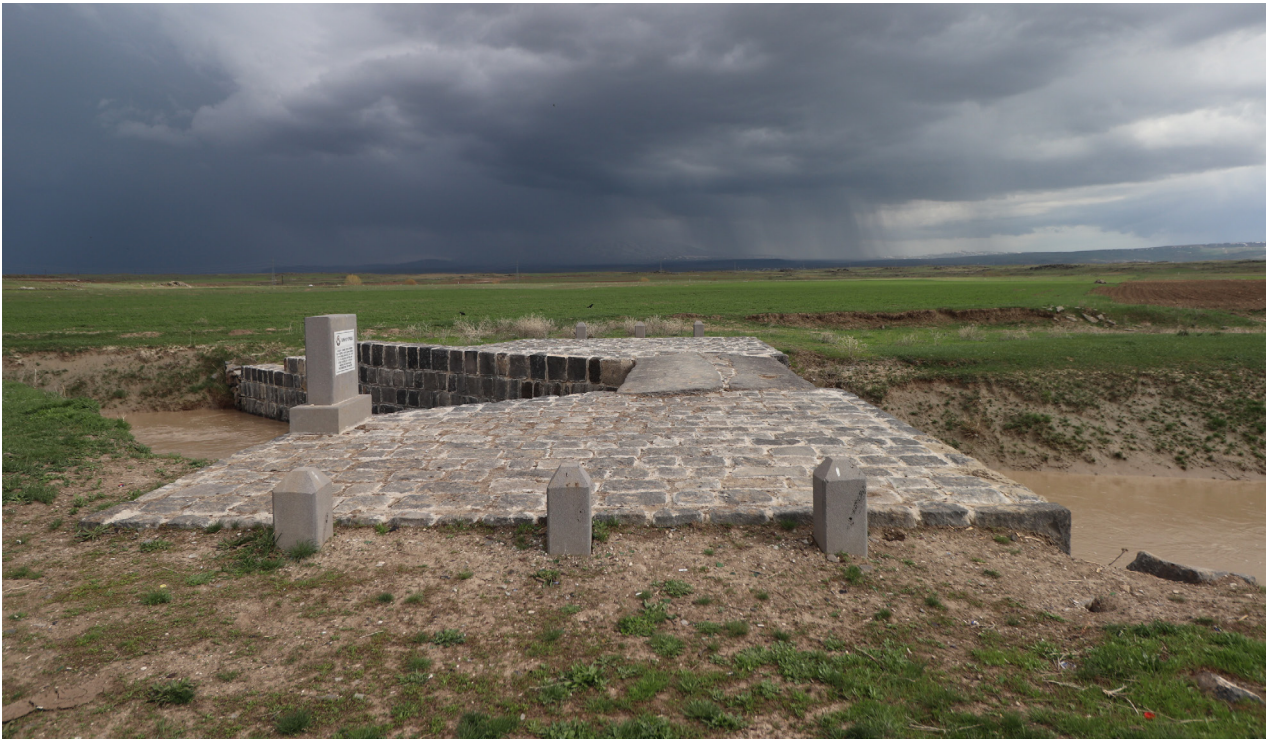
Fig. 2 - Eastern view of Kız Bridge

stone inscription that briefly informs visitors about its structural features and history. The walls of rubble that support the megaliths on either side of the stream were repaired and stone platforms were created for visitors. The structure is currently consolidated, but it has lost its relatively primitive features.

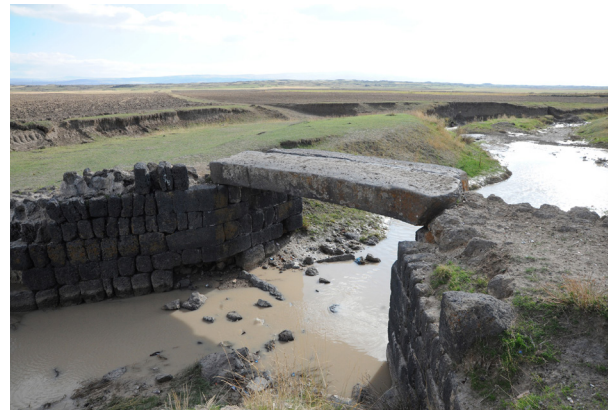
Kız Bridge is unique in terms of its construction technique and history. The bridge, which spans the stream it traverses using megaliths, was recently restored and adorned with a

Fig. 3 - Kız Bridge, before the restoration, 2014

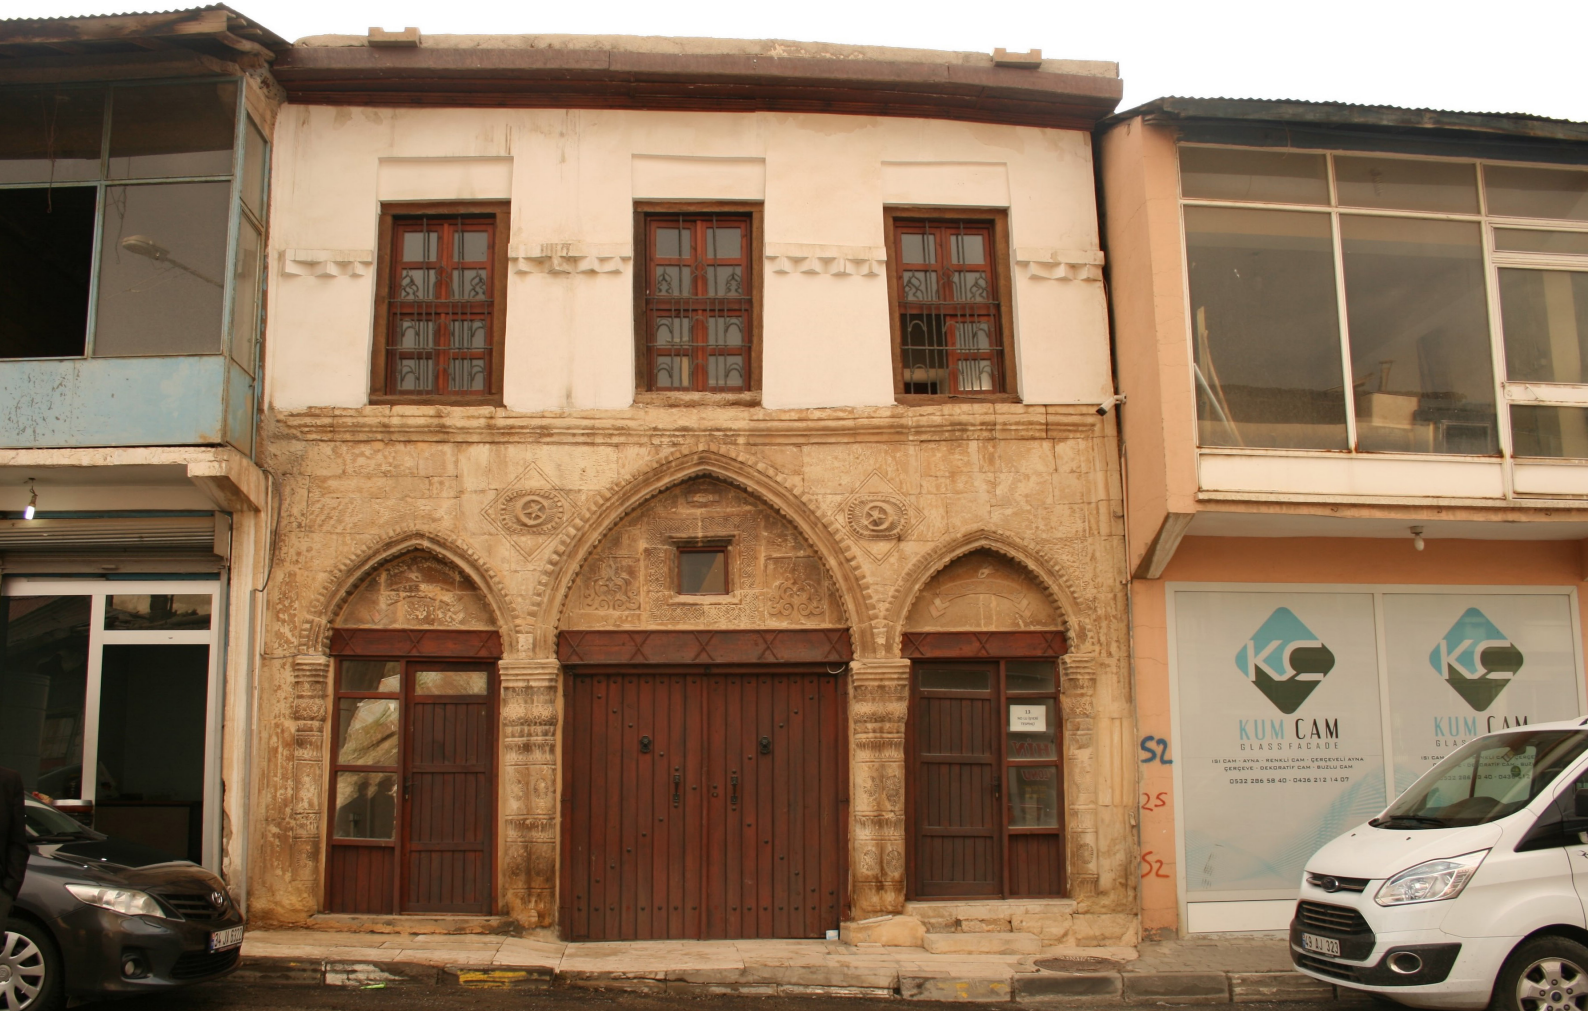
Fig. 1 - Yıldızlı Han and adjoining structures on Ziya Street

is noticeable among adjacent buildings due to its ornamentation. Entrance is through the two-story façade on Gazi Street, one of the busiest in the bazaar area (Figs. 1 and 2). The han comprises cells arranged around a rectangular courtyard and an adjoining entrance structure connecting it to the street (Fig. 3). A double-winged, wooden door leads from the street into a corridor with a wooden ceiling. This corridor, in turn, leads to the rectangular courtyard whose floor is covered with stone tiles. There are cells with shop windows around the courtyard. The cells are plastered with cement-based plaster, they also have wooden window casings and ceilings (primary beams with circular sections). A wooden staircase on the eastern edge of the courtyard leads to the level of the terrace, whose slab is of reinforced concrete.

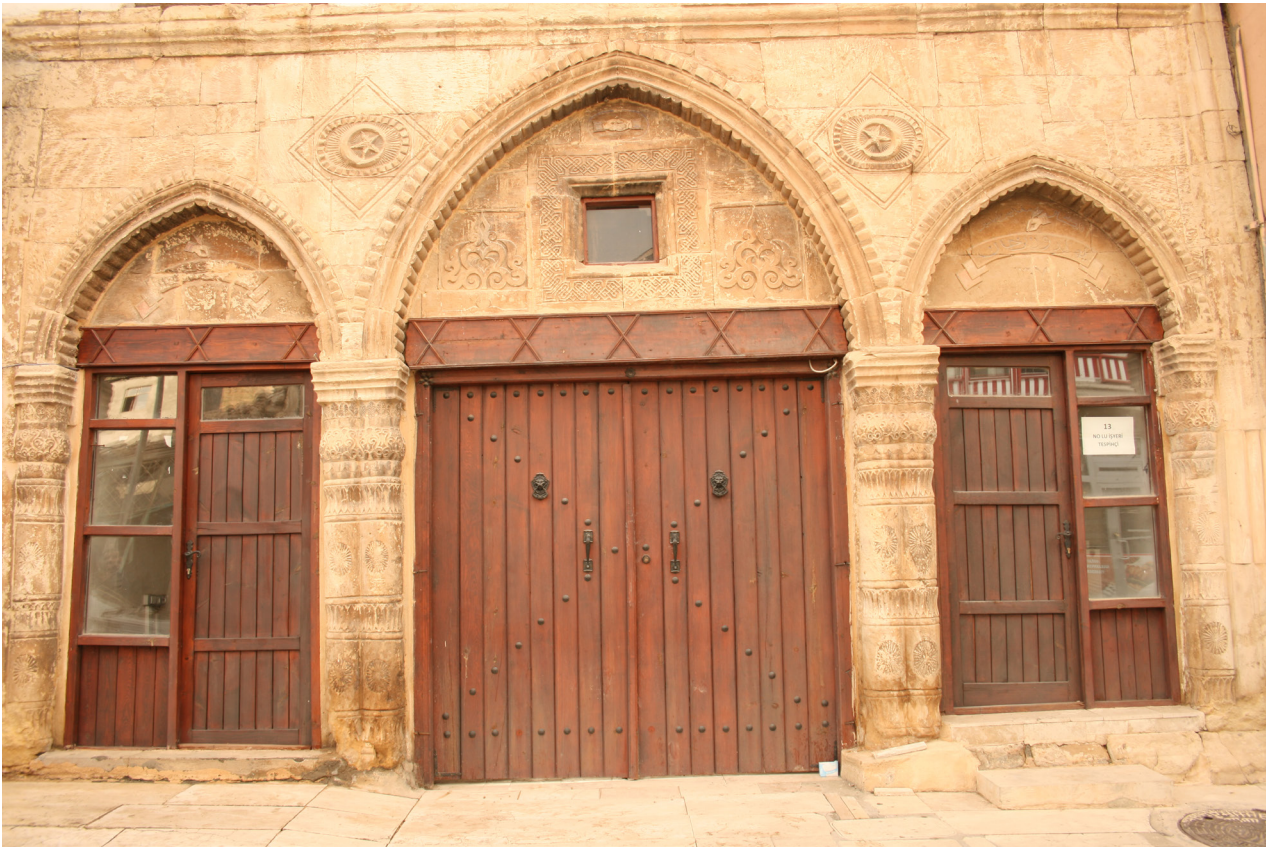
Fig. 2 - Yıldızlı Han, ground-floor of the entrance façade

The entrance façade is symmetrical. It contains three arched doors on the ground-floor level. The arch above the main entrance is wider and taller, there is also a flat lintel above the door (Fig. 2). The doors on the side provide entrance to shops that are only connected to the street such that they are independent from the rest of the han. There are pilasters with semicircular cross-sections between the arches. These are quite noticeable because of their ornamentation and remarkable moulding. The tops of their capitals are level with the arches' springing lines and consist of repeated concave moulding. An inscription in Ottoman is visible on the pediment of the northernmost arch while one in Armenian is visible on the pediment of the southernmost

arch; the latter has been damaged such that only a few letters are comprehensible (Fig. 2). There is a relief of a hand holding a quill, ready to sign a document, above both inscriptions. At the centre of the middle arch, there is a square-shaped window that is surrounded by a frame of geometric motifs (Fig. 4). A relief of a floral motif is visible on either side of the frame. There is a relief of two shaking hands above the frame. On the façade, there are oval ornamentations that each encapsulate a crescent-and-star relief situated in a diagonally-placed, square, double frame. The star is in the crescent; there are radial lines between the crescent and oval relief.

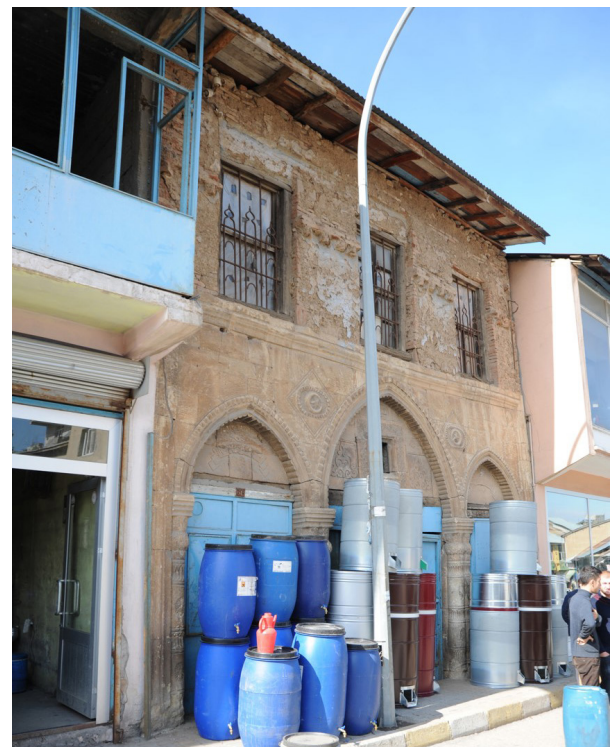
The upper level of the entrance façade has been recently repaired and plastered. Photographs from 2014 indicate that the three rectangular, wooden windows on the upper level had wooden lintels and brick casings (Fig. 5). The same images show that most of this level of the façade, which was imprecisely constructed using brick and rubble, was covered by adobe plaster. There is a decorative band created by two courses of brick near the upper levels of the window openings. The upper course is placed regularly, while the lower one is placed such that the corners of bricks are protruding from the façade. At the

Fig. 5 - Entrance façade of Yıldızlı Han in 2014

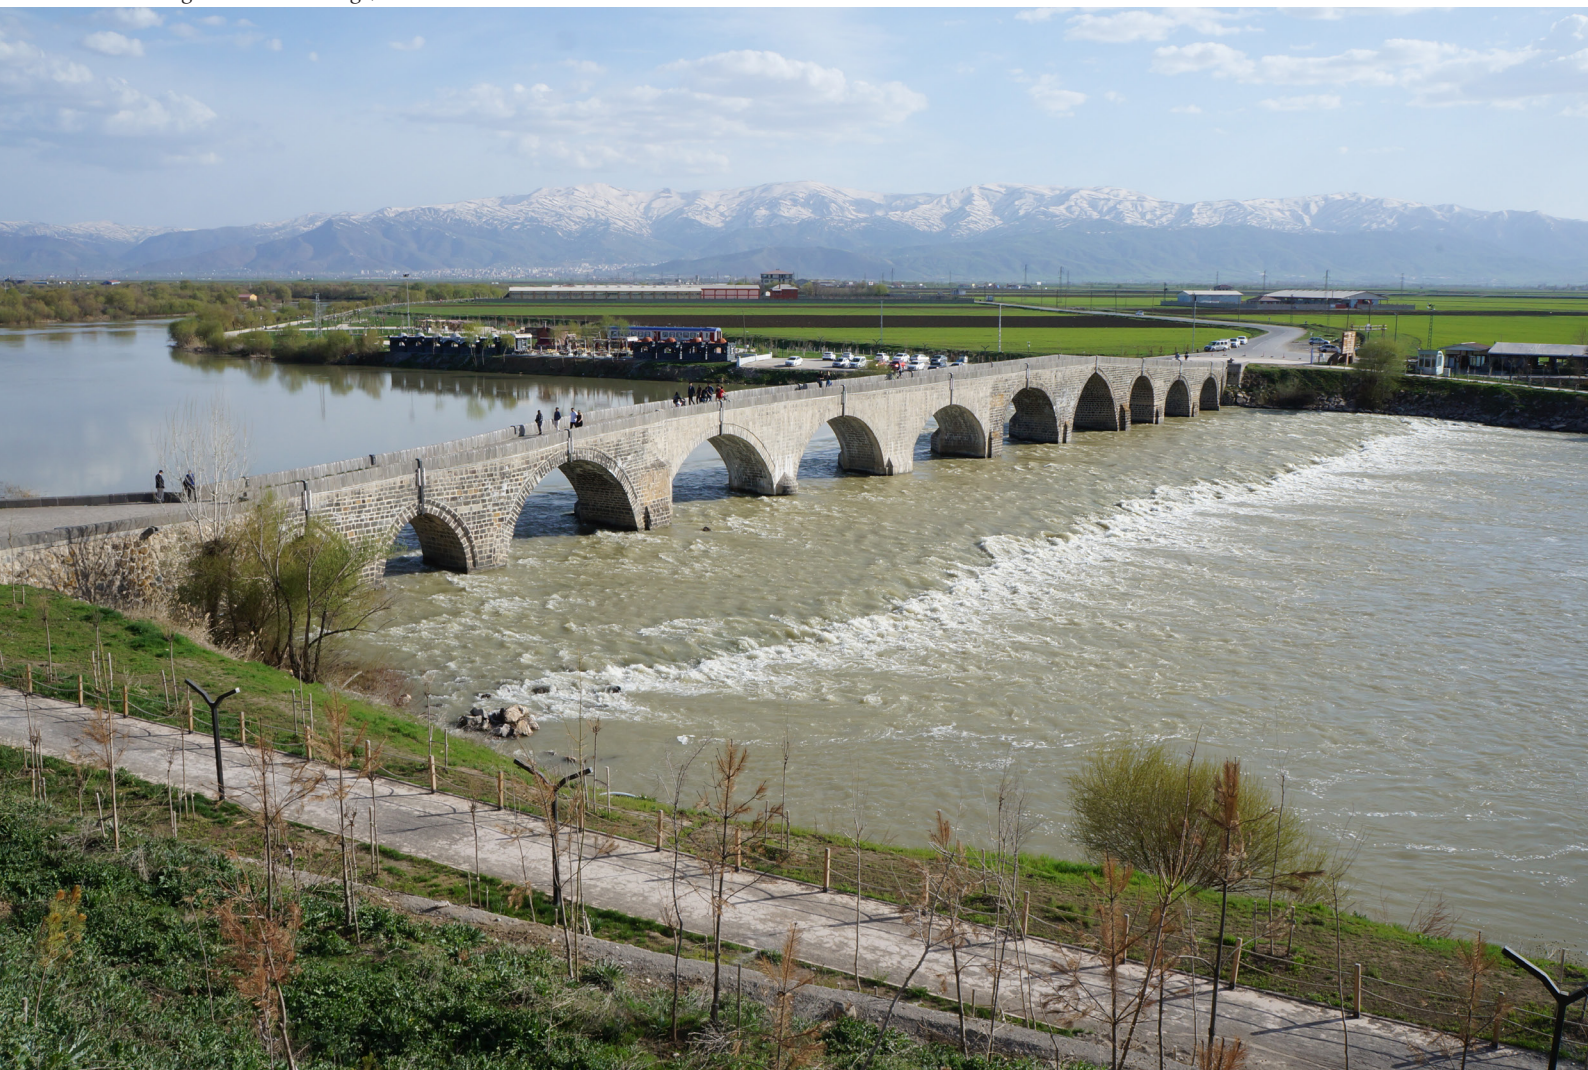
Fig. 1 - Murat Bridge, downstream direction

city to Bingöl and Erzurum (Fig. 1). The exact construction date of the bridge is unknown. Tunç (1978, 145) suggests that it is a Seljukid structure based on its architectural features, while Kulağuz (1997, 85) proposes that it may have been built in the second quarter of the 13th century considering the effect of Anatolian Seljuks on the region. Çulpan (1973, 190) writes that the inscription dated to 1817, which has since been lost, belongs to a previous repair.

roughly 140 m long and 4.80 m wide, with a total of twelve openings (Figs. 1 and 2). Its deck is sloped and covered with basalt tiles. There are parapets on either side of the buttresses in the downstream direction (Fig. 3). Indications of numerous damages and repairs are attested in the direction, deck, spandrel walls, and arches of the bridge. A primary indication is that the piers are not aligned in plan view; there are distortions in the direction of the structure (Fig. 4). A similar irregularity is attested on the deck, which bends after the fifth arch from the southwest. Each of the twelve openings is different in terms of its height and span, lacking any sense of order. Some of the arches are pointed, while some are semicircular. Different methods and materials are visible in the masonry coursings of the spandrel walls.

The deck flooring and parapets have been renewed, and the some of the masonry joints in the walls have been repaired as part of recent interventions. Furthermore, a lighting system was installed on the structure to encourage visitors to visit after nightfall. Cafes and restaurants have been opened around the bridge.

approach for Murat Bridge must be that it is a part of a natural landscape and that it should not be separated from its environment. Recent interventions have included a landscape reorganisation for the establishment of small eateries on either side of the river. This is advantageous for the structure's visibility, but these structures

should not be permitted to spread or become taller in a way that would damage the bridge or its natural landscape in the future. It will have especially adverse effects on the authenticity of this landscape if new commercial structures are built on the natural incline that follows the riverbed on the northeastern side of the river.

It is beneficial that the bridge was closed to vehicular traffic and only remains open to pedestrians. However, only the bridge has been repaired, while the roads leading to it from the north and south have been neglected. These connections could be renewed (to a limited distance) without damaging the natural landscape in order to slightly lengthen the route for visitors. Such an intervention would also benefit from the addition of some parking areas on either side of the river that are further from the bridge, and the restriction of vehicular approach to the structure.

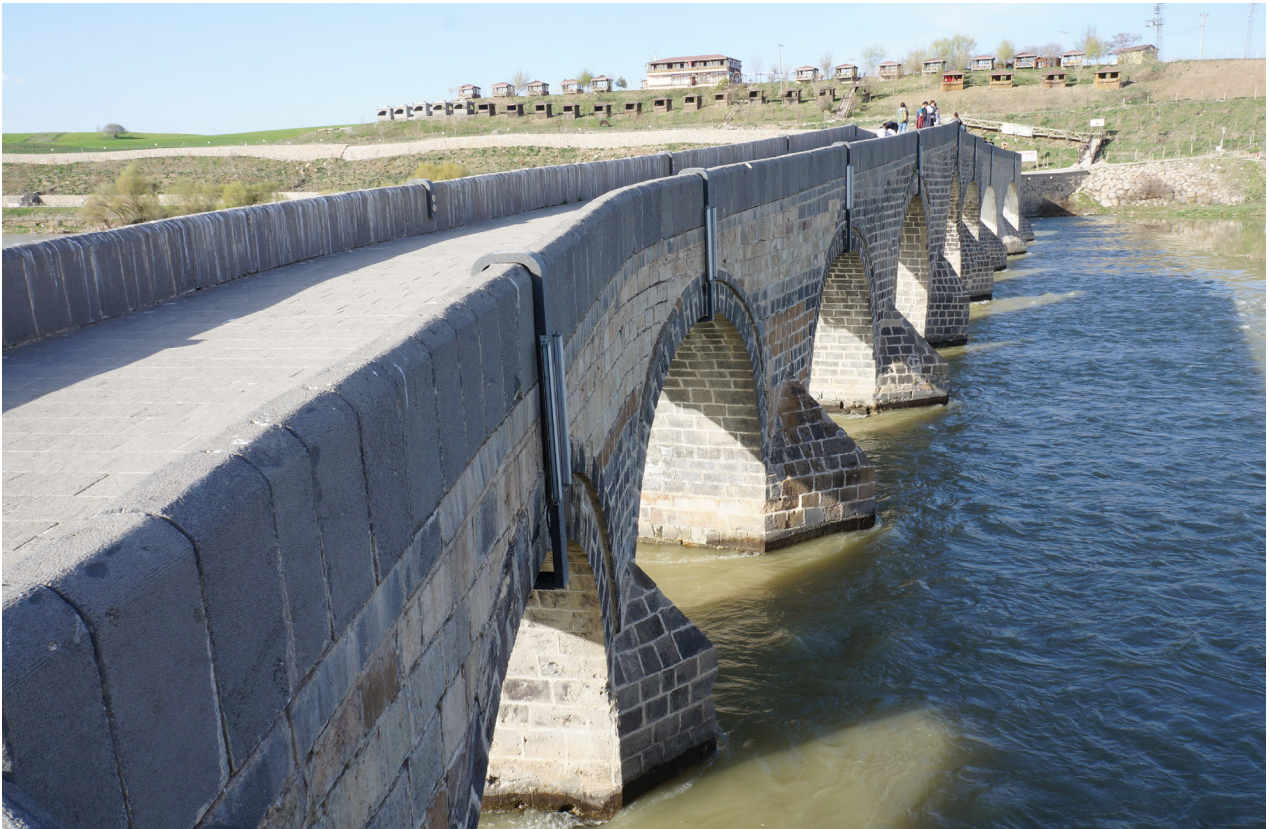
Fig. 3 - Cutwaters of the bridge facing the upstream direction
